**NOPSEMA**

Planned Inspection

Facility: Northern Endeavour  
Operator: Woodside Energy Ltd  
Offshore Inspection Dates: 25 April – 30 April 2014

Report Number 982

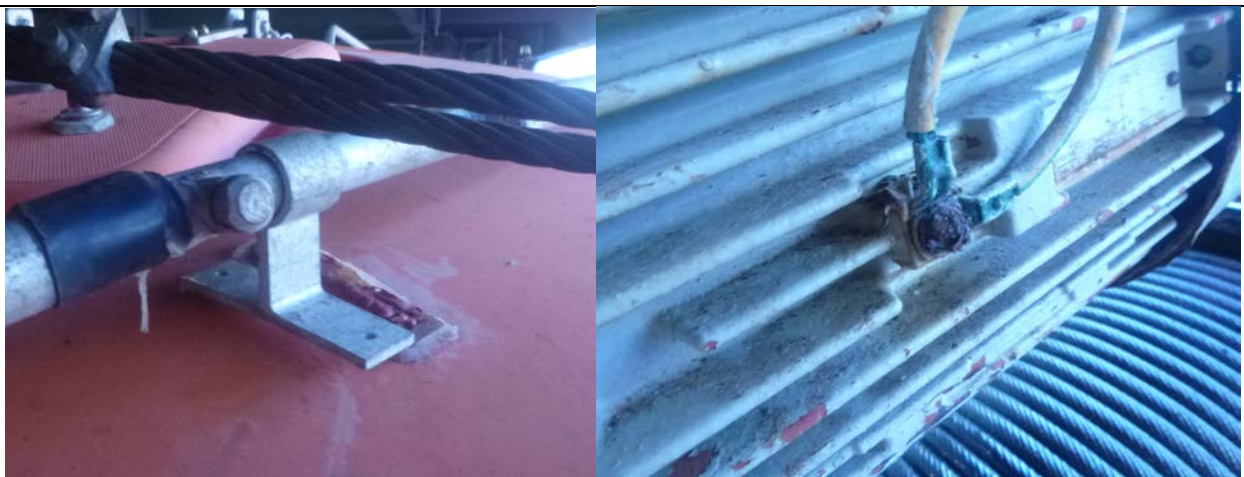
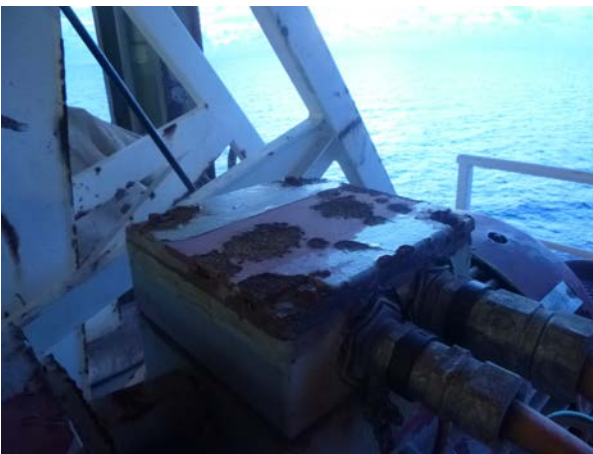
- Inspection of the lifeboats revealed that many of the defect items identified during the previous 3<sup>rd</sup> party annual inspection in May 2013, had not been completed:
  - Stbd Lifeboat items:
    - B4 – slight corrosion on keel shoe backing plates – requires removal and protective coating application
    - B6 – Deposits on propeller need to be removed
    - B13 – Port side air vent fell off – new vent required
    - B1 – Fwd. and Aft Skate wire corrosion require replacement
    - L1 – Coxswains window leaking – requires sealant
  - Stbd Davit items:
    - D1 – corrosion on winch, davit, sheaves and mounting on deck – requires removal and protective coating application
    - D13 – Aft fall wire turn turnbuckle corroded - requires replacement
    - D15 – Aft Maintenance pendant turnbuckle corroded- requires replacement
  - Port Lifeboat Items B1 windows, skate wires & deluge rail

- Port Davit D1 corrosion on winch, davit, sheaves and mounting on deck – requires removal and protective coating application

It was unclear whether all identified defects had notifications raised and assigned to them as no notifications were linked to the original yearly work order within SAP.

WEL to ensure defects raised during inspection and testing of lifeboats are reviewed and work orders raised as necessary, have notifications raised, are clearly linked to the original work order within SAP and are completed in a timely manner. The defects include but may not be limited to the following identified in the May 2013 annual inspection:

- Stbd Lifeboat items B4, B6, B13, B1, L1;
- Stbd Davit items D1, D13, D15, D1
- Port Lifeboat Items B1 windows, skate wires & deluge rail
- Port Davit D1 corrosion winch & sheaves

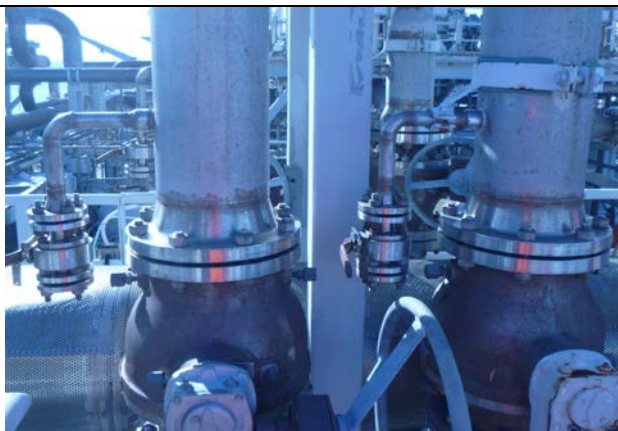
- Several small bore connections on the flare & Blowdown piping were identified by the workforce to have cracks. These pipe spools were subsequently replaced. This incident had not been reported to National Offshore Petroleum and Environmental Safety Authority (NOPSEMA) at the time of the inspection. Cracking on hydrocarbon containment pipework is a dangerous occurrence and requires reporting to NOPSEMA. It was suspected by operations personnel that the cause of the cracks was incorrectly installed bracing that had damaged the connections.

- The Coralline 1st stage separator PSV's. 21-PSV-221 has an Small Bore Connection (SBC) that is braced, while 21-PSV-045 and 21-PSV-044 are not.
- The debutaniser feed drum PSV's. 37-PSV-084 has a braced SBC, while 36-PSV-083 does not.
- Laminaria Separator choke inlet PSVs. 21-PSV-030 and 031, have identical SBCs. One of which is braced the other not.
- The debutaniser feed pre heater PSVs. 37-PSV-091 has an SBC which is braced, while 37-PSV-092 has an SBC which is not.
- Two small bore connections are braced to the pipe support next to the flow control valve (37-FCV-001) on the debutaniser preheater feed inlet. The main line is supported on resting supports allowing movement. The SBCs will therefore not be able to move with the pipe which could lead to excessive stress on their welded joints.

Figure 1 –Example of inconsistent bracing to deck SBC

WEL to undertake a review of all the small bore connections and their bracing on the topside hydrocarbon pipework to ensure that the pipework is fit for service and risk of cracking from vibration or static loading are reduced to As Low As Reasonably Practicable (ALARP). Consideration should be made to the following observations:

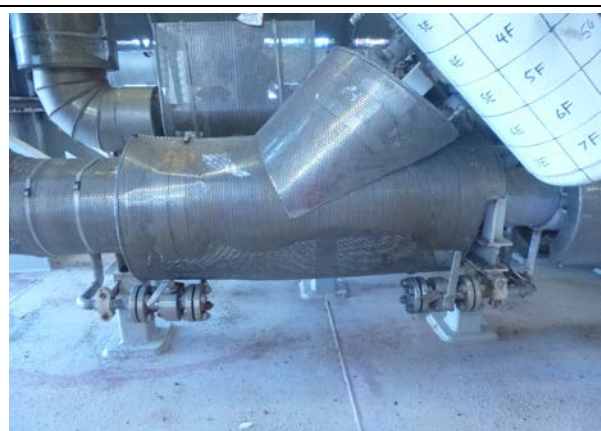
Figure 2 – Debutaniser preheater feed inlet braced to deck SBC

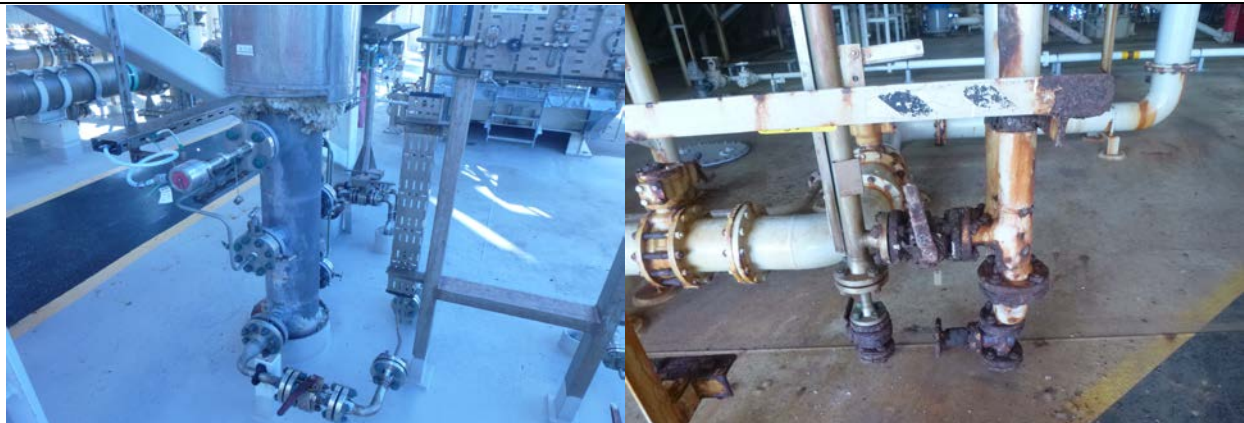
- There are several corrosion related findings:
  - Insulation on the LPG pump A discharge line (35-TE-011) is open to the elements so that the pipe is exposed to water beneath the insulation.
  - Starboard hazardous open drains level gauge 47-LG-006 and surrounding pipework is in very poor condition and requires repair.
  - Port hazardous open drains level gauge 47-LG-003 is in very poor condition and requires repair. A notification was raised (2100071754) on the 10 October 2010 for its repair.
  - Two isolation valves on the water ballast lines to slop tanks have their handles corroded off.
  - The Fast rescue Craft (FRC) launch controls box is in very poor condition

Figure 3 – LPG pump A discharge line insulation      Figure 4 – Corroded open drains level gauge

WEL to take action to rectify the following issues related to corrosion:

- Insulation on the LPG pump A discharge line (35-TE-011) is open to the elements so that the pipe is exposed to water beneath the insulation.
- Starboard hazardous open drains level gauge 47-LG-006 and surrounding pipework is in very poor condition and requires repair.
- Port hazardous open drains level gauge 47-LG-003 is in very poor condition and requires repair. A notification was raised (2100071754) on the 10/10/2010 for its repair.
- Two isolation valves on the water ballast lines to slop tanks have their handles corroded off.
- The Fast rescue Craft (FRC) launch controls box is in very poor condition.

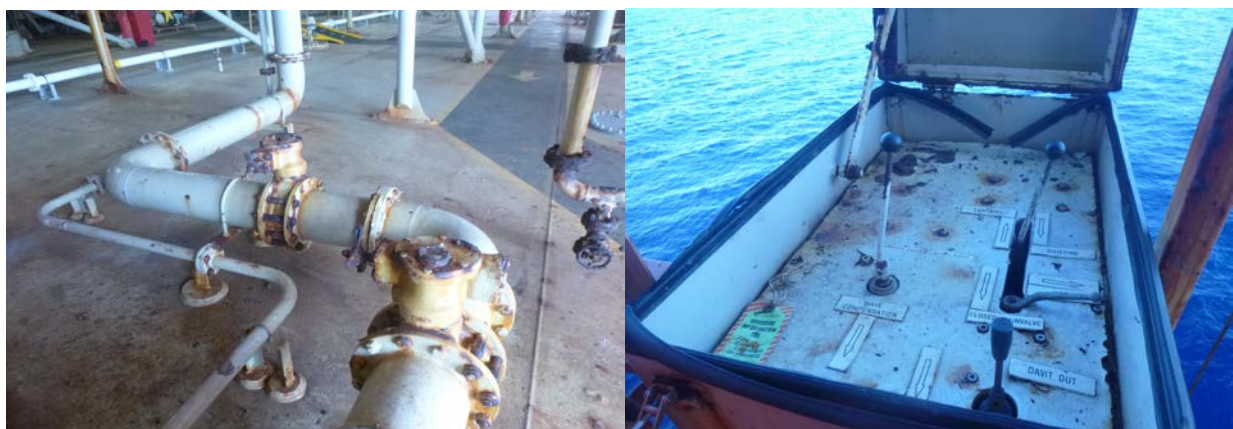
Figure 5 – Water ballast lines to slop tanks      Figure 6 – Corroded FRC launch controls box

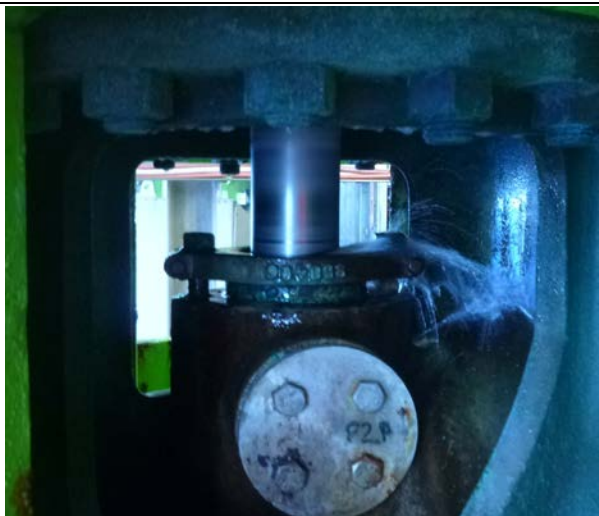
- Seawater fire pump B has water leaking from its drive shaft.
- The crude oil export cargo pump No 3 starboard has a notification (20099501) on it which was raised on the 23 July 2011 regarding a leaking mechanical seal.
- The passive fire protection on the port side forward life raft evacuation station is damaged and requires repair.
- The aft fire water diesel generator engine did not have a guard protection against burns on the engine jacket water pipework (both inlet and outlet)

Figure 7 – leaking seawater fire pump B

WEL to take action to rectify the following issues in order to ensure persons at the facility are safe and without risk.

- Seawater fire pump B has water leaking from its drive shaft.
- The crude oil export cargo pump No 3 starboard has a notification (20099501) on it which was raised on the 23 July 2011 regarding a leaking mechanical seal.
- The fire protection on the port side forward life raft evacuation station is damaged
- The aft fire water diesel generator did not have a guard protection against burns on the engine jacket water pipework (both inlet and outlet)

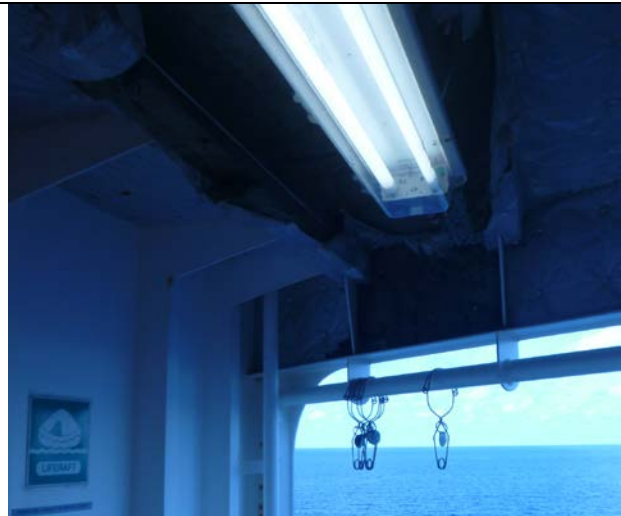
Figure 8 – Damaged fire protection Fwd life raft station
