Understanding of light well intervention safety systems is critical for safe operation

For further information email alerts@nopsema.gov.au and quote Alert 67. NOPSEMA safety alerts are published at www.nopsema.gov.au/safety/safety-alerts.

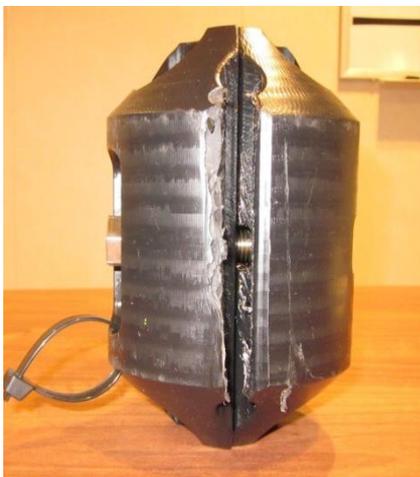
The 2-inch service hose, which remained connected to the subsea stack, is believed to have stretched under load, reducing friction with the clamp and leading to a rapid retraction of the wire by approximately 20 metres before the winch shut down on over-speed and the wire came to a halt. During the retraction of the wire, the upper two clamps collided with the sheave at the top of the tower on the vessel and parted; one of which dropped 27 metres to the deck below.

Image 1: Damaged dropped clamp

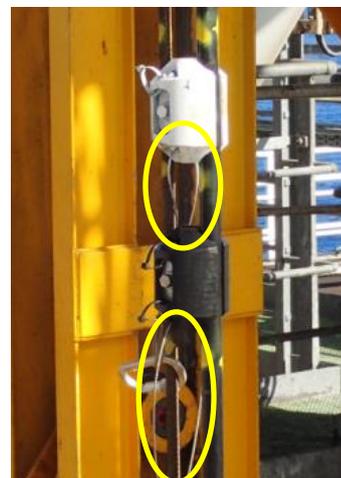
Image 2: Secondary retention subsequently fitted to the guide wire clamps

Secondary retention should be considered for all equipment (including temporary project related equipment) to be used at height and having the potential to cause harm.
