What happened?

Dropped Blocks

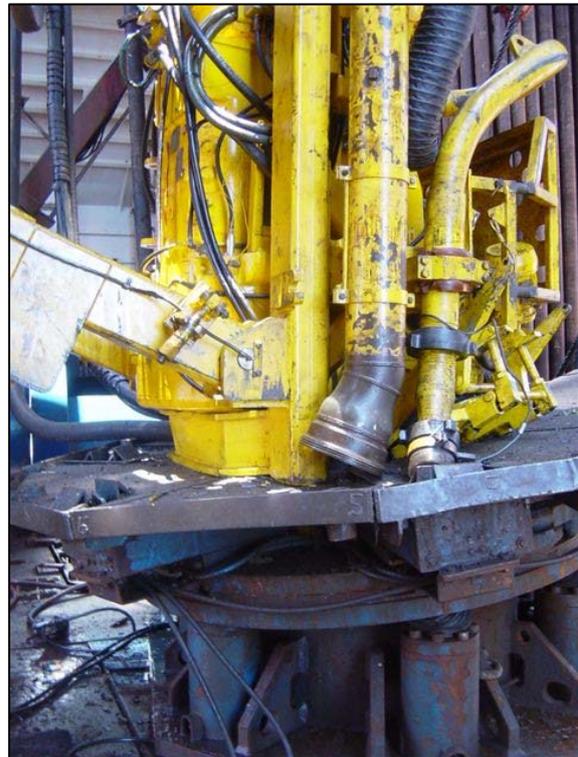
Top Drive impacted riser gimbal at rig floor level

The anti-bird nesting components were incorrectly installed thus limiting the 1200 psi used to function the service brake to 200psi.

When the drawworks were hoisted into the KEMS upper limit the anti-bird nesting system reduced the pressure to the service brakes from 1200psi to 200psi and the emergency brake pressure was dumped allowing the calipers to set. Due to the limited supply pressure of 200psi, the service calipers had minimal, if any, effect. The emergency calipers and Elmagco brake were not designed to stop the load under dynamic conditions on their own.

Causal factors included incorrect installation of the anti-bird nest / disc brake hydraulic interface; inadequate commissioning of the upgraded (6 months prior) disc brake system; the disc brake system handover from the supplier to rig personnel was inadequate; Management of Change process during system upgrade was not implemented effectively; and follow up and understanding of previous disc brake incidents was inadequate.

- Rigs equipped with disc brakes equipped with anti-bird nesting functions should be alerted to the potential problems arising from incorrect installation of hydraulic control valves.

- Commissioning procedures for modifications to existing facilities should be reviewed to ensure:
 - Commissioning is carried out on a complete system basis, as well as on the system interfaces.

- User training is adequate to obtain sound knowledge of the upgrade and its impact and interactions with other facility systems.
 - As built drawings and operating manuals are available to facility personnel for newly installed/upgraded systems

- Rig owners should review the implementation of their Management of Change process to ensure that it is properly implemented for upgrade work on their facilities with clear work scopes and accountabilities identified.
