Tensioner Failure

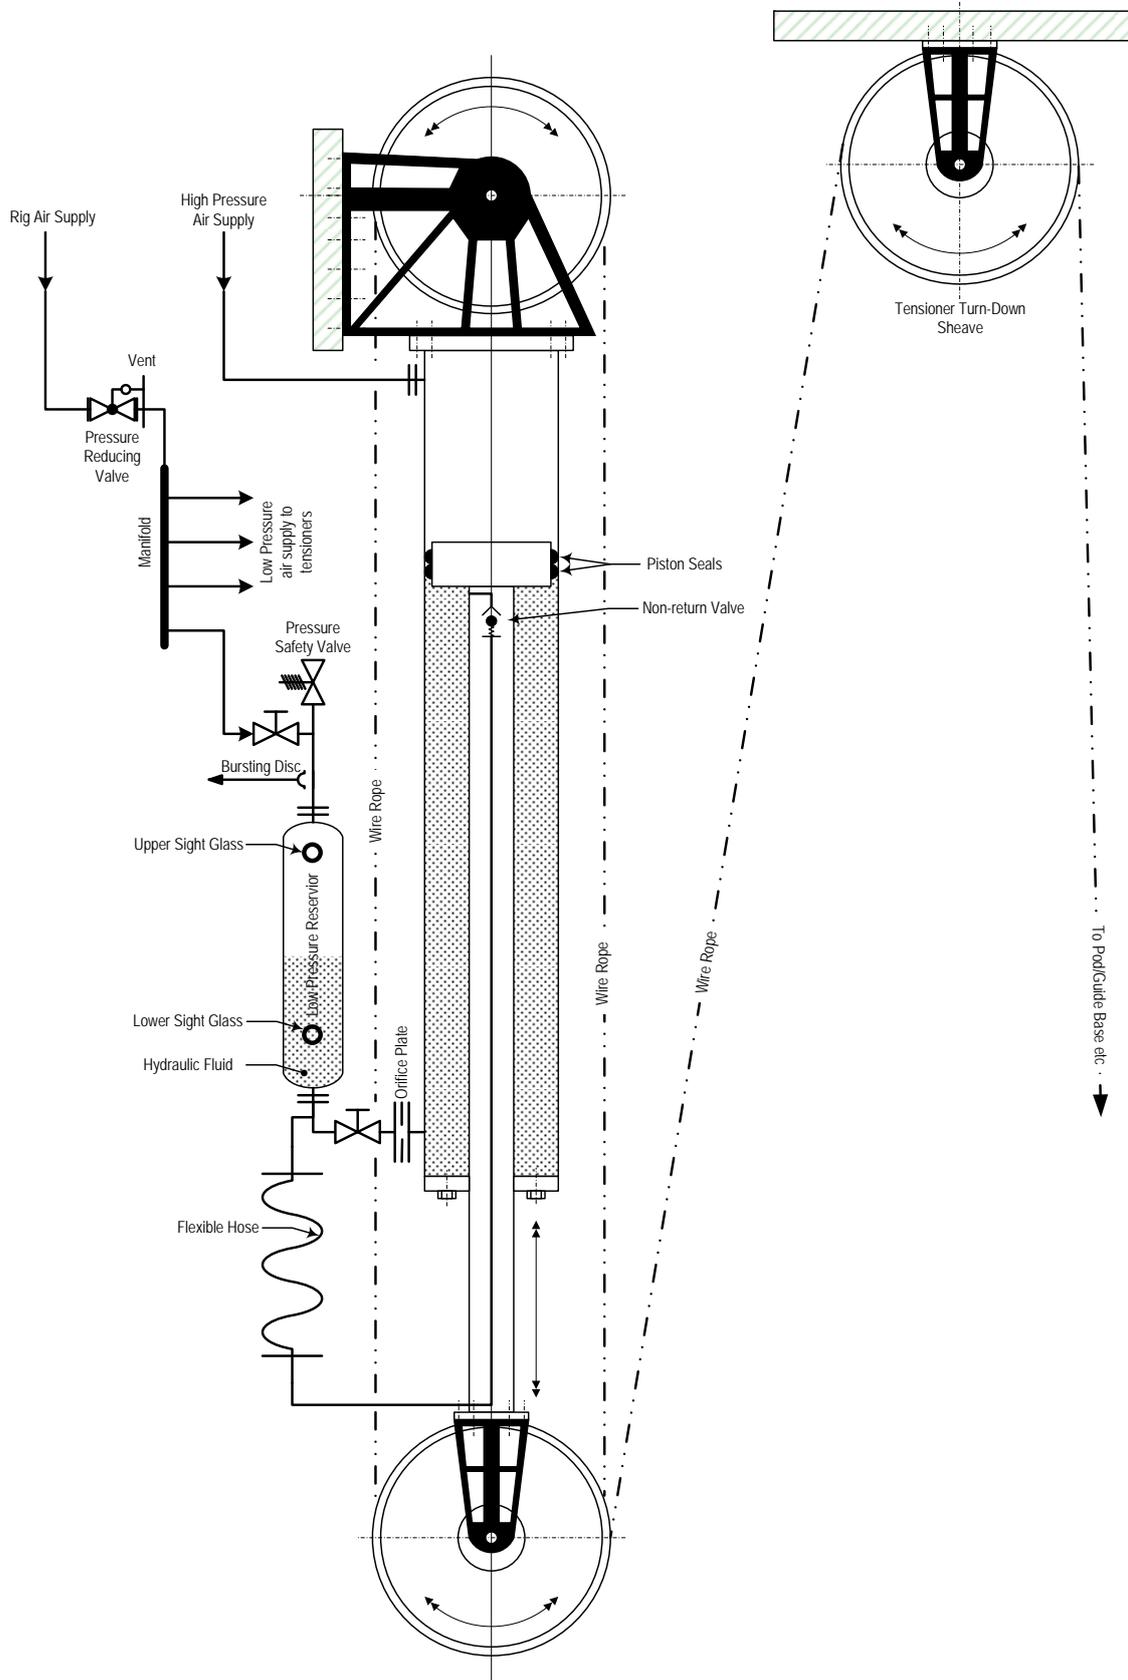
If a tensioner wire rope breaks, the load on the tensioner piston is suddenly released. The HP air pressure on top of the piston will force the piston to stroke out to the end of the cylinder in an unrestrained manner. To prevent this from happening, tensioners operating RED have the following design safety feature built into them. (*See the sketch attached to the end of this alert*).

When the piston moves downwards, it forces the hydraulic fluid in the lower part of the cylinder through an orifice plate and into the LP hydraulic fluid reservoir. For unrestrained motion of the piston, the flow of hydraulic fluid through the restriction of the orifice plate will be sufficient to restrain the speed of the piston and allow it to safely come to rest against the cylinder end cover plate without causing any damage.

For tensioners operating RED, this design safety feature incorporates a small purging non-return valve fitted into the piston rod just under the piston. The downstream side of the non-return valve is connected via a flexible hose back to the LP reservoir. When the piston is stroking downwards, hydraulic fluid is forced through the orifice plate at the bottom of the cylinder. This creates a small overpressure in the tensioner cylinder relative to the LP reservoir. The overpressure is sufficient to lift the non-return valve off its seat. Any HP air that has leaked past the piston seals will be vented through the open non-return valve and into the LP reservoir. When the piston rod moves upwards again, the non-return valve will close. The action of the purging non-return valve will keep the lower part of the cylinder purged of air and full of hydraulic fluid. It is therefore essential in maintaining the integrity of this design safety feature.
