| Titleholder name: | Woodside Energy (Victoria) Pty Ltd | Titleholder business address: | Mia Yellagonga,<br>11 Mount St<br>Perth WA 6000 | Title of environment plan for the activity: | Minerva Decommissioning and Field Management Environment Plan | |
| Activity type:<br>(e.g. drilling, seismic, production) | Decommissioning | Month, Year: | March 2025 | Facility name and type:<br>(e.g. MODU, Seismic Vessel, FPSO) | Minerva Pipeline (VIC/L22) | |

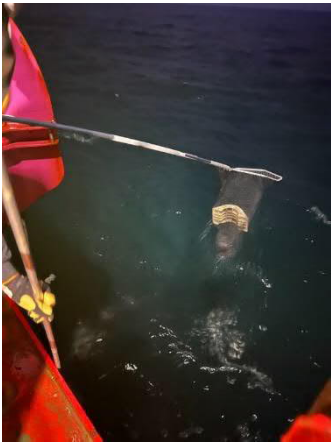
Figure 4: Piggyback clamp being recovered to deck using pool scoop.
