## **Incident Summary Notice**

Environmental – Marine Debris

Date: 12/01/2025  
Location: Seven Sisters

- Synergi Case Number: 24929200
- Project: Minerva Decommissioning
- Project Location: Minerva Field
- Specific Location: KP9 vicinity
- Work Process / Activity: Dredging
- Incident Classification: Environmental consequence - marine debris

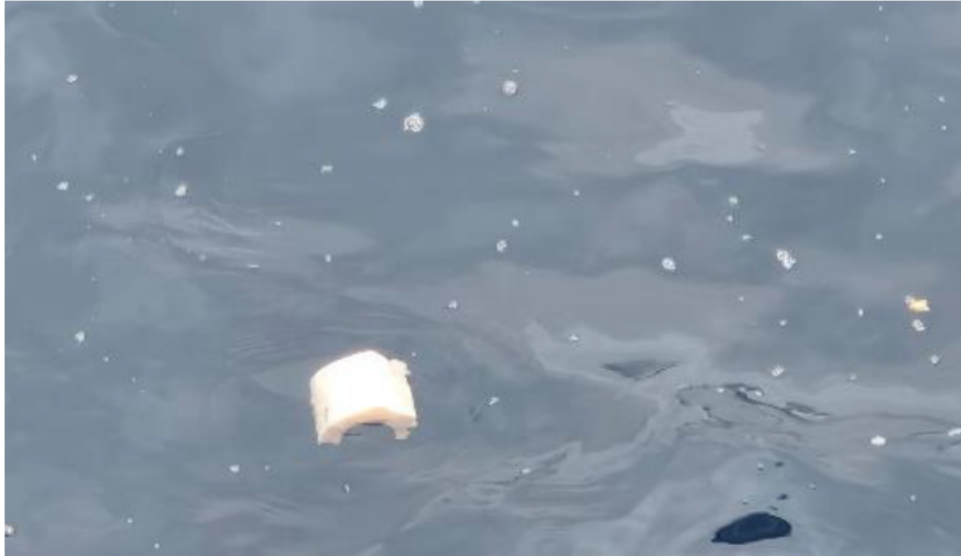
On the 12/01/25, whilst the vessel was dredging in the vicinity of KP9, a white plastic saddle less than 100mm x 100mm was observed floating on the port side of the vessel. Initial assessments were that the item became dislodged during the dredging activities however it is not known if it was due to the dredging equipment contacting the plastic bundle or from the water pressure of the dredger. A risk assessment was undertaken to determine if recovery was safe and practicable. The debris could not be reached from the vessel and it was deemed not safe or practicable to launch the rescue craft given the safety risk to personnel was significantly higher to attempt recovery than the environmental impact of the bundle spacer lost to the marine environment.

**#1: Plastic saddle sighted in water.**

- #1
- Action type: Temporary
- Deadline: 12/01/25
- Action required: Attempt to safely recover the plastic saddle.
- Person responsible for action: [REDACTED]
- Status: Attempt unsuccessful
- Action taken: [REDACTED] was advised and attempt to recover considered however, could not be reached from the vessel and sea conditions were not amenable to launch a recovery vessel. Personnel safety and practicability assessment was undertaken, and the decision was made that the safety risk to personnel was significantly higher to attempt recovery than the environmental impact of the plastic saddle lost to the marine environment. Recovery was deemed to not be practicable which also includes the risk of launching and using the fast rescue craft.
- Action completion date: N/A

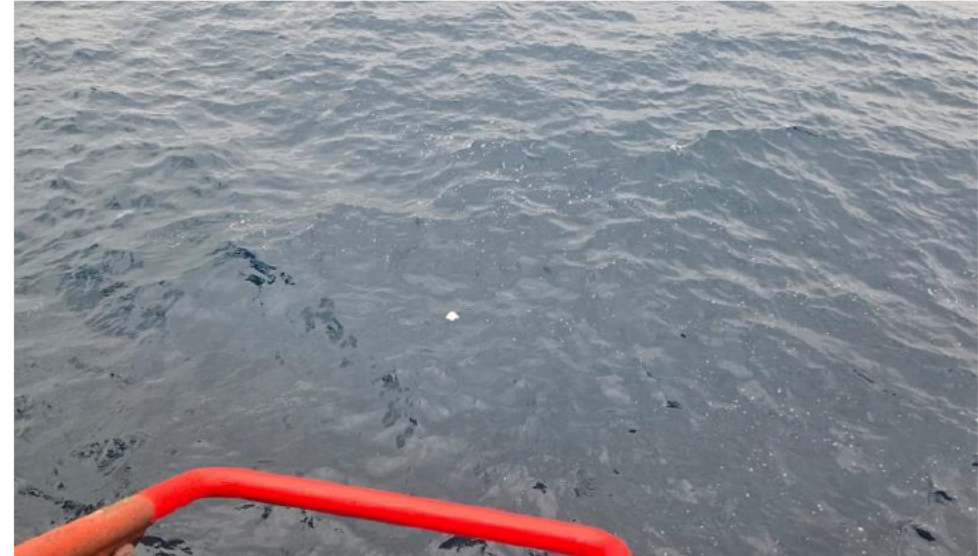
**#2: Plastic saddle sighted in water.**

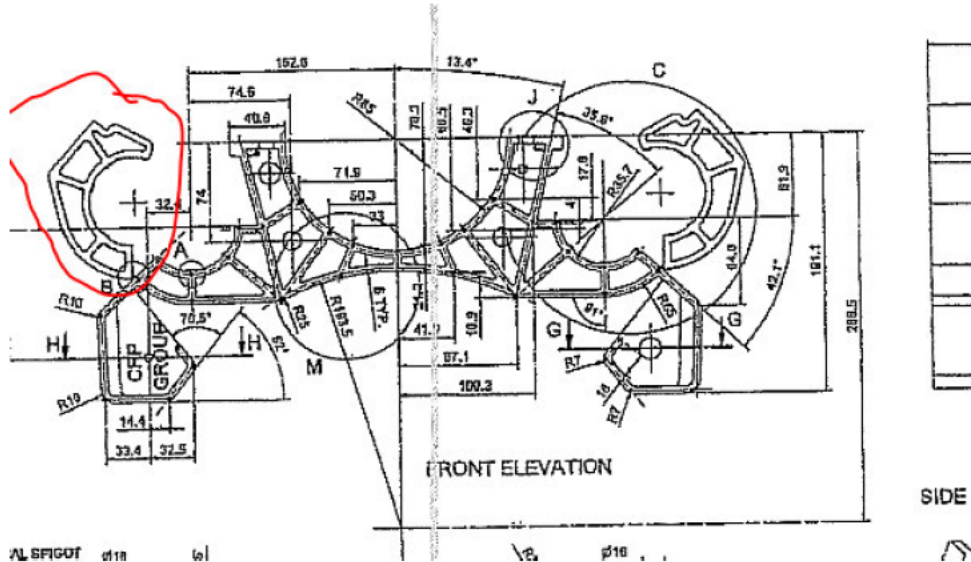
**#2: Detail of bottom part of plastic saddle. Circled in red is the part that was identified in the water.**

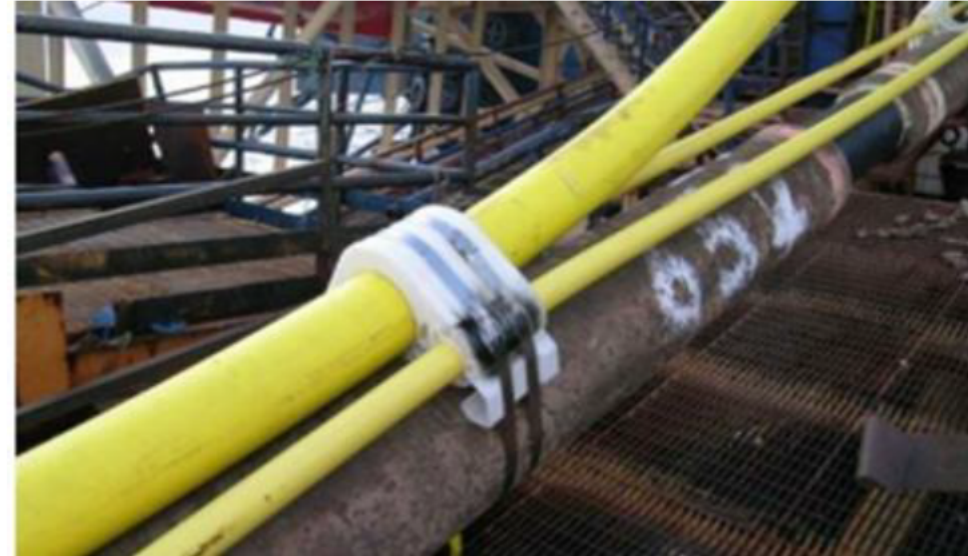
- The wind was approximately 5 knots and wave height of 1.5m at time of incident.
- There are approximately 1000 of the plastic saddles currently subsea on the infrastructure with a risk of these becoming dislodged during the activity. The risk is likely to increase during the pipe cutting stage and if the cutting device is close to the plastic saddle.
- The pipe bundle will typically be cut into 11m sections for recovery and saddles are typically spaced 6m apart.
- The plastic saddles and banding straps are over 20 years so their structural integrity may have reduced.

**#4: An existing photo during construction showing the plastic saddle bundled together with other pipes.**
