| Please check the following boxes if applicable to this report | | | Nil Incident Report: <input type="checkbox"/> | Final report for this activity: <input type="checkbox"/> | |
|---|---|---|---|--|--|
| RMS Assessment: 7780 | | | | | |
| Titleholder name: | Woodside Energy (Victoria) Pty Ltd | Titleholder business address: | Mia Yellagonga, 11 Mount St Perth WA 6000 | Title of environment plan for the activity: | Minerva Decommissioning and Field Management Environment Plan |
| Activity type: (e.g. drilling, seismic, production) | Decommissioning | Month, Year: | March 2025 | Facility name and type: (e.g. MODU, Seismic Vessel, FPSO) | Minerva Pipeline (VIC/L22) |

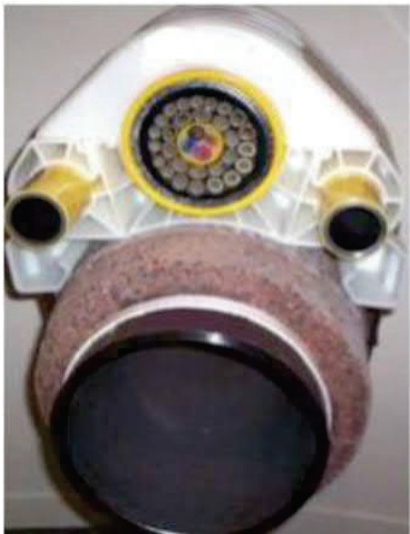
Figure 1: Piggyback clamp

| | <p>now reached the end of their 20 year design life.</p> <p>It has been observed on ROV footage during pipeline cutting with the hydraulic shears, fragments of piggyback clamps being dislodged and floating to the surface. Stored energy held within the 2-inch injection line and 5-inch umbilical is released placing stress on the piggyback clamps resulting in the breaking of stainless steel straps and releasing piggyback clamp components to the marine environment.</p> <p>The piggyback clamps consist of 7 separate components that are held together with two stainless-steel straps (see Figure 3, Appendix A).</p> <p>It has been estimated that approximately 150 individual components have been lost in Commonwealth Waters, resulting in the release of approximately 65 kilograms of polypropylene into the marine environment over the period from the 4/03/2025 to 31/03/2025. Whilst the dimensions of some of the individual components are below PS 9.2 debris criteria of 300 mm x 300 mm, this report includes all components lost as a cumulative total during March 2025.</p> | | <p>the water or observed on ROV footage during pipeline cutting.</p> <p>Procedural Enhancements: Undertook a procedural review of the cutting methodology to cut at least 0.5 m either side of the clamp, to minimise the release of stored energy and reducing stress exerted on the bundle clamps.</p> | <p>for evaluation of saddle integrity and identification of any lost or damaged components.</p> <p>In parallel, the shear cutting methodology was revised. Adjustments included targeting cuts at field joints to reduce the number of cuts and the associated stress on both the pipe bundle and clamps. The closure of the shear gap enabled cleaner cuts, which should further minimised stress on the pipe bundle clamps.</p> | <p>Woodside conducted an initial targeted coastal survey was conducted on the 10 April to identify and retrieve any dislodged piggyback clamps. Additional costal surveys are proposed for April utilising a combination of visual inspections from lookout locations using binoculars and beach inspection where access is safe, focusing on likely landing locations from the drift trajectories as determined by hydrodynamic modeling.</p> <p>Environmental Risk Assessment: An environmental risk assessment was undertaken to review the risk from unplanned release of plastic piggyback clamps to the marine environment, in response to this incident. The risk assessment includes a review of ecological effects resulting from the presence, movement, or degradation of the lost components within the marine and coastal environment.</p> <p>The assessment includes consideration of all controls, analysis of the risk reduction proportional to the benefit gained and final acceptance or justification if the control was not considered suitable. The assessment demonstrates that the impacts and risks are reduced to ALARP and are of an acceptable level.</p> <p>The Environmental Risk Assessment will be included in a Management of Change to the Minerva Decommissioning and Field Management (Cth) EP, with additional control measures incorporated into the Environmental Commitment and Assessment Register.</p> <p>To date clamp losses outlined in this report have been confined to Commonwealth Waters. Woodside intends to follow the same process outlined in this report if clamps are dislodged during decommissioning activities scheduled for April/May in Victorian State Waters. Minerva pipeline removal activities in Pipeline Licence VIC-PL33 are covered under the Minerva Decommissioning and Field Management</p> |

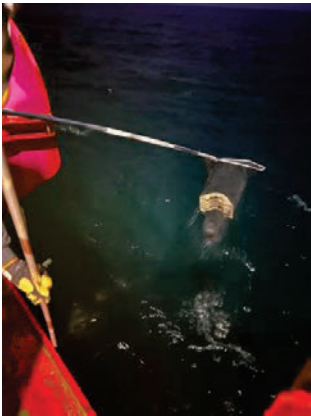
Figure 4: Piggyback clamp being recovered to deck using pool scoop.
