# Watertight doors and hatches kept open at sea

# Safety alert 51

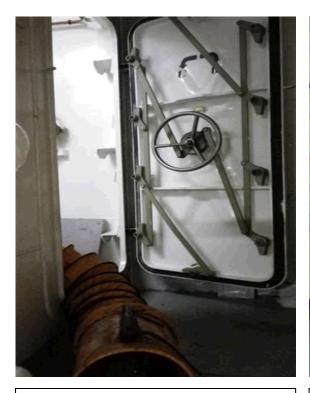
Photo 1 – Water tight door to High Precision Acoustic Positioning System space, marked "To be kept closed at sea" left open and blocked with ventilation trunking. The facility was in Dynamic Position mode close to a petroleum production platform.

Leaving these doors unattended and permanently open at sea, especially during Dynamic Position operations and when the vessel is close to another facility, increases the risk to the health and safety of personnel. SOLAS II-I Regulation 22, regarding the prevention and control of water ingress, describes how watertight doors should be used, including how and when these doors can be left open and when they need to be closed.

- Operators of vessels that are facilities should ensure compliance to load line, stability (intact and damage) and watertight integrity requirements.
- Operators should ensure they are fully compliant with commitments made in their safety case.
- Operators should ensure their personnel are aware of the risks and their responsibilities associated with leaving watertight doors unattended and in the open position when at sea.

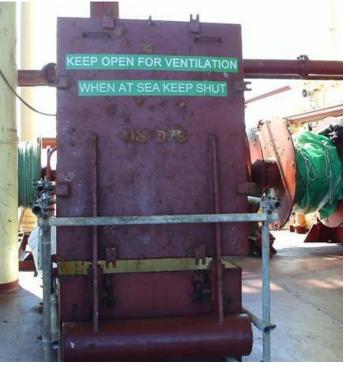
Photo 2 – A large hatch on an FPSO was left open while the FPSO was connected to a buoy. The hatch leads to lower machinery spaces. The hatch is clearly marked "When at sea keep shut".
