Collared Eyebolts as Lifting Equipment

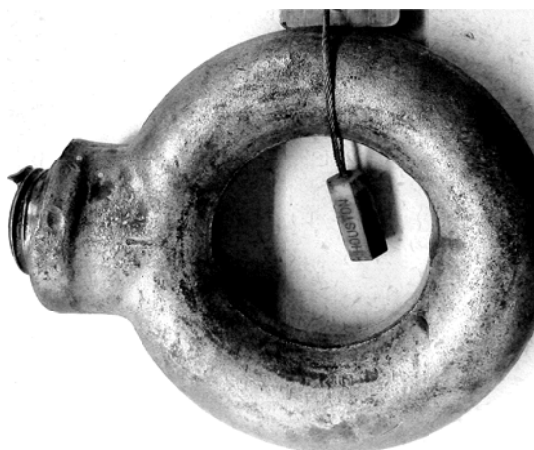
Fig. 1: Failed eyebolt

MODU crew were replacing the diverter on a MODU facility operating in Australian waters. The new diverter had been placed on its side in a cradle on the main deck for change-out of the flex-joint. Subsequently, the diverter was lifted with the intent of rotating it from the horizontal to its working, vertical axis. When the diverter had been lifted between 1.2 to 1.8 metres above its cradle, one of the two collared eyebolts used for lifting the diverter body sheared, see Figure 1 below. This caused the diverter to rotate and the second eyebolt to become dislodged from the diverter body. The diverter then fell back into the cradle on the main deck. The combined diverter and the running tool weighed approximately 21.7 tonnes and fell a distance of 1.2 to 1.8 metres. No persons were injured in the incident.

- The lifting equipment was configured such that the direction of pull was at an angle to the shaft of the eyebolt, so that a “fleet angle” from the vertical was created. An angular load such as this reduces the Working Load Limit (WLL) of the eyebolt significantly. See Figure 2 below;
- The collar of the eyebolt was not fully flush with the body of the diverter, causing a shearing force due to the fleet angle to be applied to the shaft of the eyebolt, instead of the load being spread across the eyebolt’s collar and the surface of the diverter as per design.

- Lifting arrangements such as spreader bars to ensure that the lifting force is applied in line with the axis of the threaded shaft of the eyebolts should be considered when planning lifts;

- Eyebolts should be tightened fully down to the face of the lifted load. It should not be possible to fit a 0.04mm feeler gauge at any position between the collar of an eyebolt and the lifted load. However, eyebolts should not be over-tightened;

- A shim washer might be required to ensure that the direction of the load is aligned with the plane of the eye;
- Where the direction of the lifting force on the eyebolt is at an angle to the axis of the threaded shaft of the eyebolt that exceeds 5 degrees the Working Load Limit of the eyebolt will be significantly reduced. This must be taken into account when planning a lift using eyebolts;

- Collared eyebolts should only be used up to an angle of 45 degrees to the axis.
