**RE: STYBARROW VENTURE: MPA Compressor 1st Stage Flow Restrictor Valve Failures – 21<sup>st</sup> April & 11<sup>th</sup> May**

## STYBARROW VENTURE: FLOW RESTRICTOR VALVE LEAKS

Brief Description: Repeat gas releases from MPA Compressor 1st Stage Suction instrument tapping for SIS PIT-0301A-06.

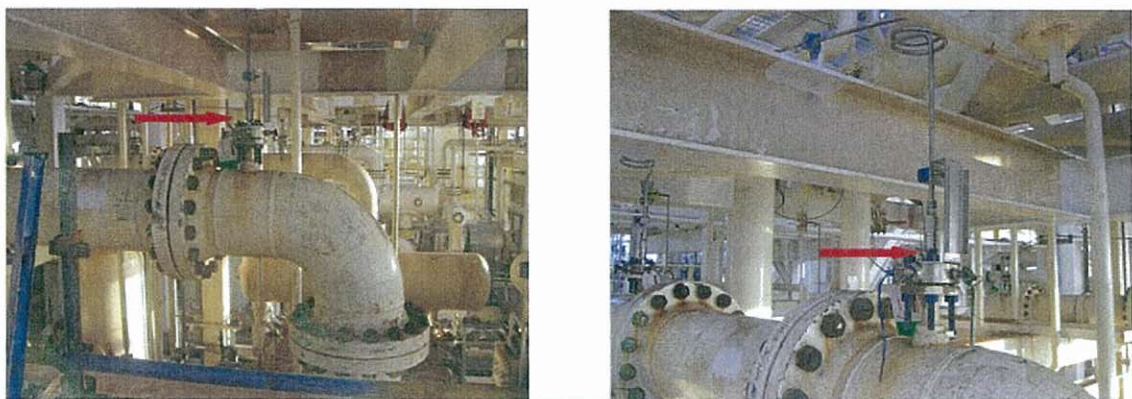
From the vibration surveys completed the vibration of the 1st Stage Suction piping is high, and the change to FRVs with heavy wall tubing loops in 2009 has exacerbated the prevailing high vibration of the small bore FRV & tubing when compared to the new build instrument hook-up arrangement. Lab reports and removal of all other FRVs has confirmed that these threaded valves were over-tightened – overtightening creates a high residual stress in the threaded component that reduces its fatigue life and therefore accelerates fatigue failure.

Figures 1 & 2 Pre-event Piping and Instrument Tubing arrangement at MPA 1st Stage Suction

- (4) All tubing pigtails temporarily replaced with flexible hose connections under an approved Temporary ECR prior to returning compressors to service

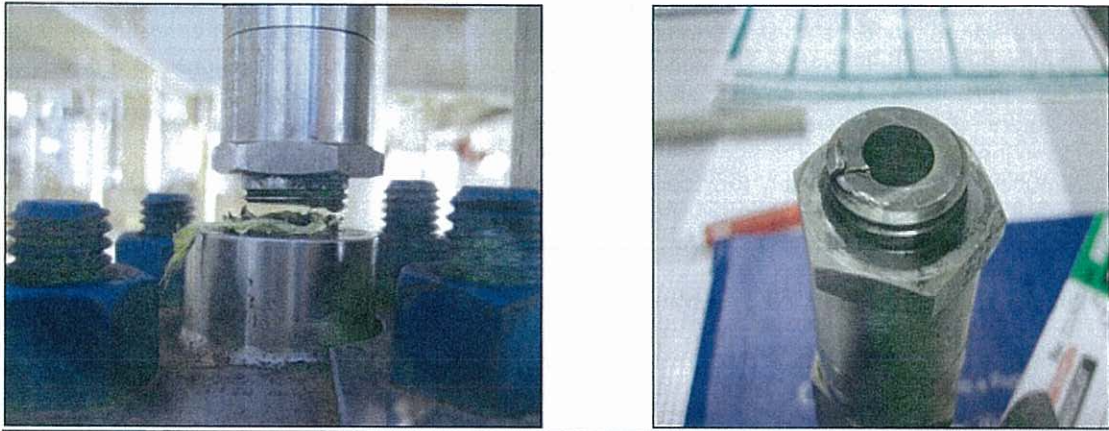
The fractured FRVs were inspected, and in both cases found to have fractured right through the inlet threaded section.

The failure root cause has been confirmed as vibration induced mechanical fatigue which was accelerated by over-tightening of the FRV NPT thread.

Figures 3 & 4 Close-up of Failed Flow Restrictor Valve

- (2) All Flow Restrictor valves have been removed and either replaced with new ones (enough spares for one compressor only), or NDT performed to assure integrity of any that are to be temporarily re-used. Installing Technician's have been re-advised of the correct tightening method for NPT threaded connections.

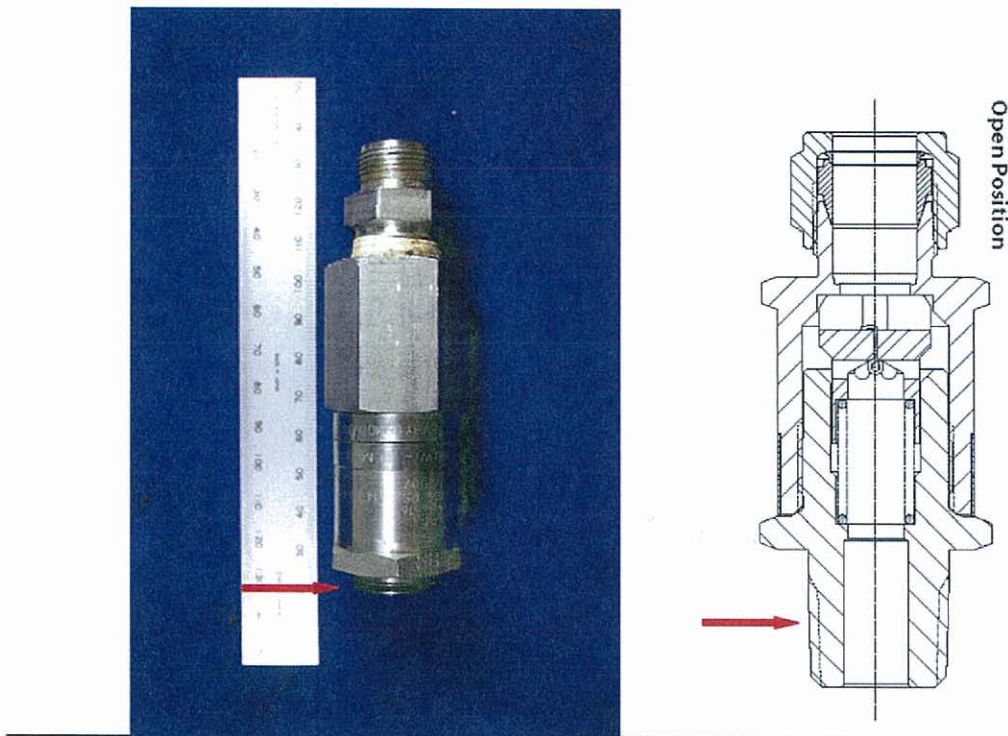
In both incidents the running MPA Compressor tripped on low low pressure in the 1st Stage Suction as read by field SIS Pressure Transmitter PIT-0301A-06. The cause of the low low pressure signal to the transmitter was sudden fracture of the threaded inlet section of the 414 bar (6000 psi) rated flow restrictor valve (FRV), which therefore created the reported gas releases. Soon after tripping, the MPA compressor package was blowdown in a controlled manner, and then isolated and Nitrogen purged to prevent further leakage. It was estimated for both events that 22kg of gas escaped to atmosphere from the fractured flow restrictor valves.

The FRVs specified and installed in 2009 were the NACE certified Hoke make XVH Series with NPT threaded connections for the inlet and outlet ports. These threaded FRVs valves are commonly used in the offshore hydrocarbon industry and are key elements of standard instrument tubing hook-ups for FPSO's such as Griffin Venture, Pyrenees Venture for other Operators such as Woodside. These FRVs are pressure rated for 414 bar (6000 psi), and the wall thickness in the fracture zone is 6 mm plus the NPT thread form.

Figures 5 Failed Flow Restrictor Main Body & 6 Flow Restrictor Cross Sectional Drawing
