INCIDENT INVESTIGATION SUMMARY	
IMPACT Incident ID	667751
Incident Title	Cobia failed nipple on CBA 2430 seal oil regulator
Incident Date	26/2/13
Site	Cobia
Investigation started / completed	02/03/13 to 19/03/13 (dd/mm/yy)

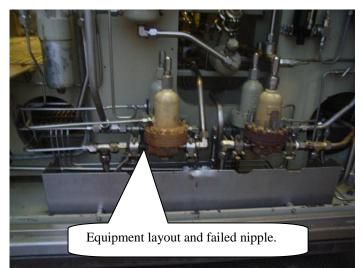
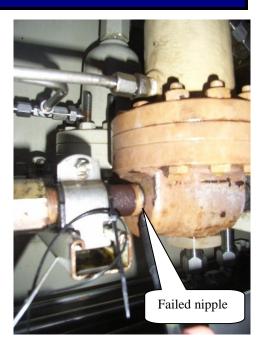
The failed nipple was a 20mm diameter NPT carbon steel schedule 80 nipple with a wall thickness of 3.91mm. In this type of service the ExxonMobil Design Specification, *Piping wall thickness selection tables (03-06-03)* requires a schedule 160 wall thickness of 5.56mm to be used for carbon steel screwed NPT threaded piping.

The failure of the nipple was determined to be as a result of fatigue failure for the following reasons

- Reduced wall thickness (schedule 80 vs. Schedule 160)
- Vibration from within the turbine module causing stress
- The location of the failure is consistent with vibration induced fatigue failure

Sched 80 nominal wall thickness 3.91mm

6 threads engaged into regulator body

Action Item Description	Custodian	Verifier	Target Date	Priority	R C
Replace the nipple with a schedule 160 nipple			Complete	1	*
