Title:Major Investigation Report Angel Loss Of Containment Piping Failure On Coalescer B Vent Line Welev13060135

**Major Investigation Report: Angel Loss of Containment :
Piping Failure on Coalescer B Vent Line -
WELEV13060135
Asset/Site: Angel Facility
Date of Occurrence : 20th June 2013**

Incident Reference: WELEV13060135

Location, Date and Time: Angel Facility, 20th June 2013, 01.12 hrs

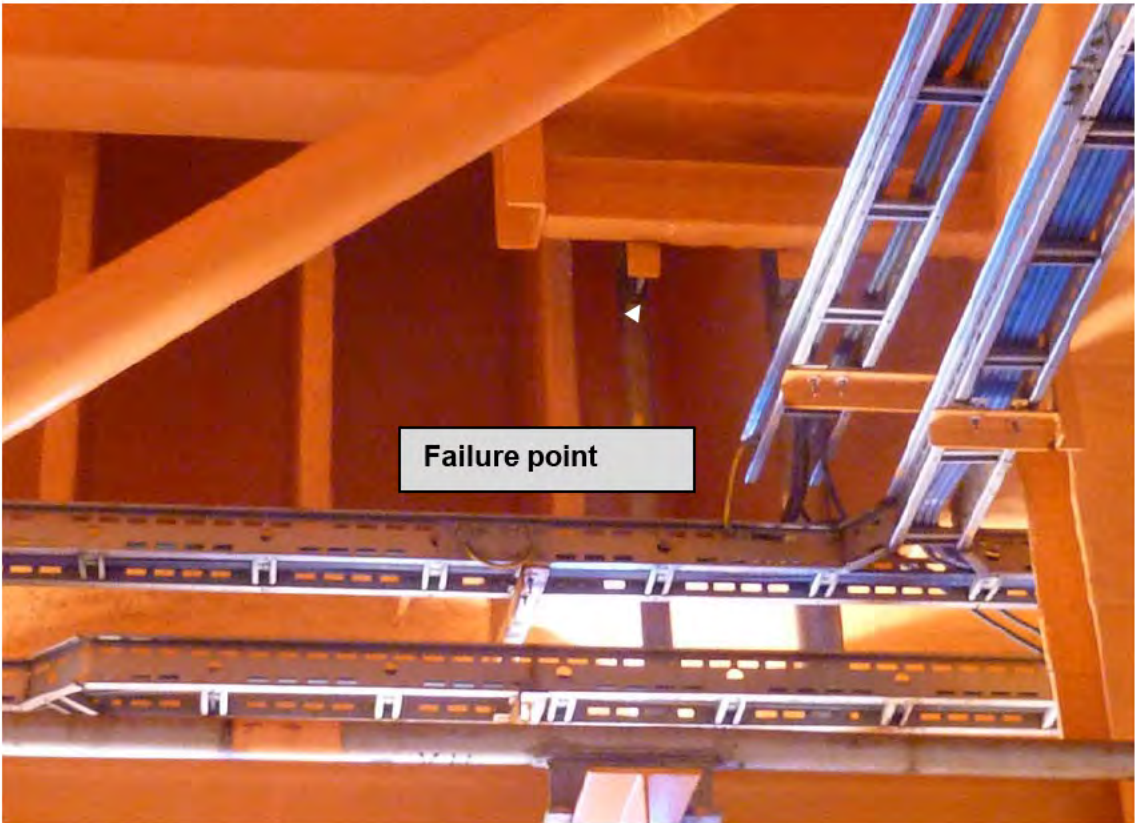
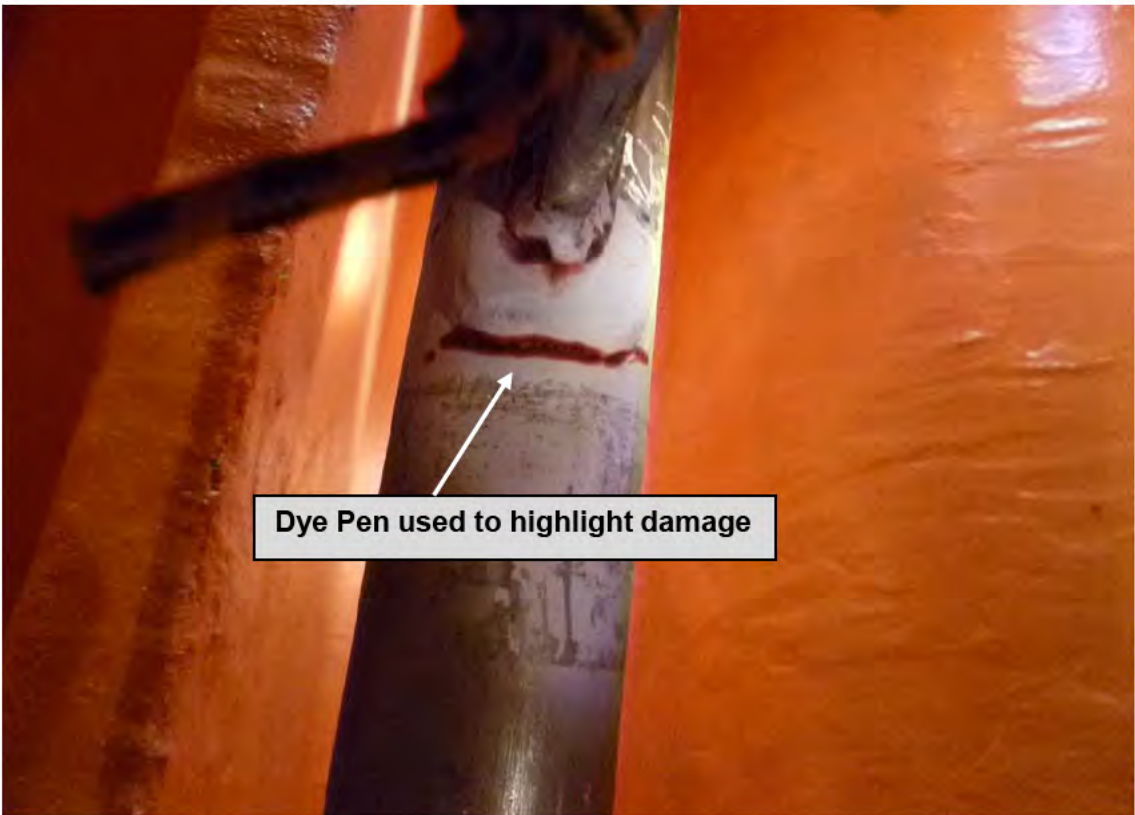
Figure 1.2 – Images of Pipe Failure

During the restart there was issues that required troubleshooting that took the focus of the team away from the abnormal noise source. It was the extended duration of PSV chatter that would have resulted in the eventual pipe failure.

As indicated in section 4.3 the pipe failed due to chatter of PSV causing excessive vibration for extended period of time.

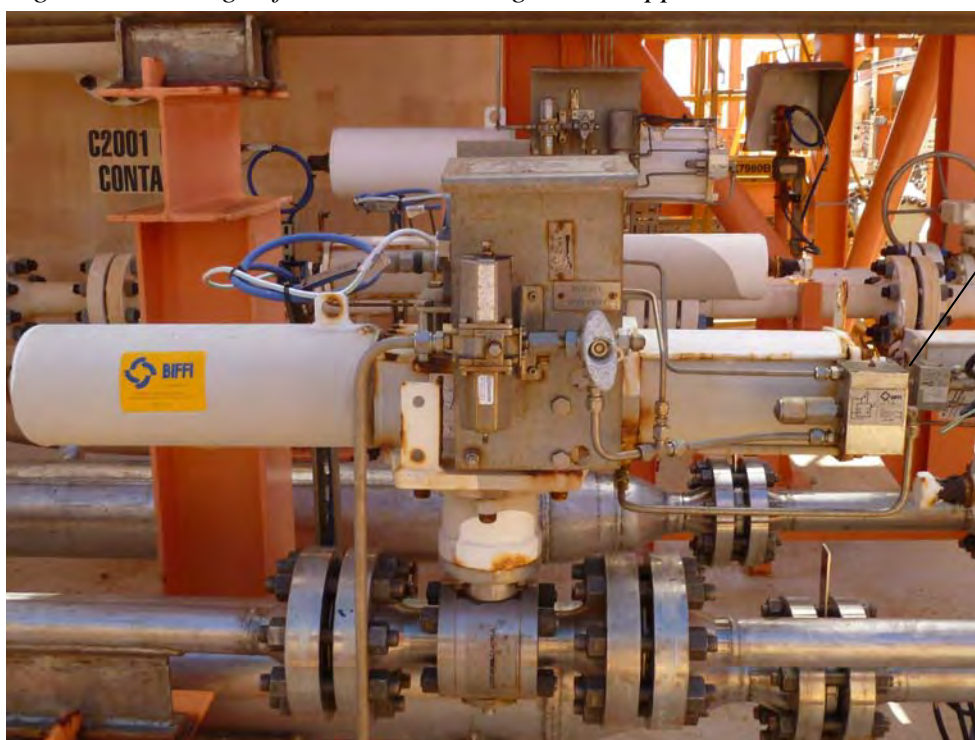
Figure 4.2 – Image of Exhaust Flow Regulator Supported on XV11420

The exhaust flow regulator for the XV11420 weighs ~5 kg (est.) and is supported by close coupled nipple to actuator body and associated instrument tubing. It is the opinion of investigation team and numerous interviewees that this is inadequate for fatigue vibration. However this XV11420 nipple has been the only recorded failure to date on the facility.

Exhaust Flow
Regulator (~6
kg).

- 5.) Contact Biffi actuator vendor and inform of failure of unsupported Exhaust Flow Regulator for the greater learning across the community.

- 6.) Exhaust Flow Regulators were installed to guarantee consistent opening and/or closure times due to the risk of varying upstream instrument air pressure [Ref 9]. Air pressure could now be monitored and be found to be steady and thus exhaust flow regulators could be challenged out of the design and replaced with a standard design. This would remove the defect and also remove a significant 4Yrly PM plan.
 - Raise a Technical Query to investigate opportunity of alternative methods of controlling actuator stroke timing with the benefit of Exhaust Flow Regulator removal.

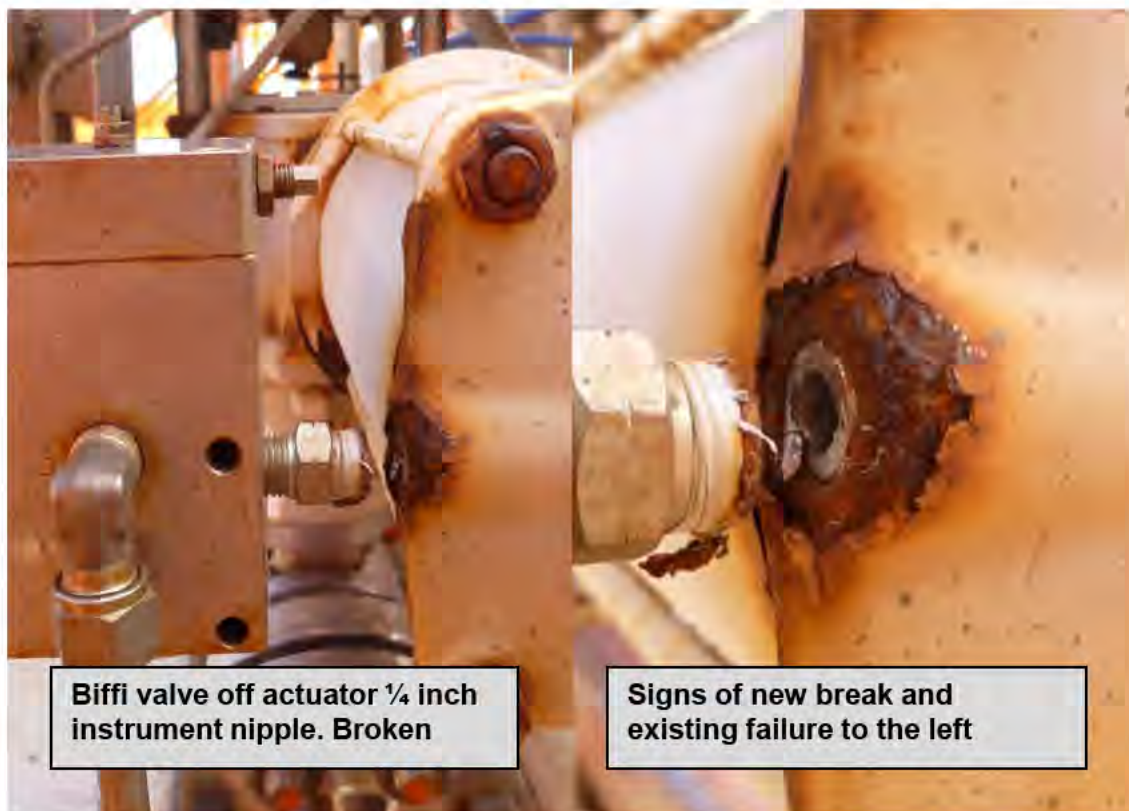
Figure 4.3 – Exhaust Flow Regulator Nipple Failure Images

- XV11420 stuck open at 10% for 10 days prior to ESD causing initial vibration fatigue and partial failure of exhaust flow regulator (as can be depicted by the clearly 2 signs of fracture on nipple in Figure 4.3).

XV11420 was identified through PHD trends on 7th June to be stuck in a 10% position for approximately 10 days. It was used to provide the flare some gas to ensure it was alight. Potential loss of flare was captured under WELEV13060040 at the time on 7th June. PHD indicates valve was again cycled assumed to see if it could return to 0%. It is believed that this is where the source of vibration has started that has led to fatigue cracking. There is clear evidence (as from image in figure 4.3) of 2 modes of failure on the nipple on the exhaust flow regulator of XV11420.

The first is fatigue cracking ("beachwaves" or "tidemarks") believed to be due to vibration of the valve over time, indicated by the numerous waves of cracking and dull appearance of the nipple.

The second is a catastrophic shear as can be seen by the bright shiny appearance on the nipple.

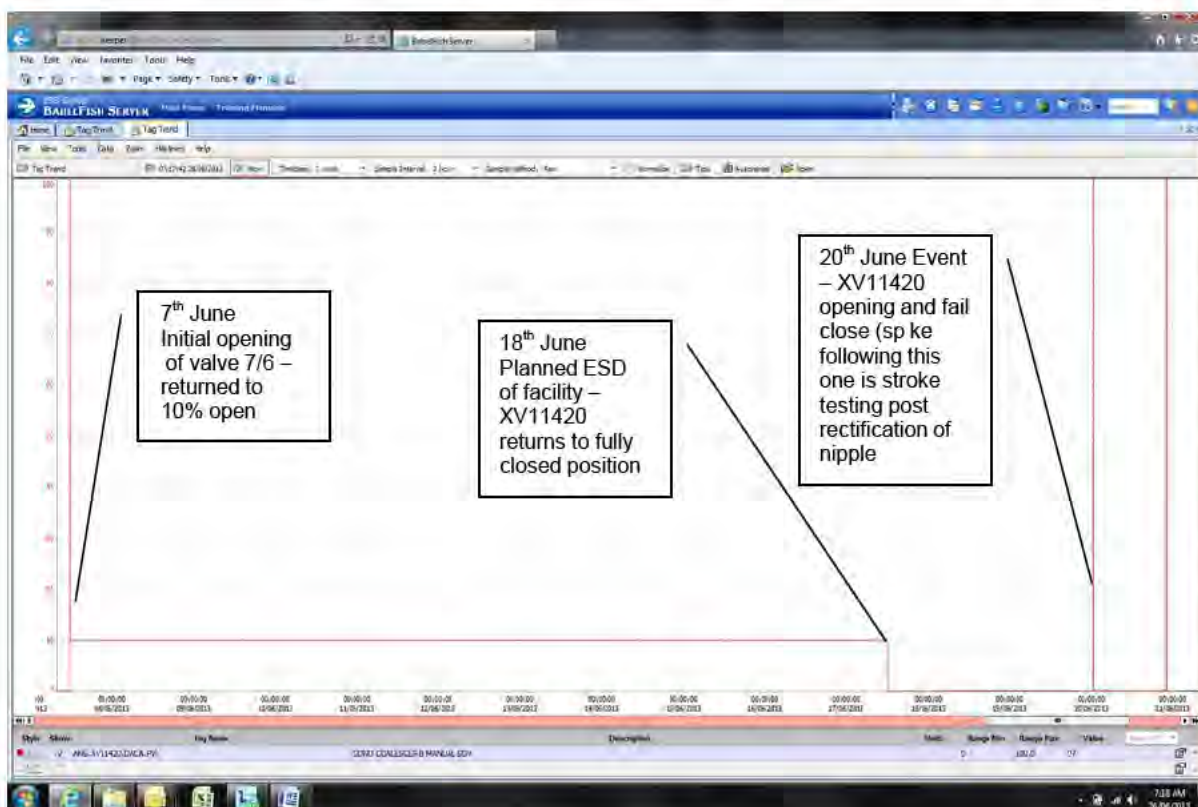
Figure 4.4 – PHD Trend on XV11420 Openings

On startup of the process train XV11420 was commanded to open and close 2 times. On the second closure it is assumed that exhaust air force catastrophically failed the nipple allowing the XV11420 to fail close in a much faster time than the normal 3 seconds. This would have resulted in a pressure spike in the piping and assume the cause of lifting of PSV11416.

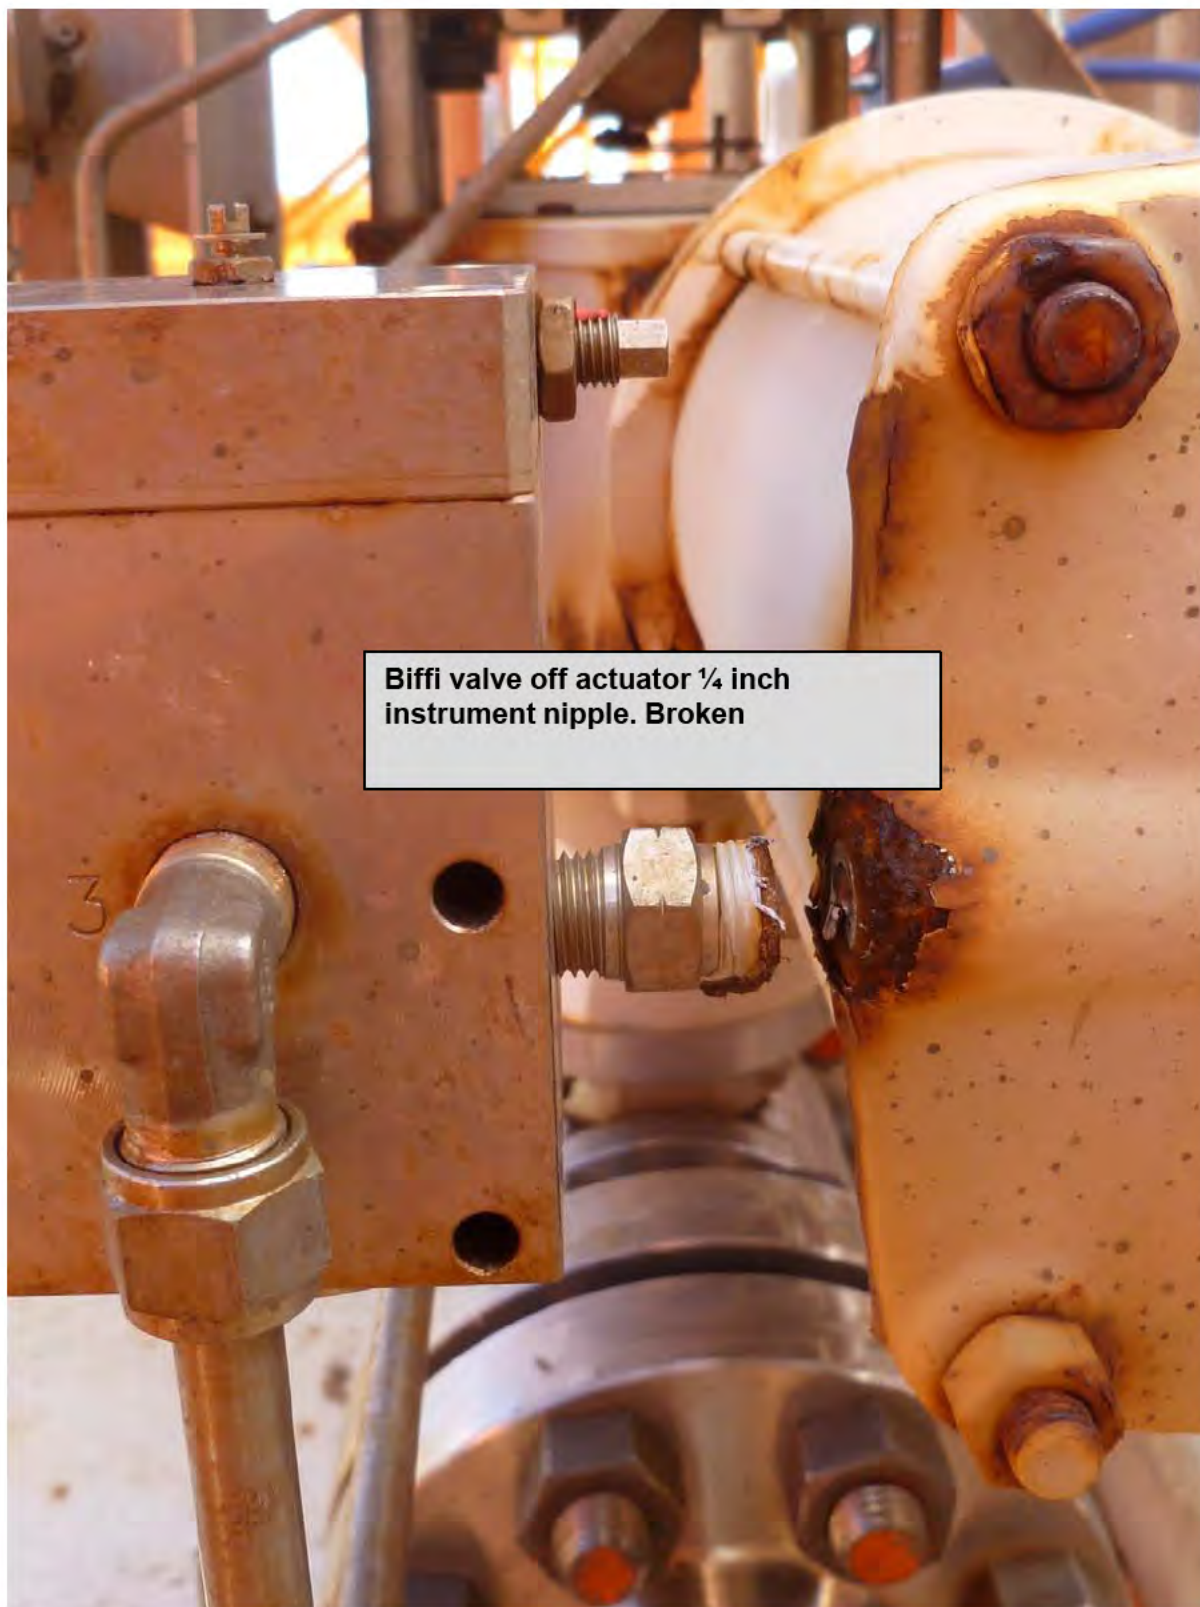
Biffi valve off actuator 1/4 inch instrument nipple. Broken

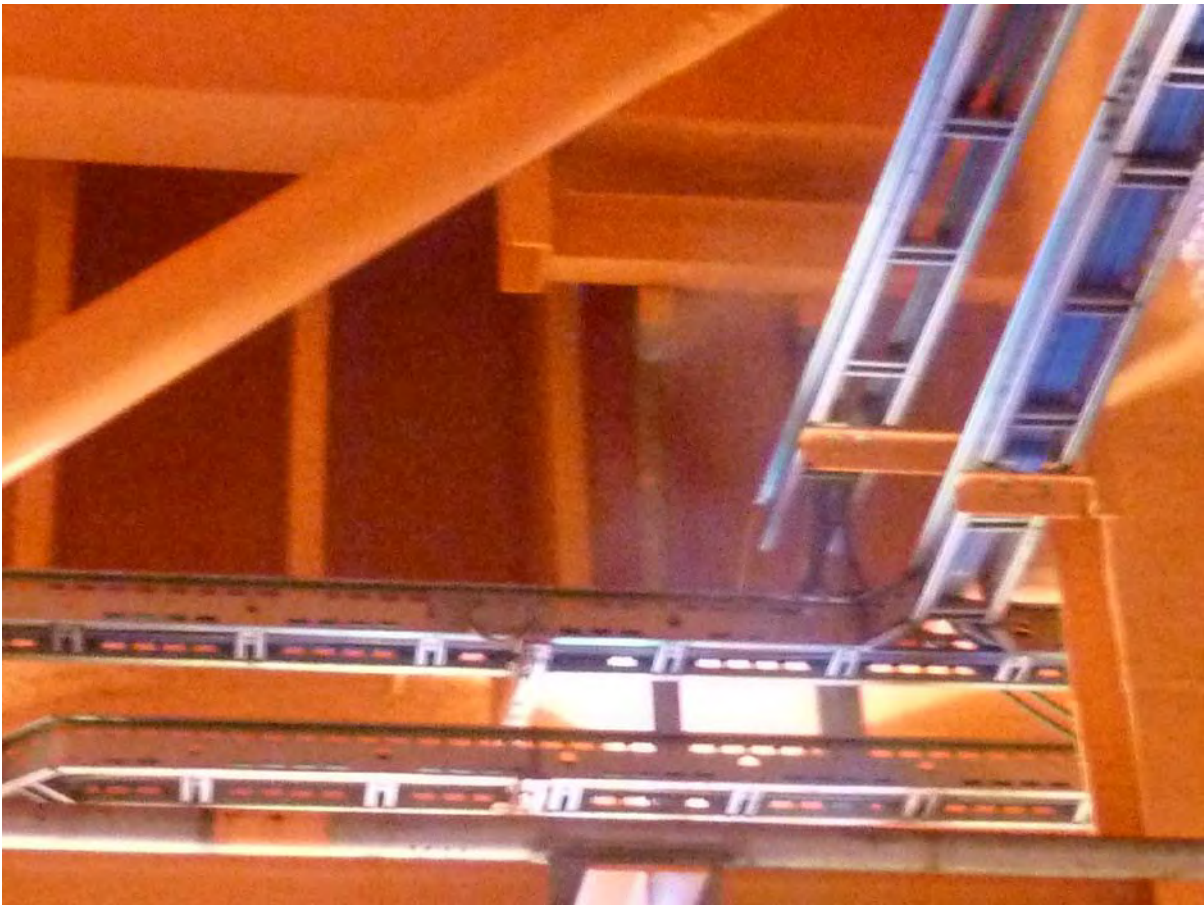
500 KPag N2 and water soap mix slowly poured from above.
