LOC Pinhole Gas Train Leak Between E37023 and E3704 Report

No. 4900-HS-H0071-02

Revision 0

Issue date: 30/01/2017

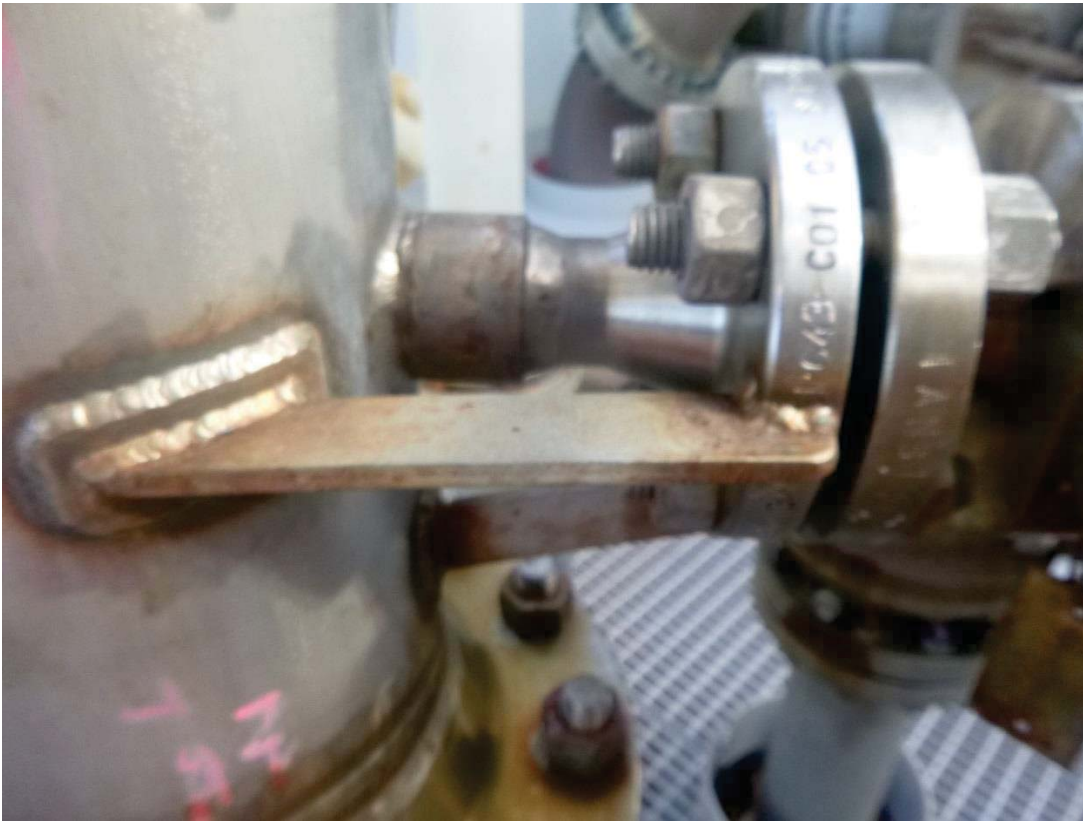
Figure 1 - 150-FG-4028-03D01-0 TP1 (B) confirmation of brace

The offshore inspector confirmed that braces had been installed and weld reinforcement had been completed to all the above lines. Photos in Appendix A.

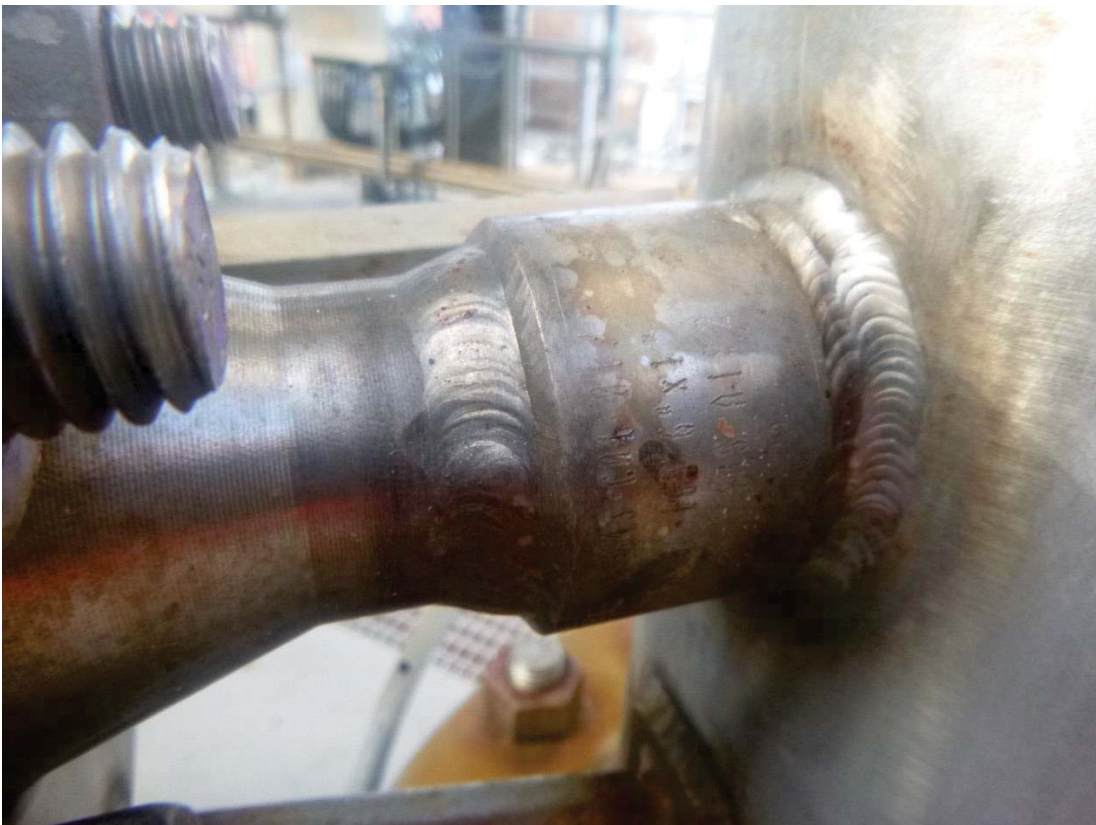
Figure 2 - 150-FG-4028-03D01-0 TP1 (B) condition of small bore fitting weld

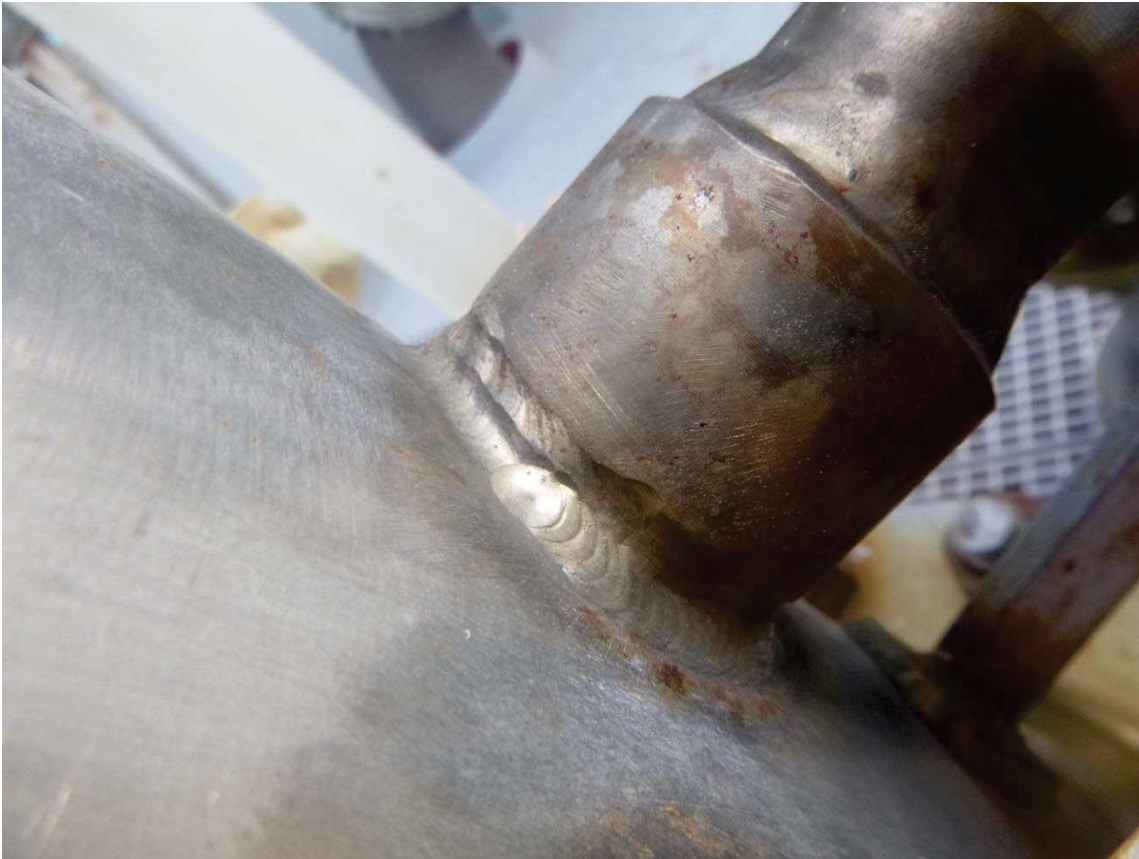
Figure 3 - 150-FG-4028-03D01-0 TP1 (B) condition of small bore fitting weld

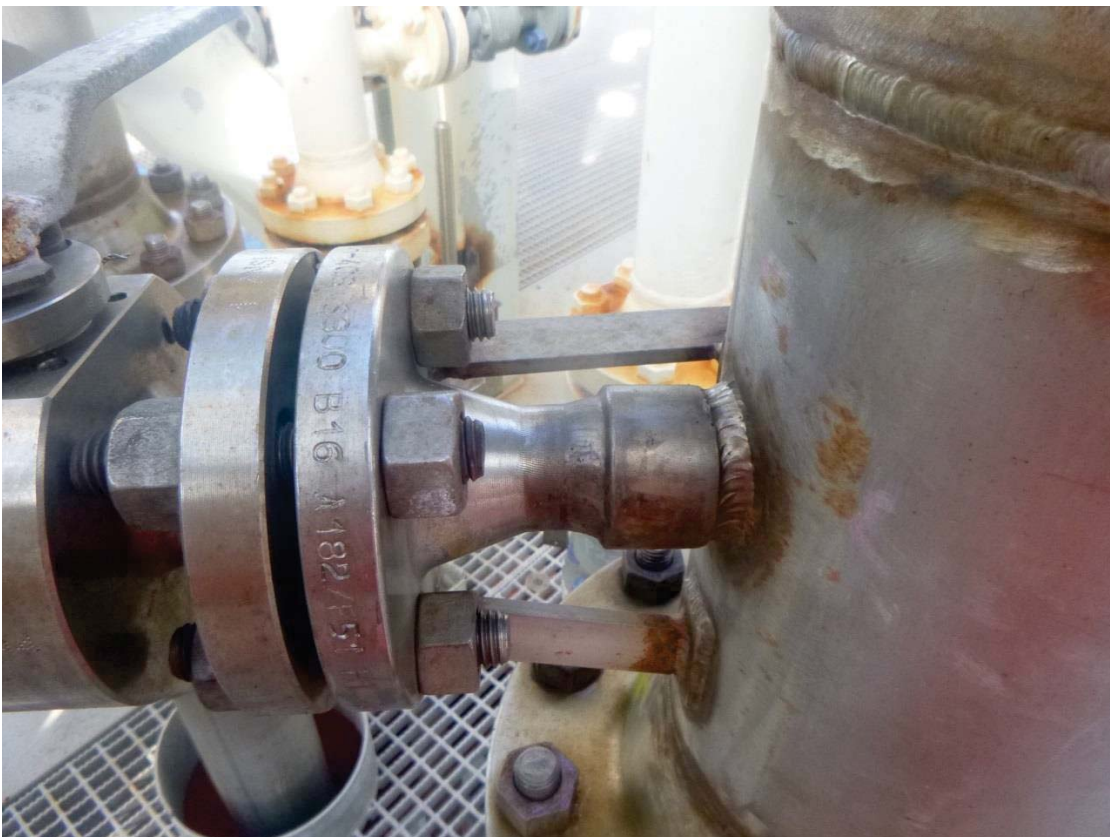
Figure 4 - 150-FG-4028-03D01-0 TP1 (B) condition of small bore fitting weld

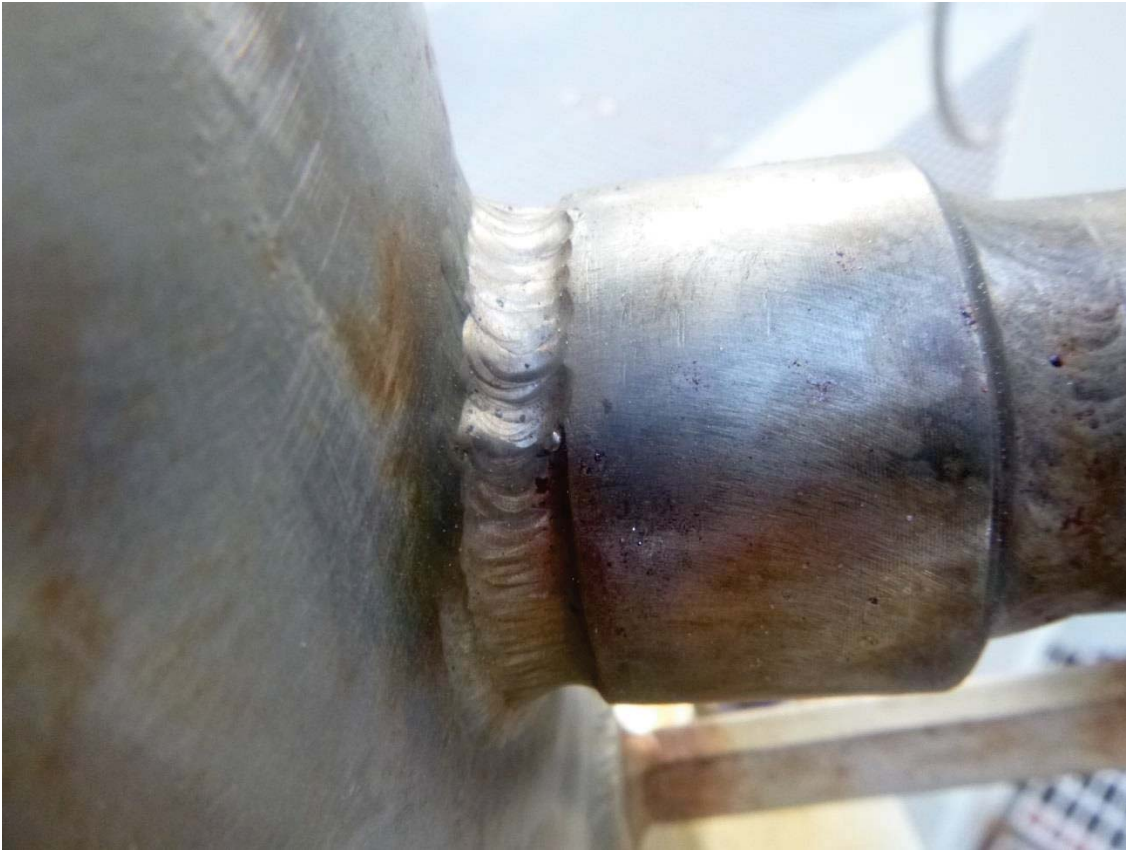
Figure 5 - 150-FG-4028-03D01-0 TP2 (A) condition of small bore fitting weld

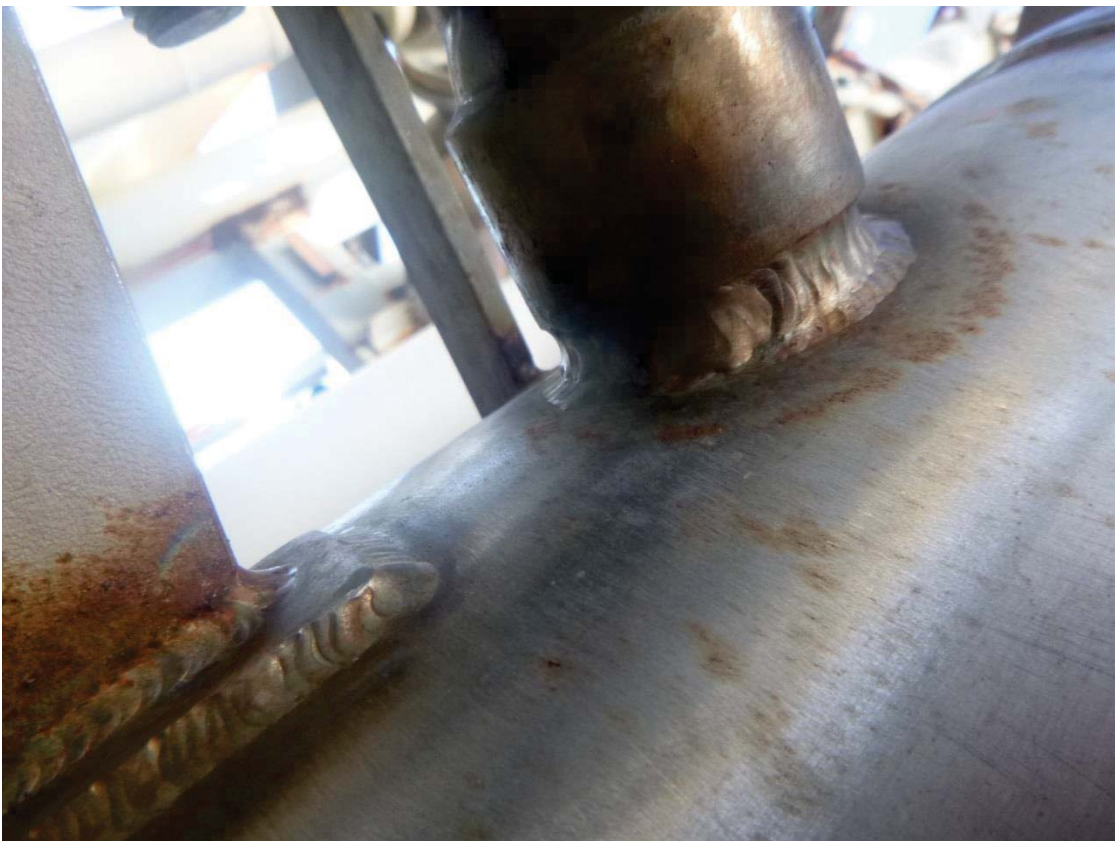
Figure 6 - 150-FG-4028-03D01-0 TP2 (A) condition of small bore fitting weld

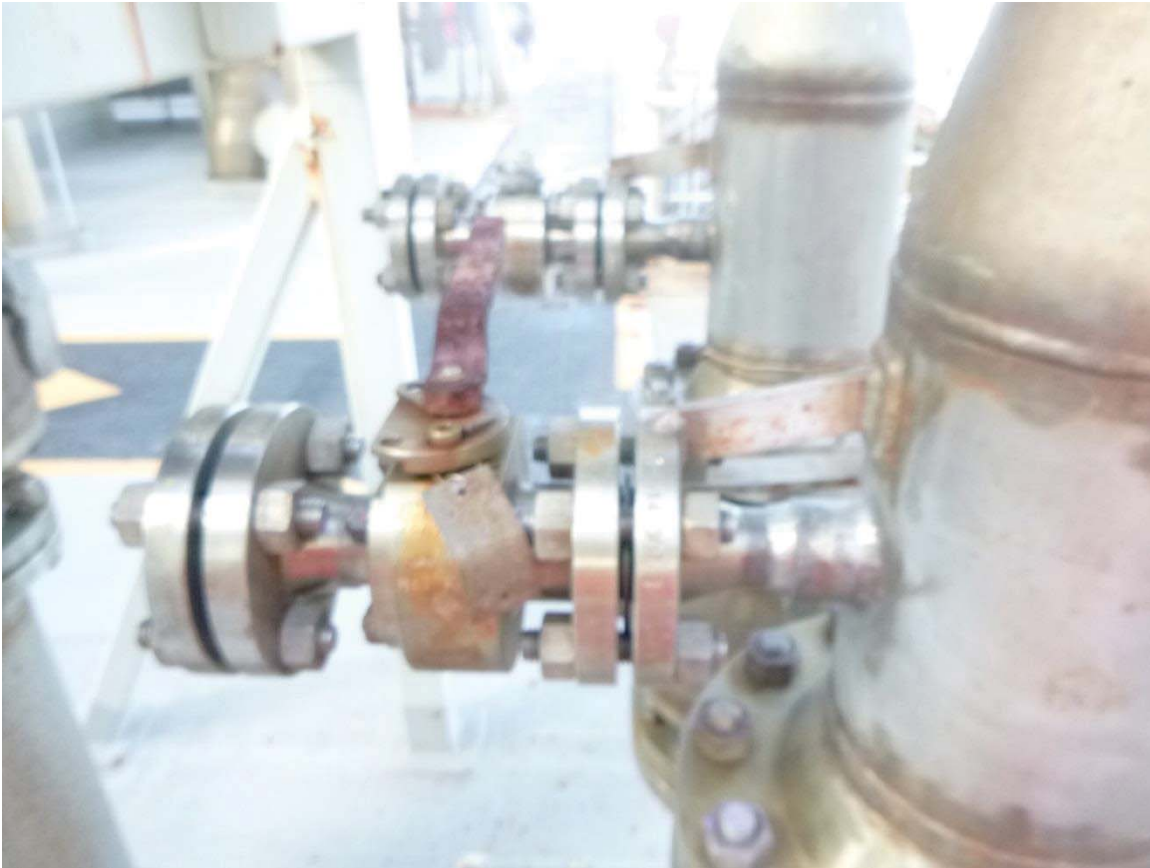
Figure 7 - 150-PG-3037-03D01-0 TP1 (P) confirmation of brace

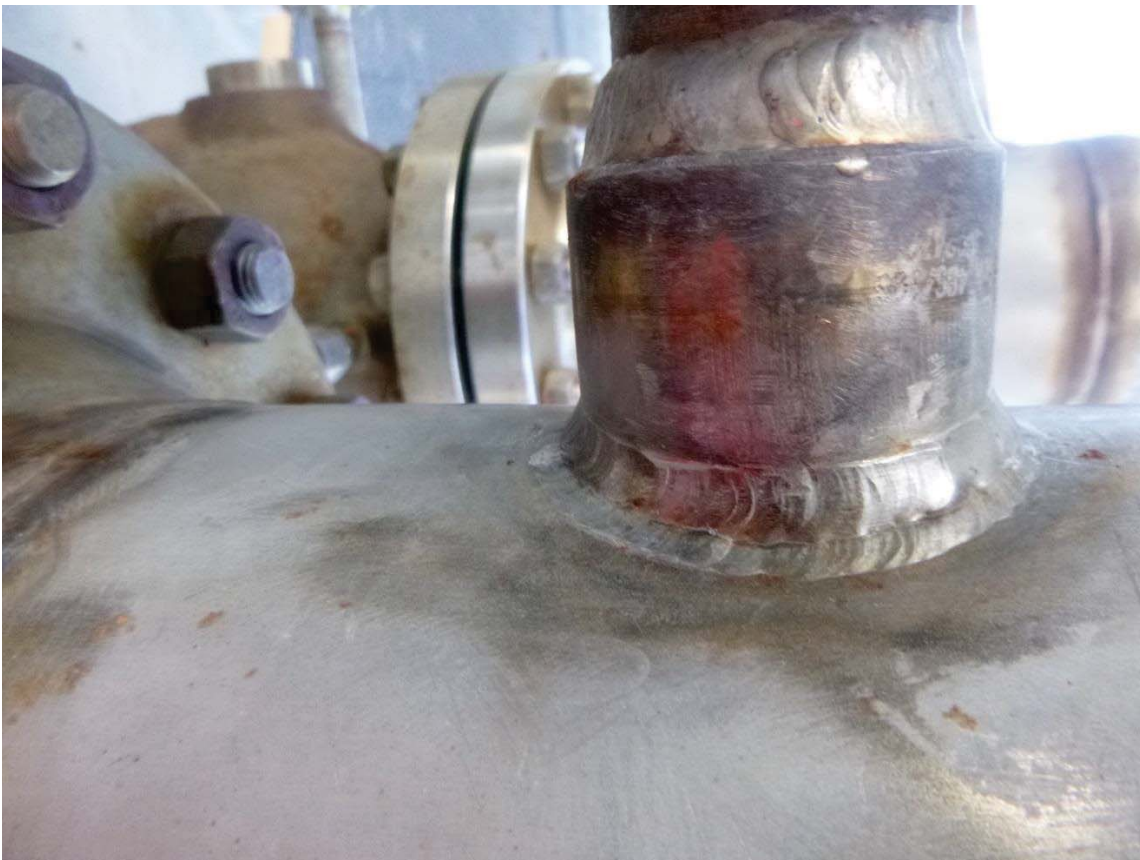
Figure 8 - 150-PG-3037-03D01-0 TP1 (P) condition of small bore fitting weld

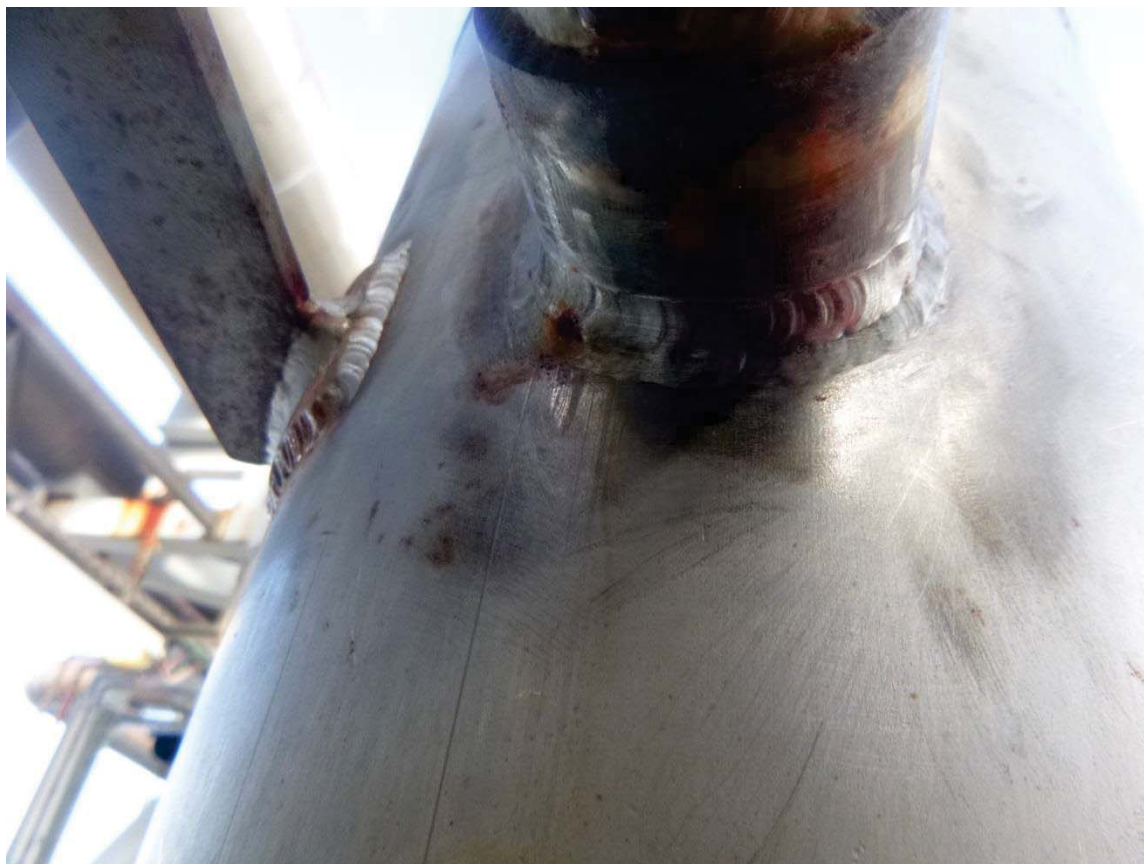
Figure 9 - 150-PG-3037-03D01-0 TP1 (P) condition of small bore fitting weld

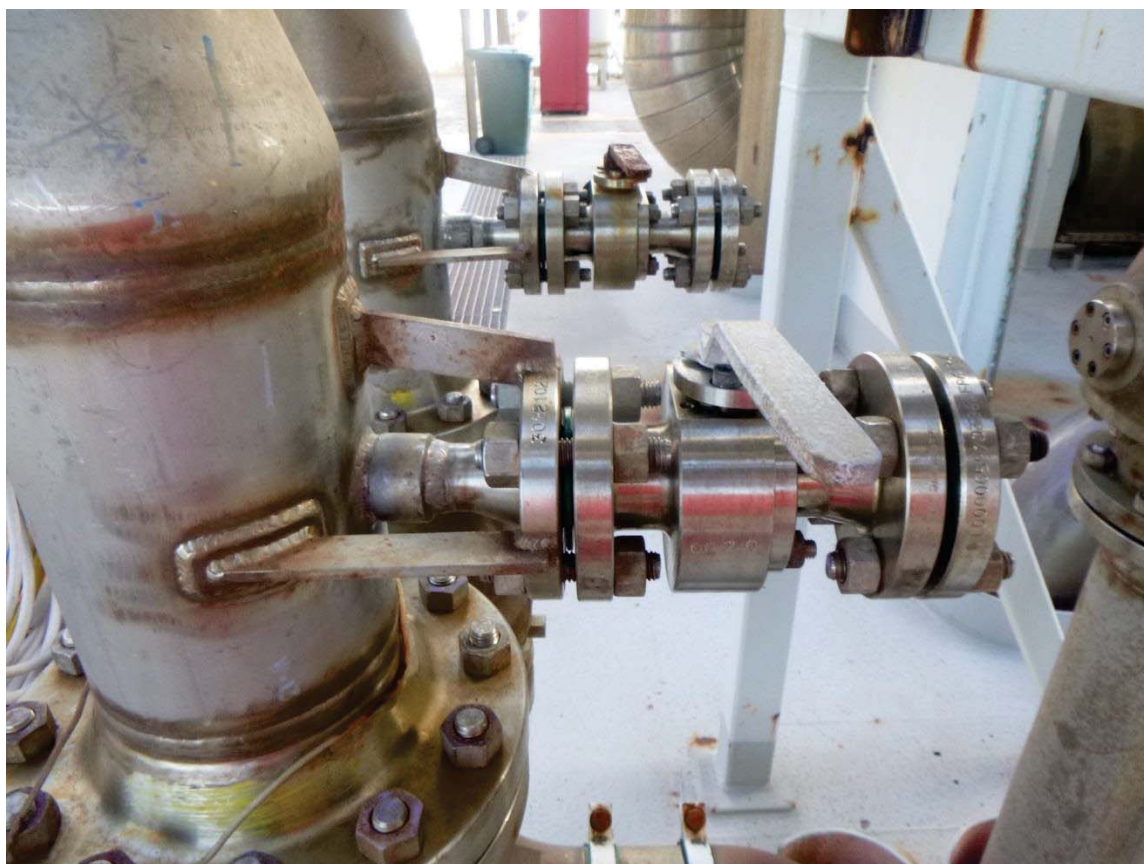
Figure 10 - 150-PG-3037-03D01-0 TP2 (Q) confirmation of brace

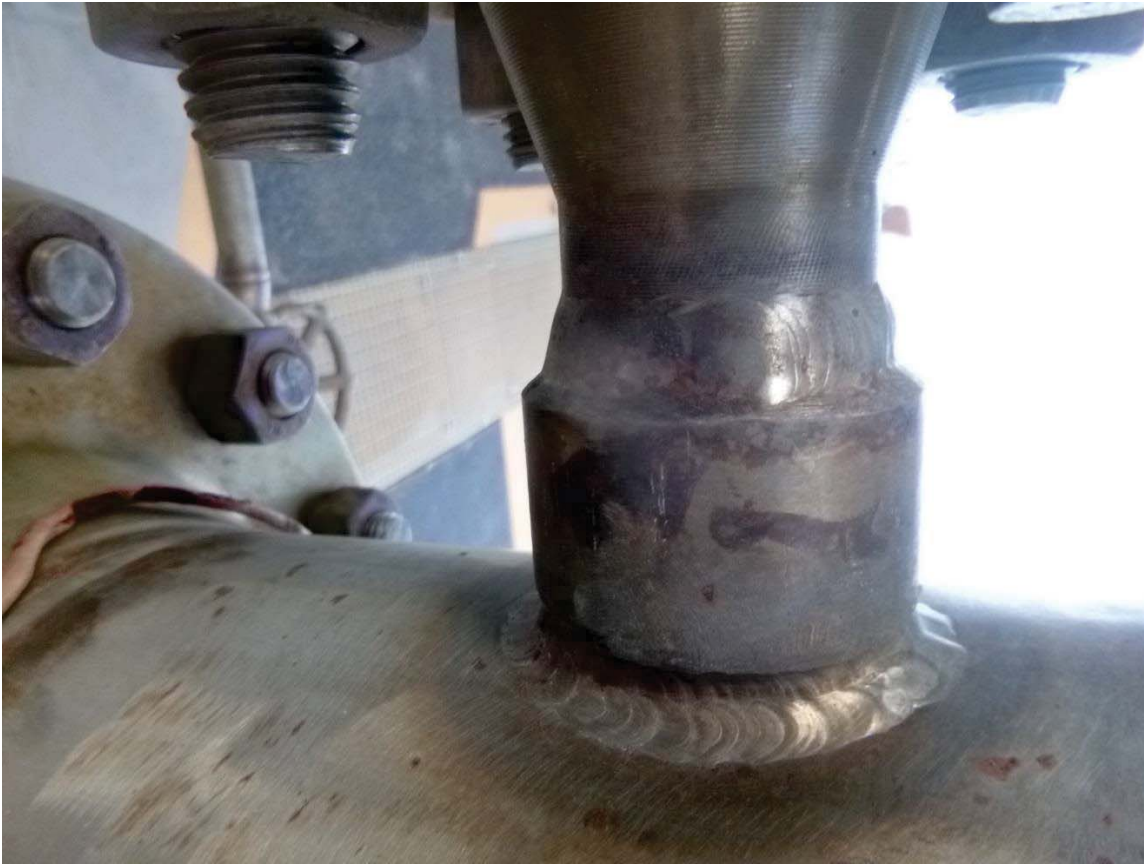
Figure 11 - 150-PG-3037-03D01-0 TP2 (Q) condition of small bore fitting weld

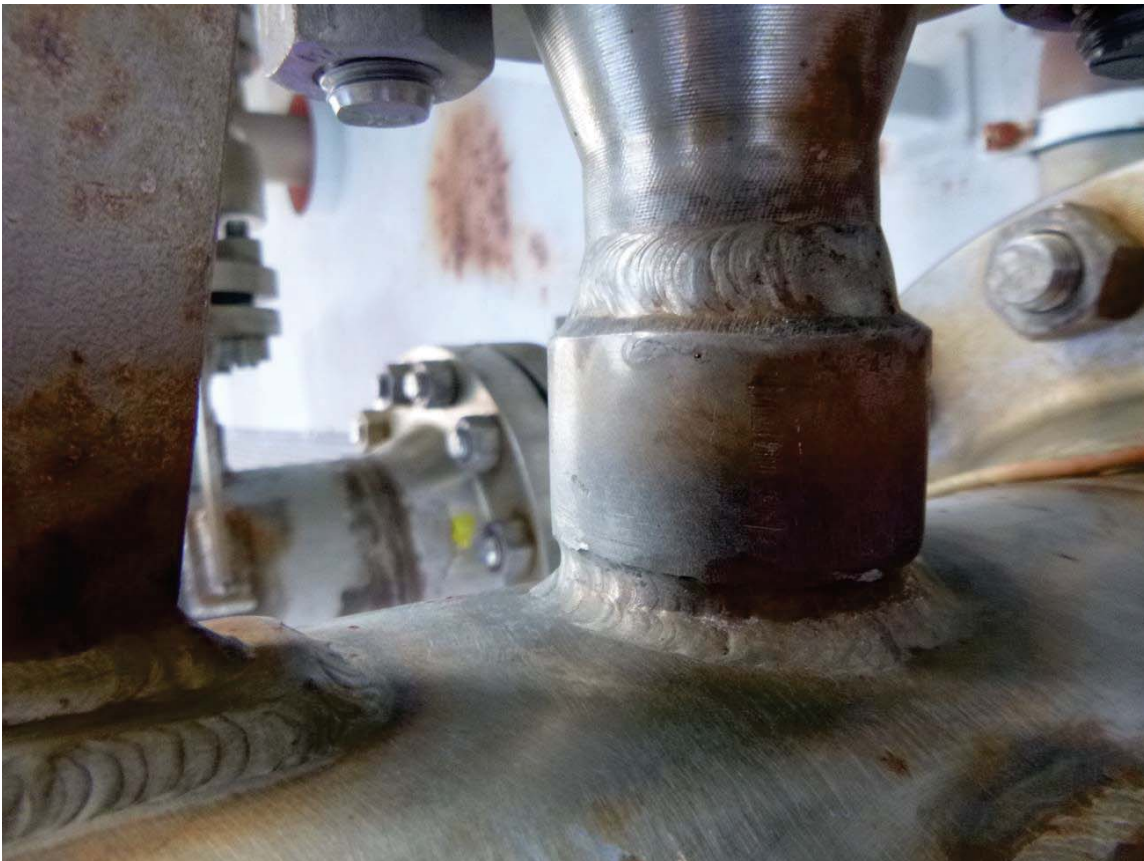
Figure 12 - 150-PG-3037-03D01-0 TP2 (Q) condition of small bore fitting weld

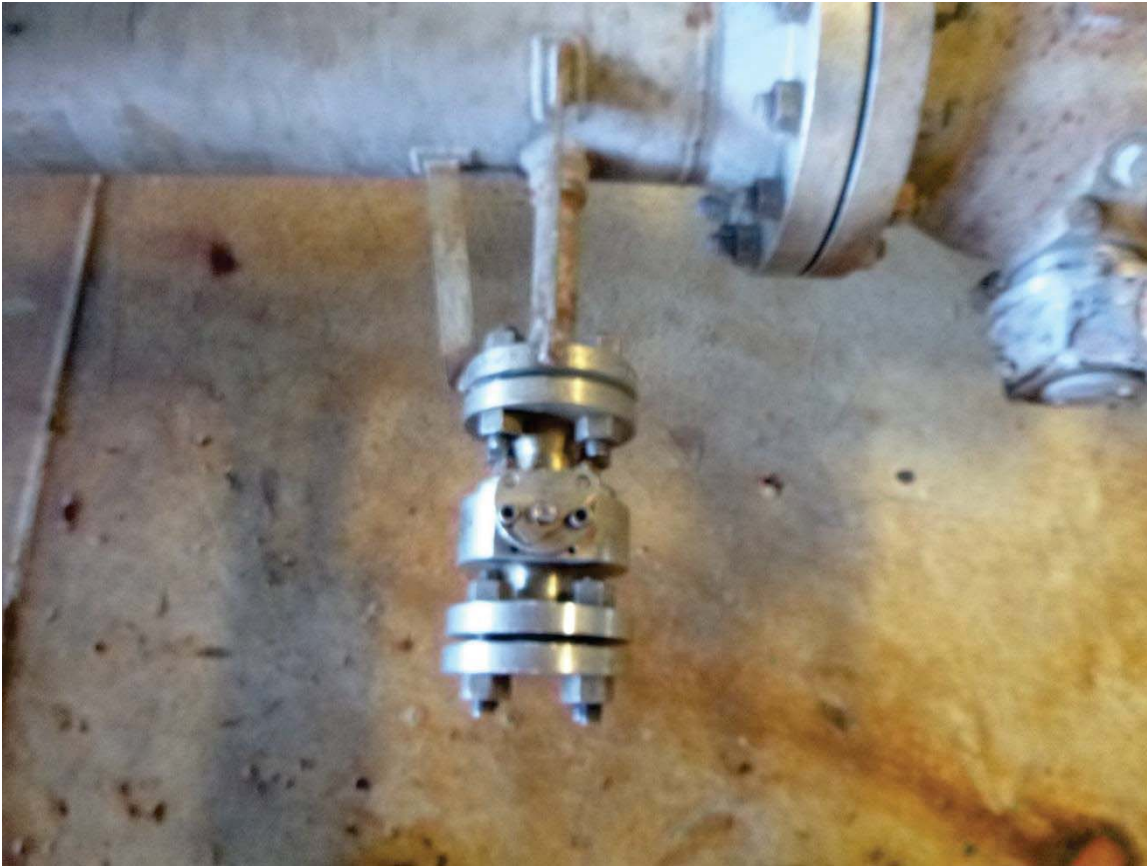
Figure 13 - 150-PL-4030-03D01-0 TP1 (H) confirmation of brace

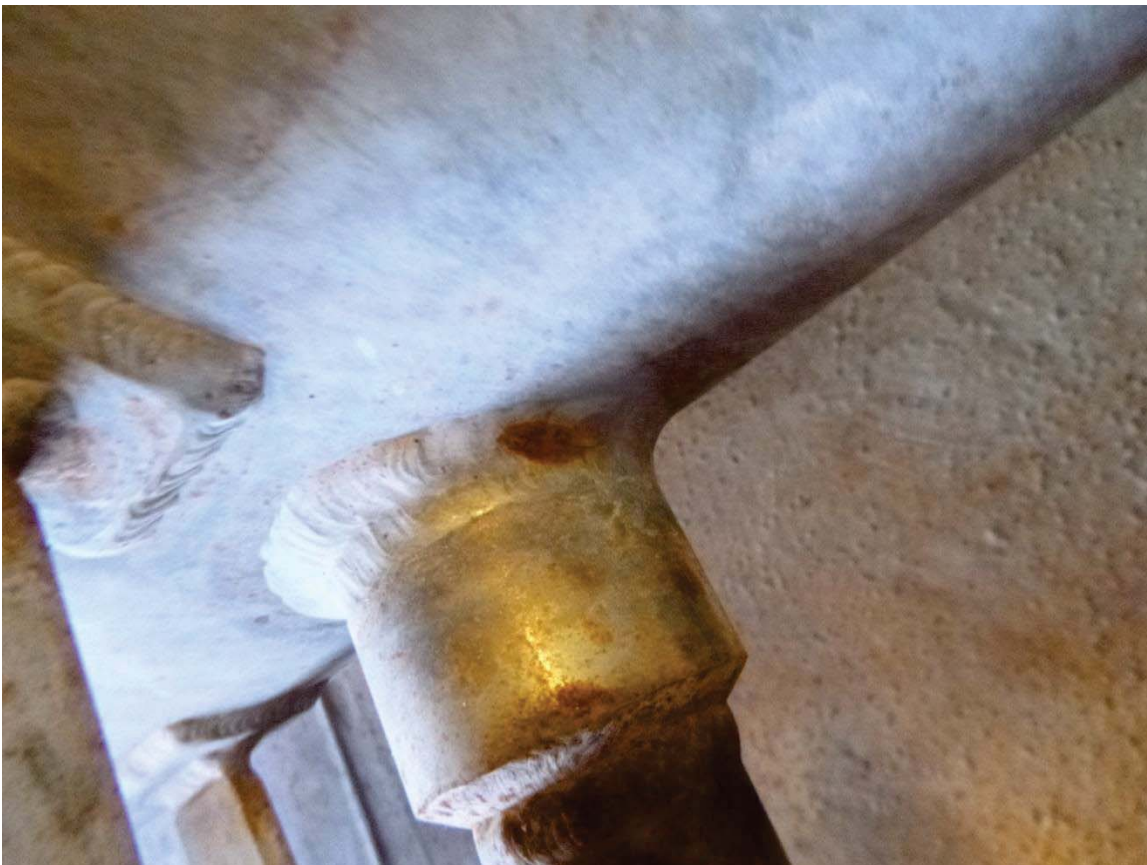
Figure 14 - 150-PL-4030-03D01-0 TP1 (H) condition of small bore fitting weld

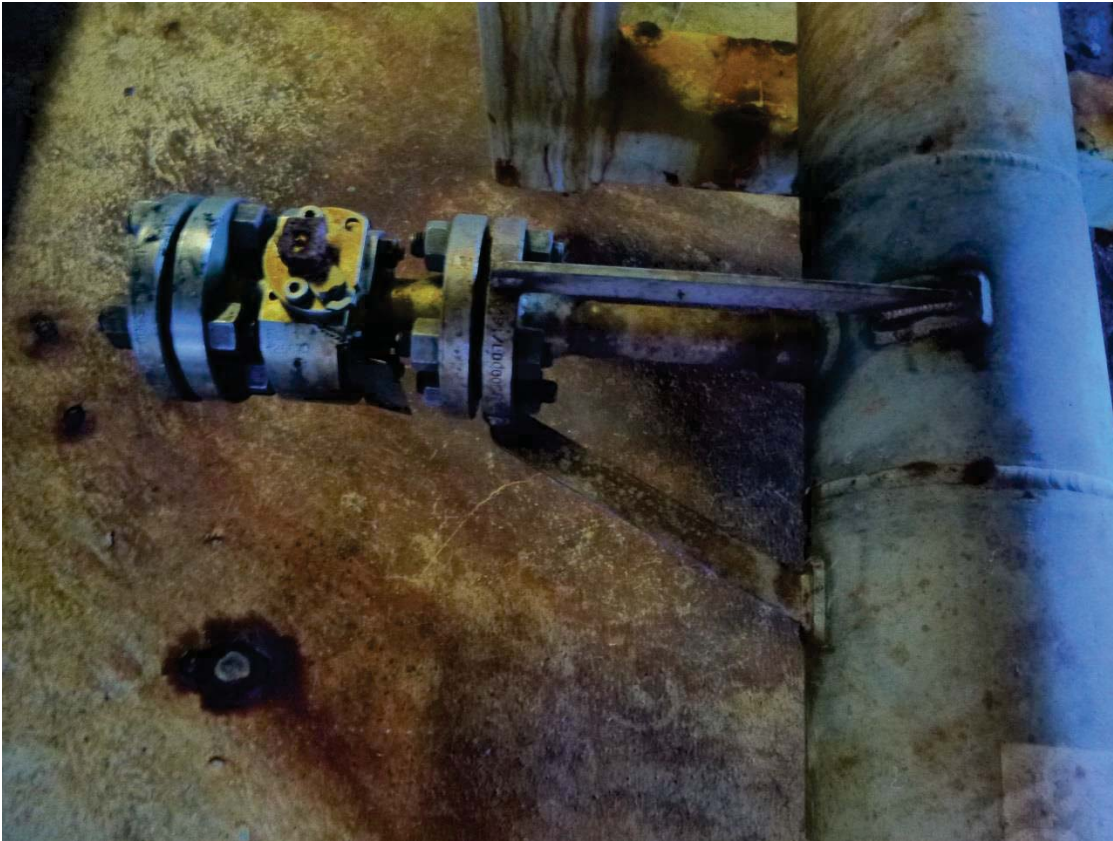
Figure 15 - 150-PL-4032-03D01-0 WOL (T) confirmation of brace

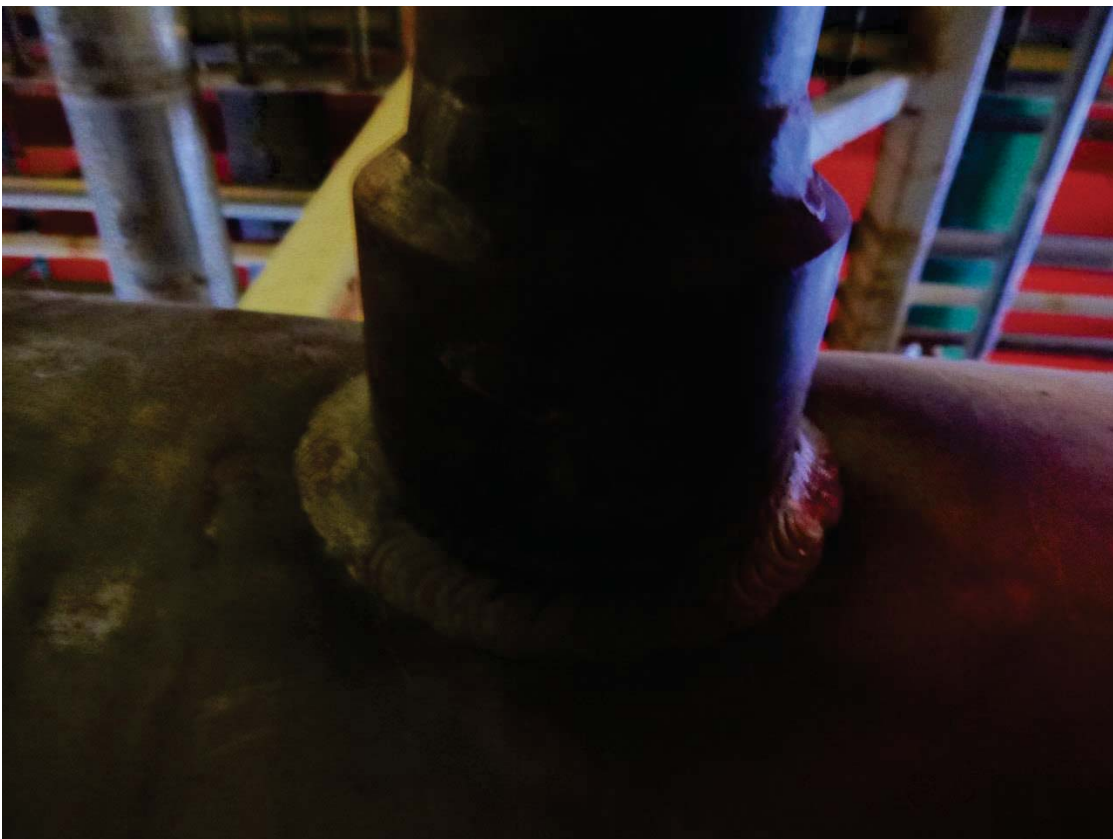
Figure 16 - 150-PL-4032-03D01-0 WOL (T) condition of small bore fitting weld

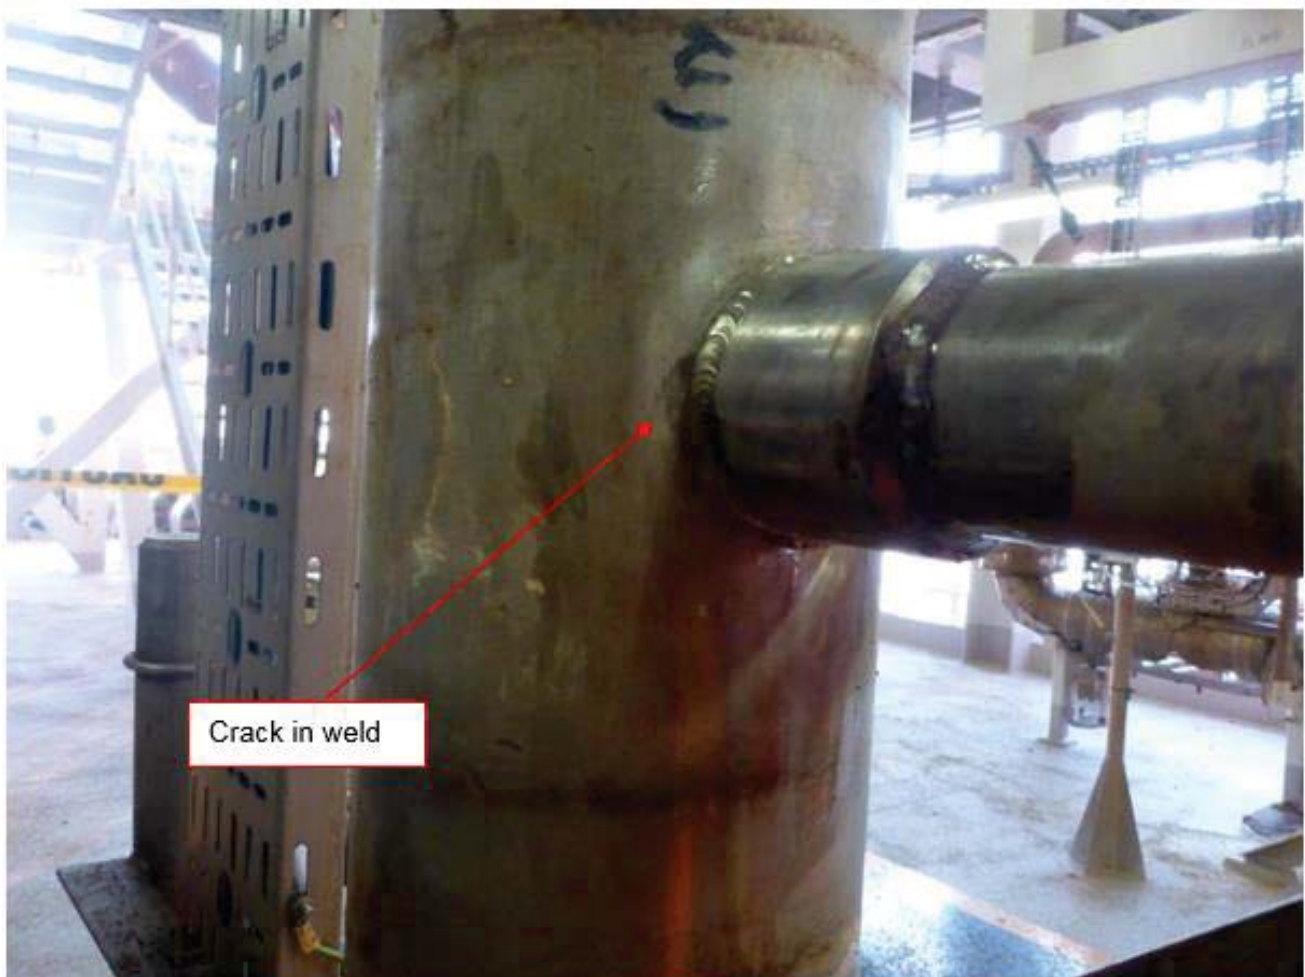
Whilst performing rounds an operator noticed ice formation on a section of pipework in the process area at around 21:10 hours CST on 29 November 2016. On closer inspection, the ice appeared to be condensation formed from a hydrocarbon leak at the weld between the 6" main line and 2" weldolet [refer to Appendix B.1]. The presence of hydrocarbons was confirmed via a personal gas monitor. The central control room was immediately notified via radio and the control room operator immediately notified the production supervisor. Isolation points upstream and downstream of the leak were identified and put in place. The OIM was notified and the section of piping was blown down to a safe location. Depressurisation of the system was complete at 21:40 hours CST.

Figure 17 - Failed weld at SBF 37PI072 on line 150-PL-3052-03C01-3

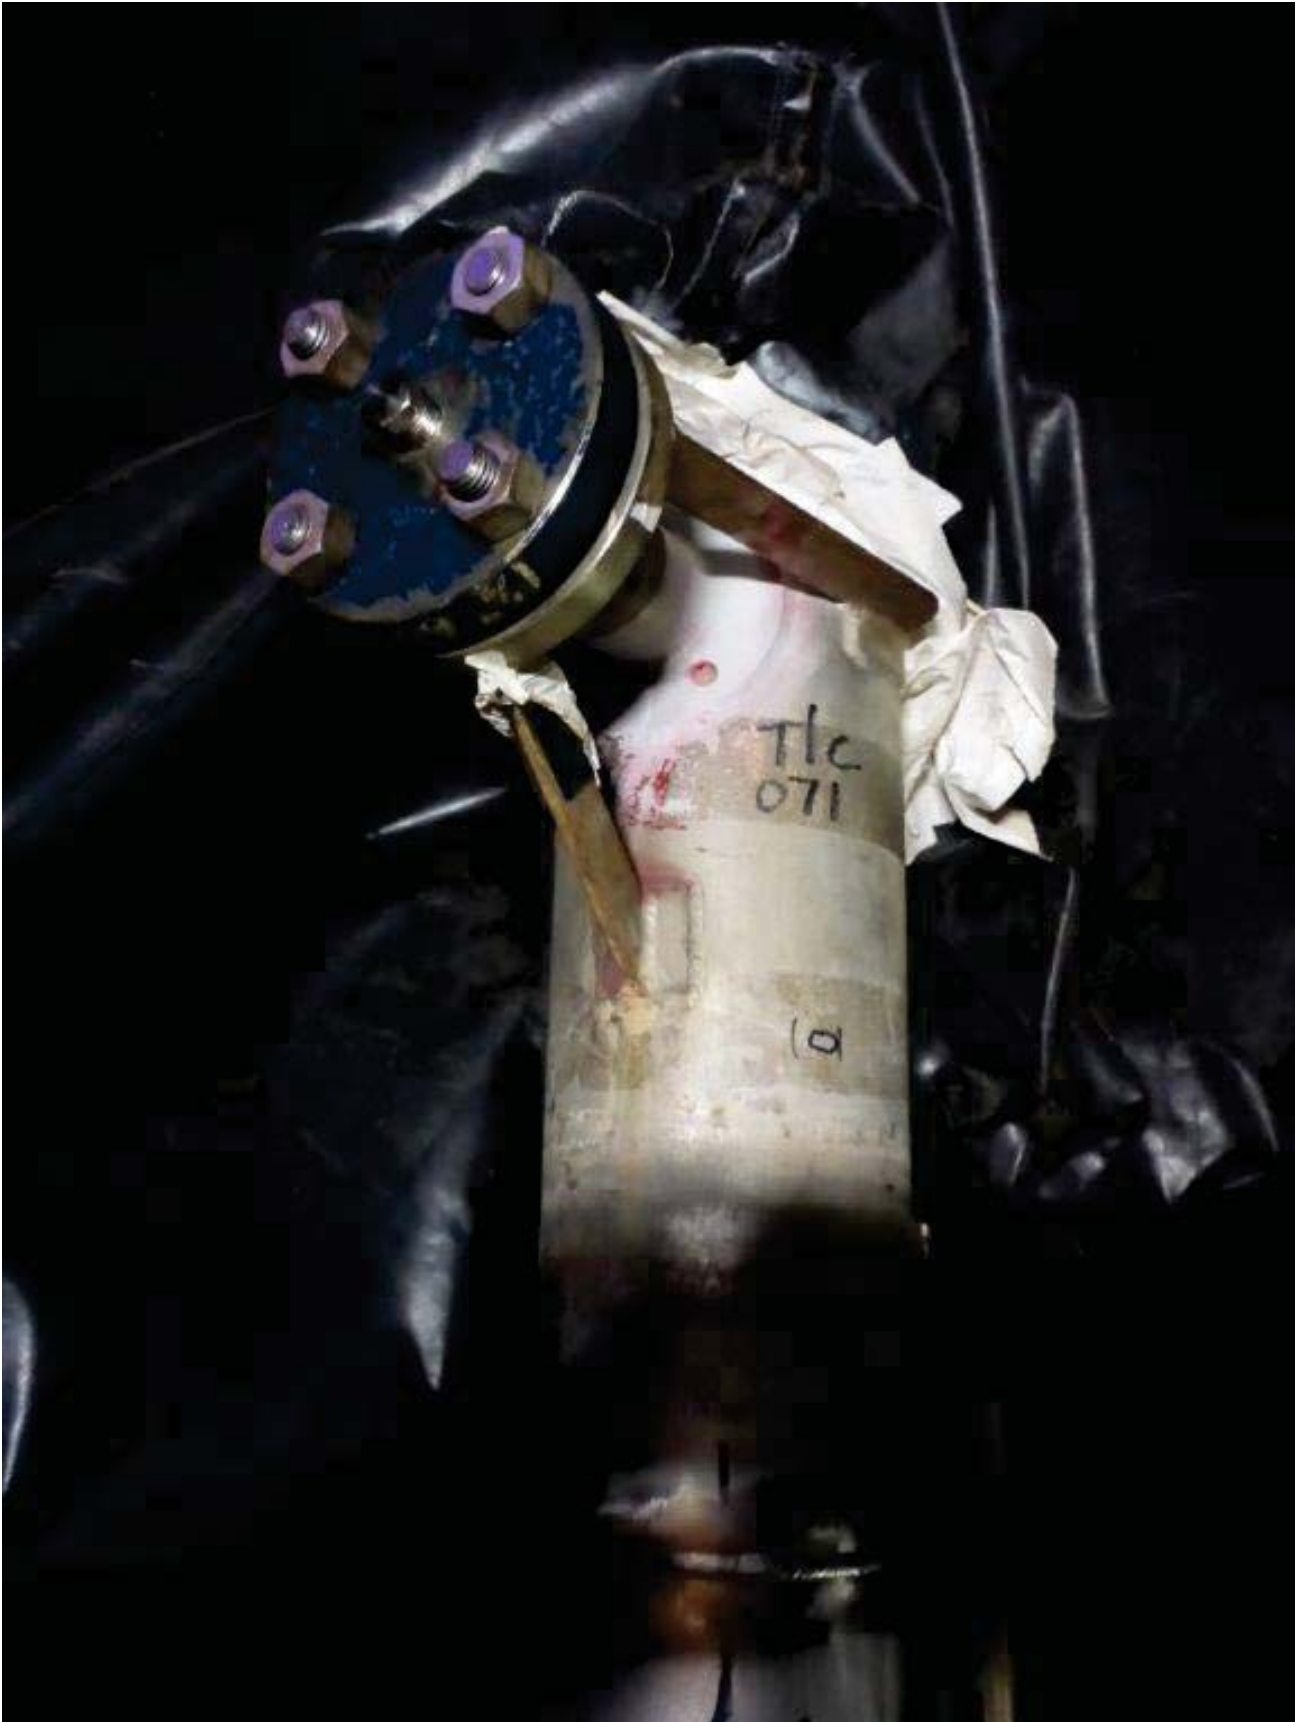
Figure 18 - Previous brace configuration at 37PI072 on line 150-PL-3052-03D01-3

The scope of work for the repair consisted of cutting and removing the failed section of duplex piping including the attached weldolet [Appendix B.2], and replacing with a straight piece of duplex piping [Appendix B.3]. The work was carried out and captured in WO M220050499.

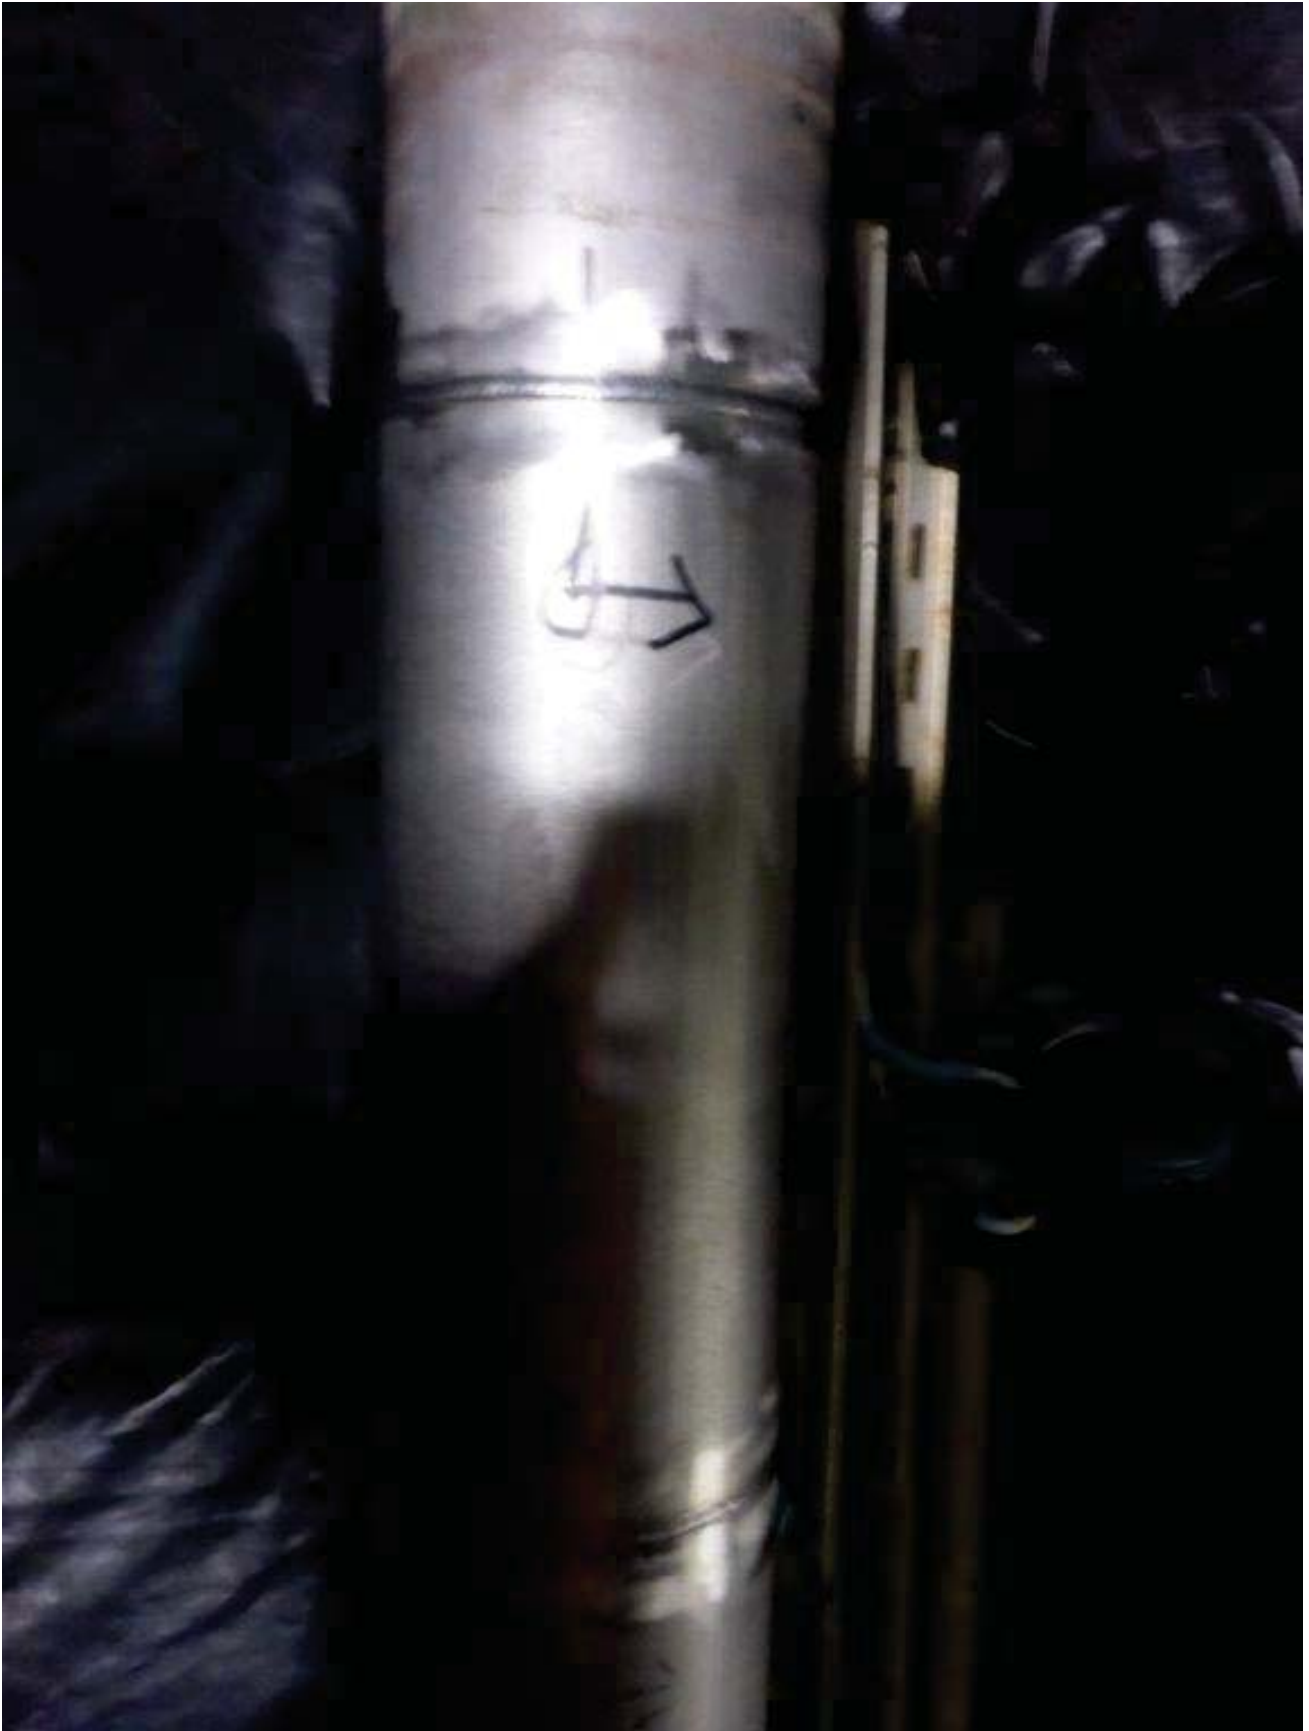
Figure 19 - Replacement spool piece on line 150-PL-3052-03D01-3 with SBF designed out

Management of Change was captured via Engineering Change Request (M2000067) and was completed prior to the work being conducted. The ECR covered replacing the 6" SCH 10 duplex piping that had failed, with 6" SCH 10 duplex piping without the attached 2" weldolet. The piping system was flushed and purged, and a pressurised welding habitat was set-up prior to any hot work conducted. The existing 6" pipe was cut considering the heat affected zone. A replacement piece of 6" SCH 10 duplex was cut to length and welded into place using a qualified welder (DS 3001) and was pickled and passivated in accordance with A380/A380M-13. Following completion of the weld, 100% dye penetrant inspection (DPI) and 100% radiographic testing (RT) was conducted on both welds by a NATA certified technician. A hydrostatic pressure test on the repair was performed at x1.5 the design pressure as per ASME B31.3 and held for 30mins. Refer to Debutaniser Duplex Piping Repair Report [4900-HS-H0071-03].
