NOPSEMA

Planned Inspection

Facility: Northern Endeavour
Operator: Woodside Energy Ltd
Offshore Inspection Dates: 27/04/2016 – 29/04/2016

Lead inspector [REDACTED]
Inspection Team [REDACTED]
Report Number 1346

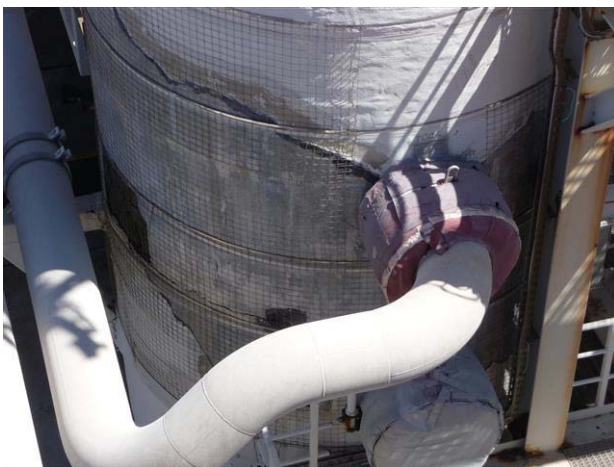
Passive Fire Protection (PFP) was cracked and damaged on the debutaniser column as shown in Figure 1 and Figure 2 below.

Figure 1 - Temporary Repair to PFP on the Debutaniser Column

Recommendation 1346-16

Ensure that the damaged passive fire protection on the Debutaniser column is repaired so that it will meet the requirements of the associated performance standard and is fit for purpose.

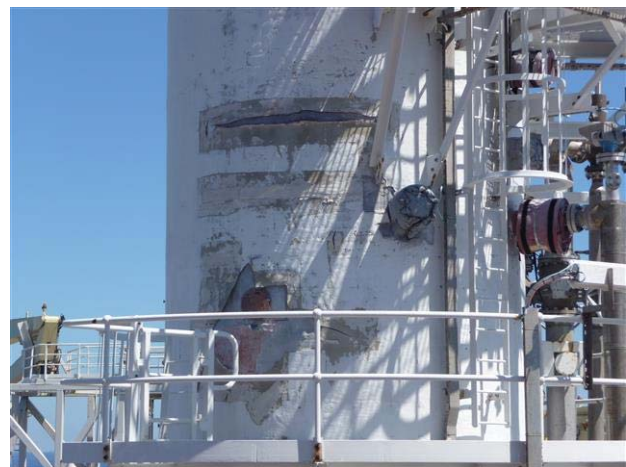
Figure 2 - Damage to the PFP on the Debutaniser Column

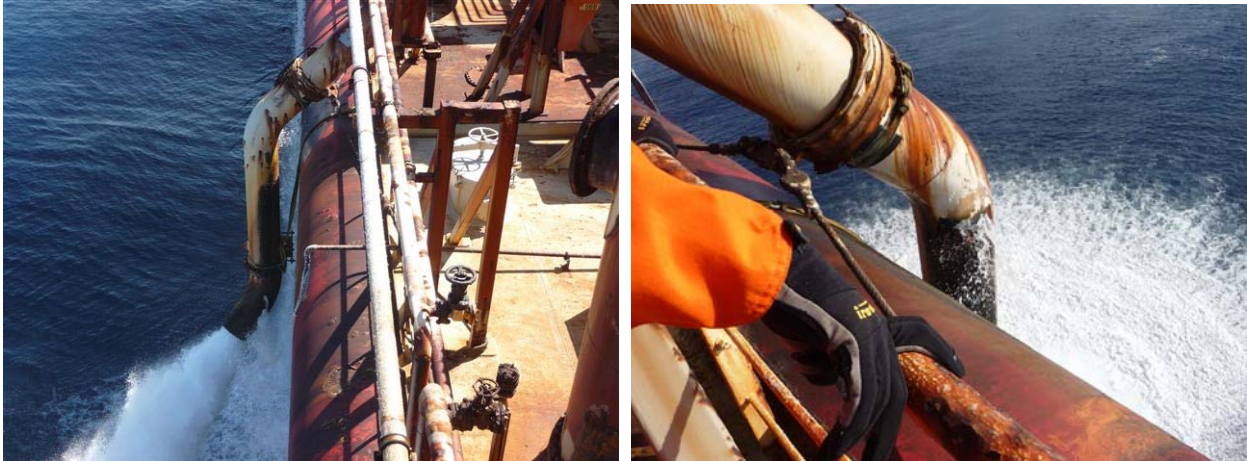
Significant corrosion was observed in the process cooling overboard line as shown in Figure 3 and Figure 4 below. It was also observed that there was cyclic lateral movement of the discharge line which was being transferred back to the header located in the pipe rack.

Figures 3 and 4 - Process Cooling SW Overboard Line

Recommendation 1346-17

Ensure that corrosion on the overboard sea-water cooling line is addressed and that the existing line is reviewed for fitness for purpose. Ensure that any corrective work is undertaken in a timely manner.

Recommendation 1346-18

Ensure that the cyclic loading of the process cooling sea-water piping, caused by cyclic lateral movements of the overboard sea-water cooling line, is reviewed for the potential for fatigue induced failures. Undertake any corrective work in a timely manner.

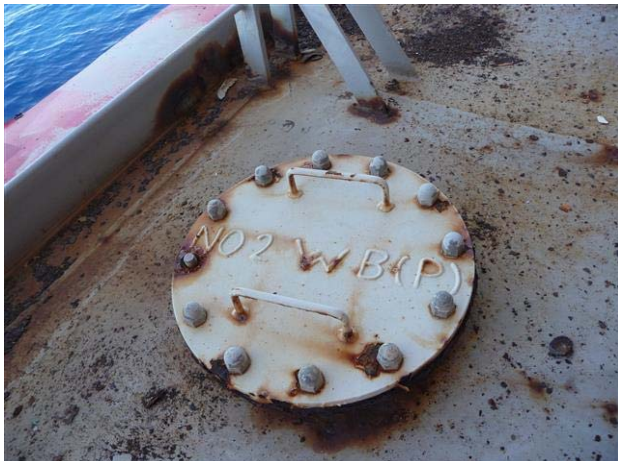
The inspectors observed that the #1 and #2 water ballast tanks and cargo tanks Butterworth hatches as well as various tank lids and deck penetrations at these locations have significant corrosion as shown in Figure 5 through Figure 8 below.

Figure 5 - Corrosion on the #2 Water Ballast Tank

Recommendation 1346-19

Ensure that corrosion on the deck penetrations of #1 and #2 water ballast tanks and cargo tanks including Butterworth hatches and tank lids are assessed for fitness for service and that corrective work is undertaken in a timely manner.

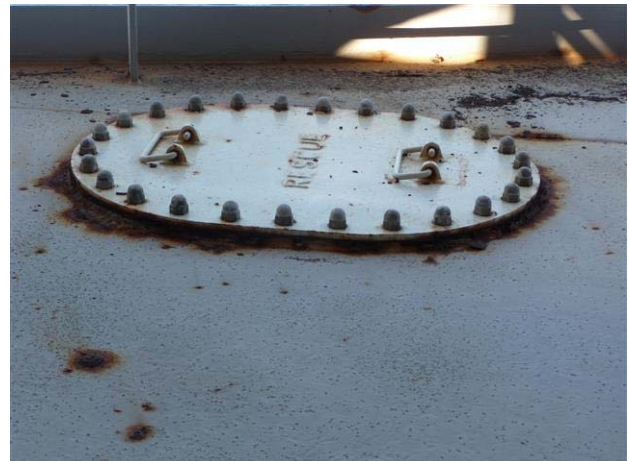
Figure 6 – Corrosion at Deck Penetration

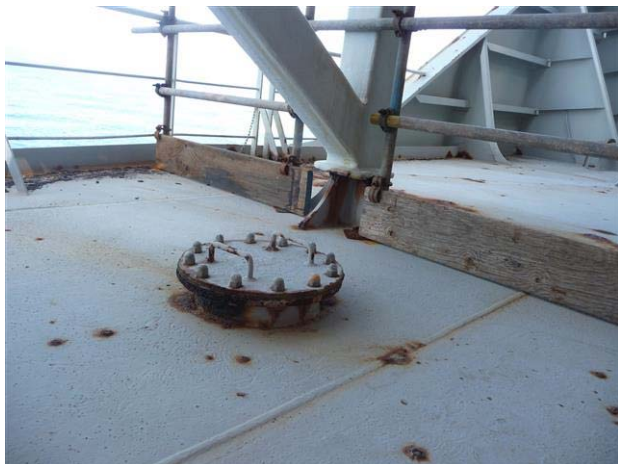
Figure 7 - Corrosion at Deck Penetration

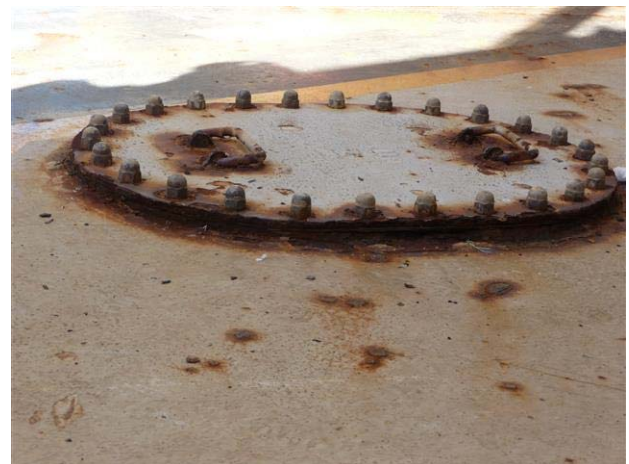
Figure 8 - Corrosion at Deck Penetration

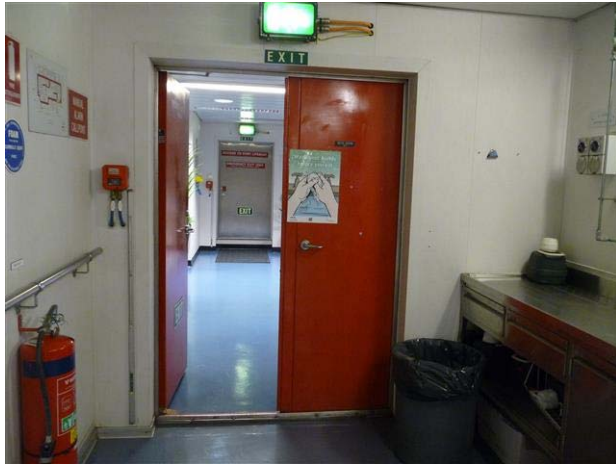
During the inspection the inspectors noted that the A60 Galley door and the A60 Mess room (temporary refuge) entrance door were locked or wedged open without any automated closing arrangement provided. The Mess room door is shown below in Figure 9 and Figure 10 below.

Figure 9 - A60 Fire Door to the Mess Room (TR)

Recommendation 1346-20

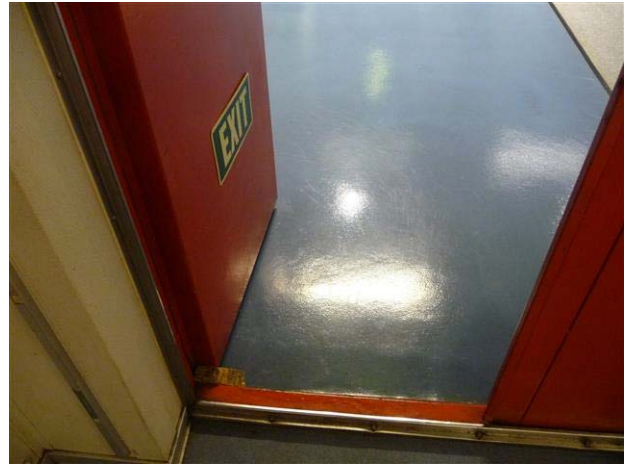
Figure 10 - A60 Fire Door to the Mess Room (TR)
Showing Wedge
