Failed Pipe Support

Produced Water 300mm Super Duplex Line

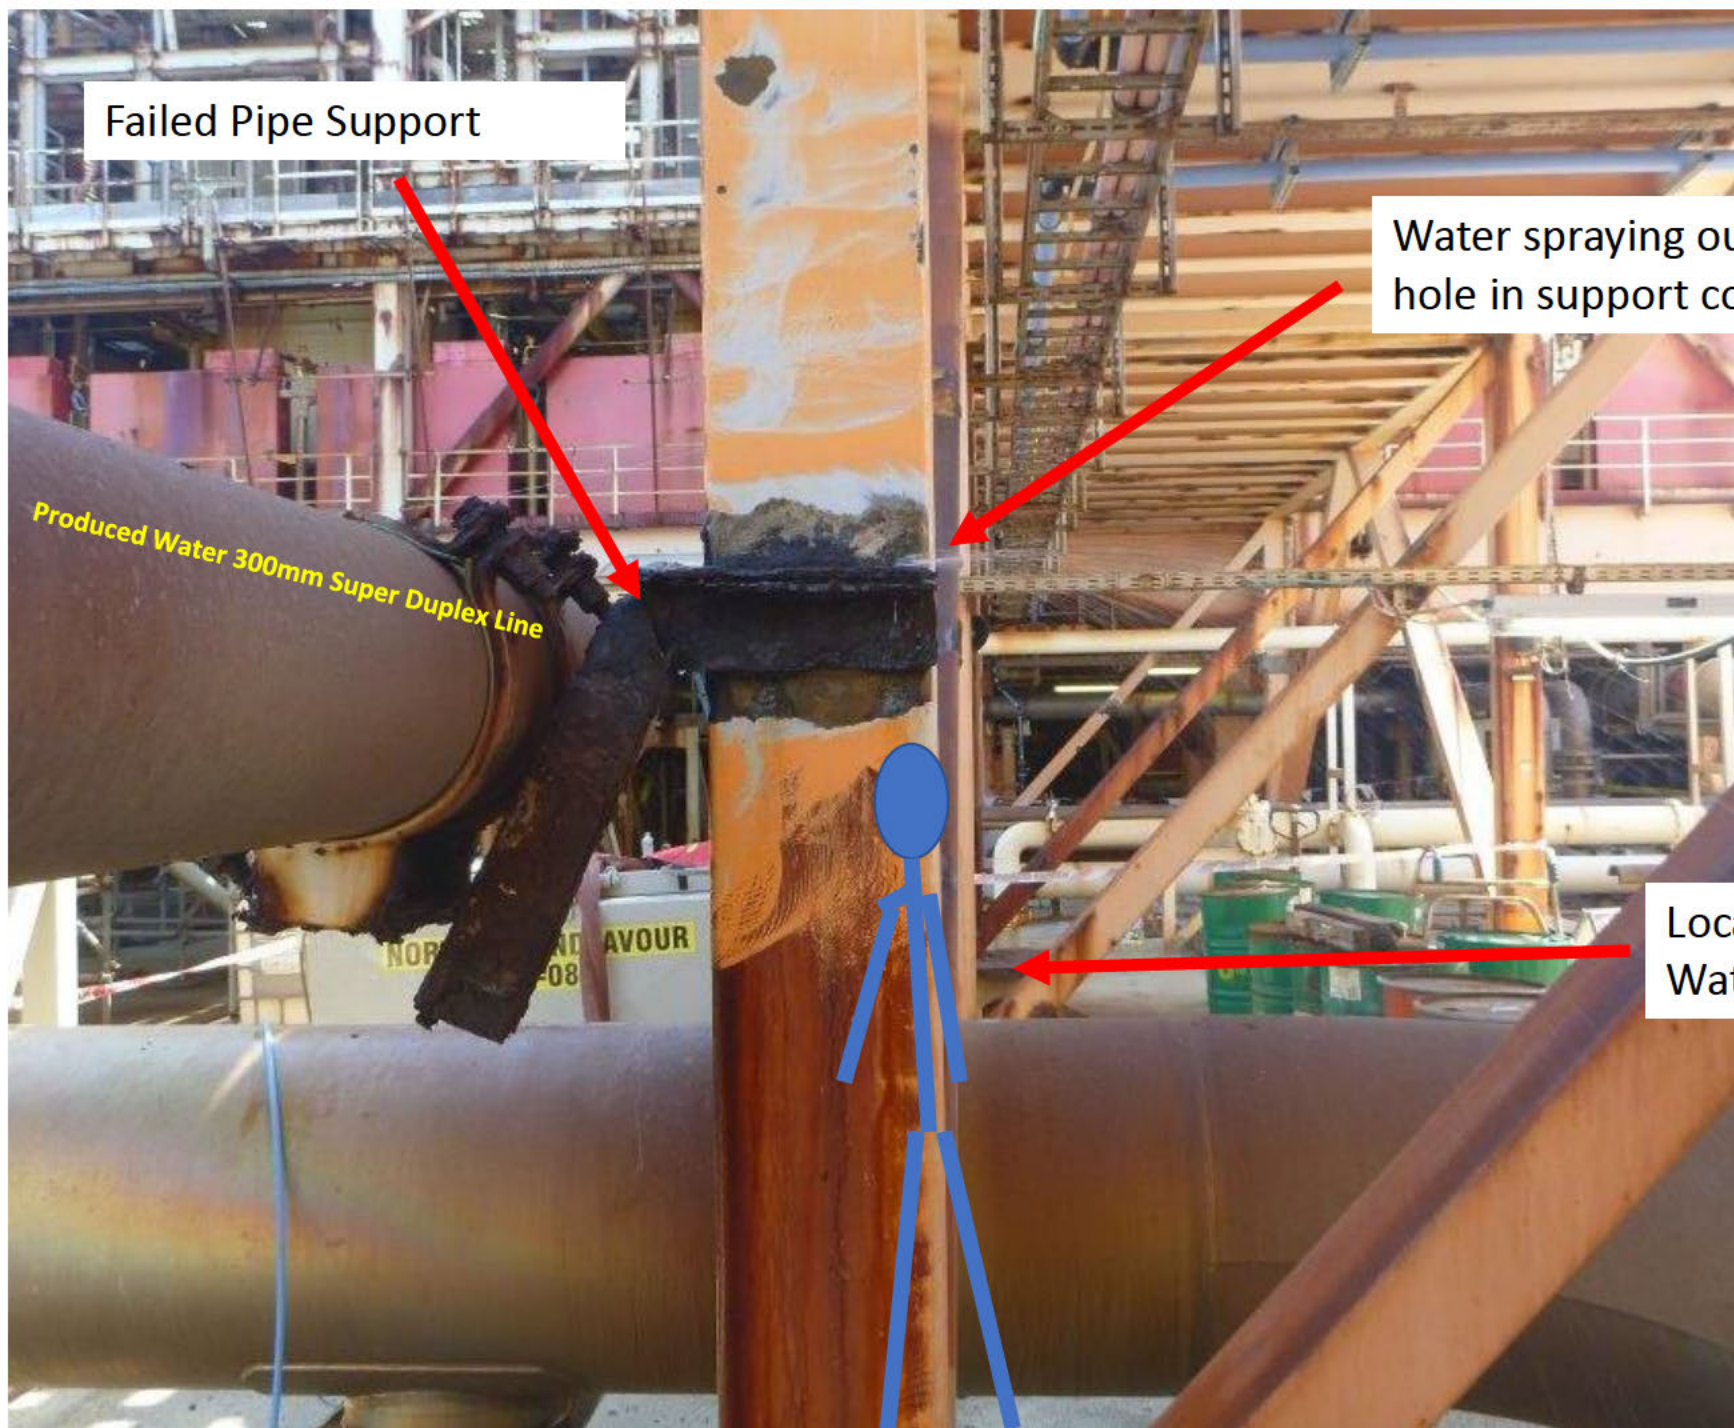
Water spraying out from
hole in support column

Location of UHP
Water Blaster

Side view showing
degree that pipe has
moved/lowered

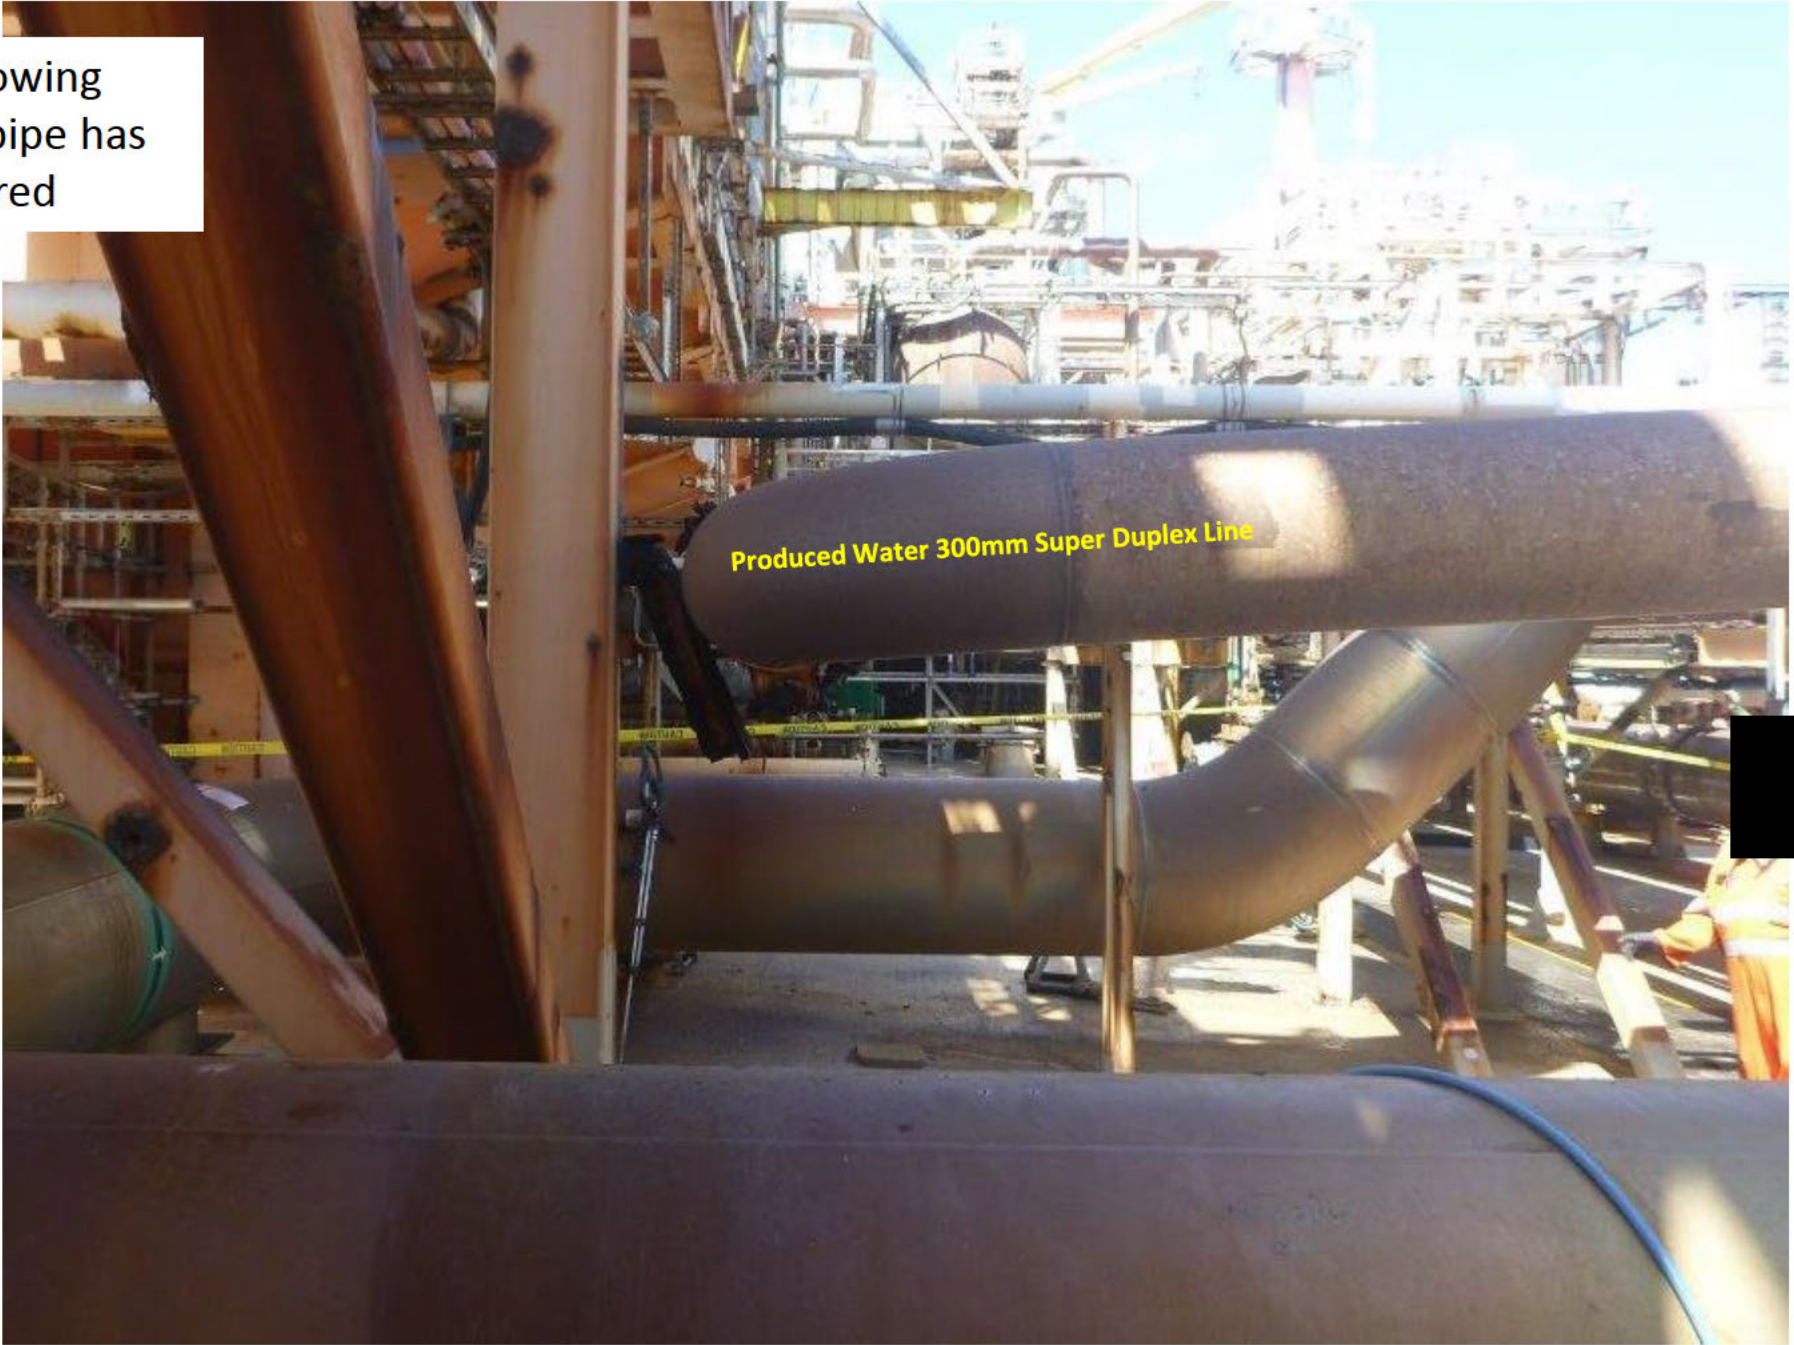
Under side of
Orchard Rd Bridge

Showing canter
levered section of
line from a distance

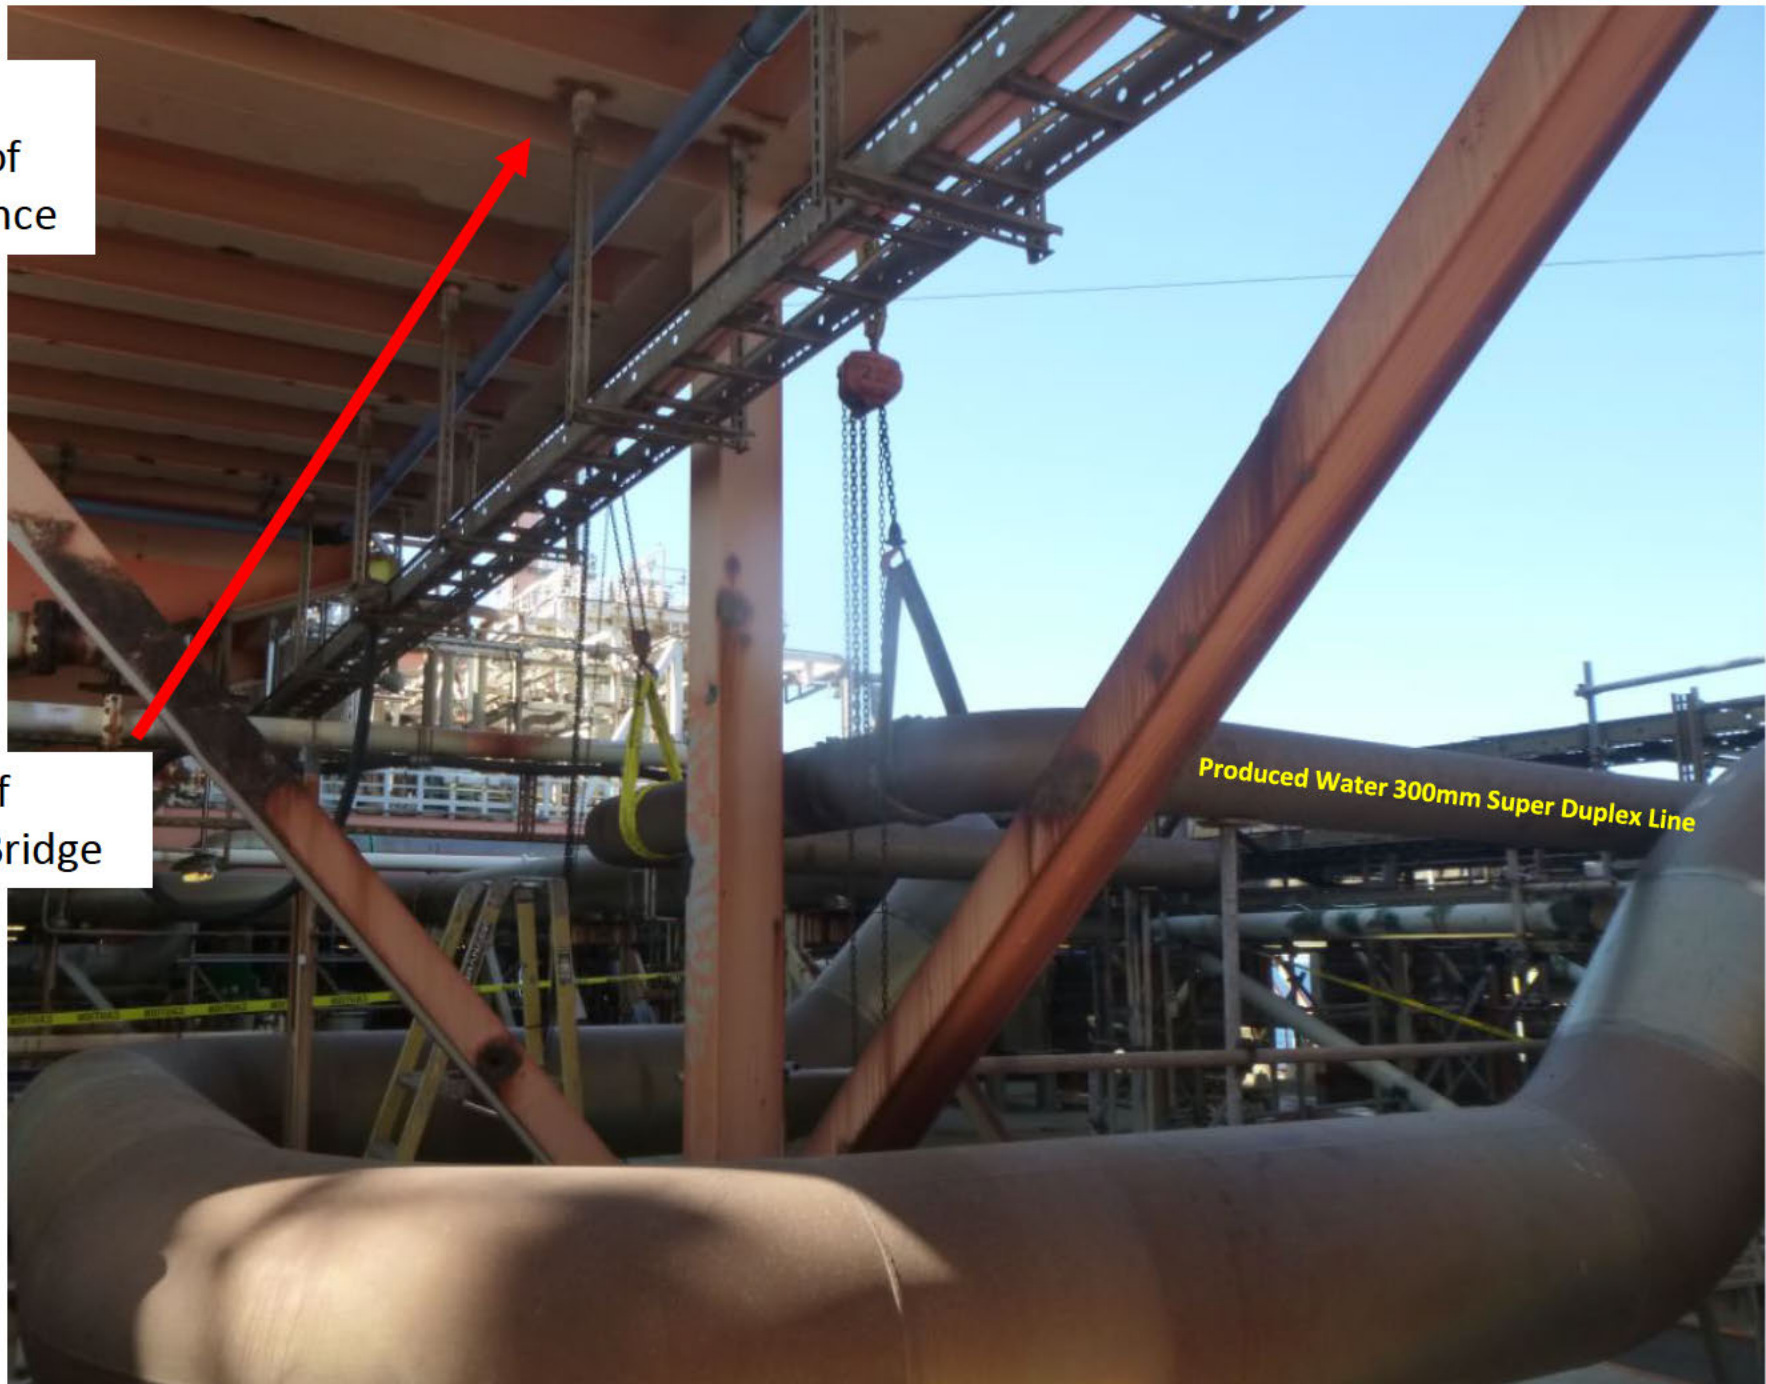
Layered corrosion
on failed pipe
support
