Near Miss: Dropped Object -Valve Shroud from Heat Medium Bypass

No. 4900-HS-H0077-03

This Near Miss: Dropped Object - Valve Shroud from Heat Medium Bypass has been reviewed by Upstream Production Solutions Pty Ltd and Northern Oil & Gas Australia Pty Ltd and is approved for the Northern Endeavour Project.

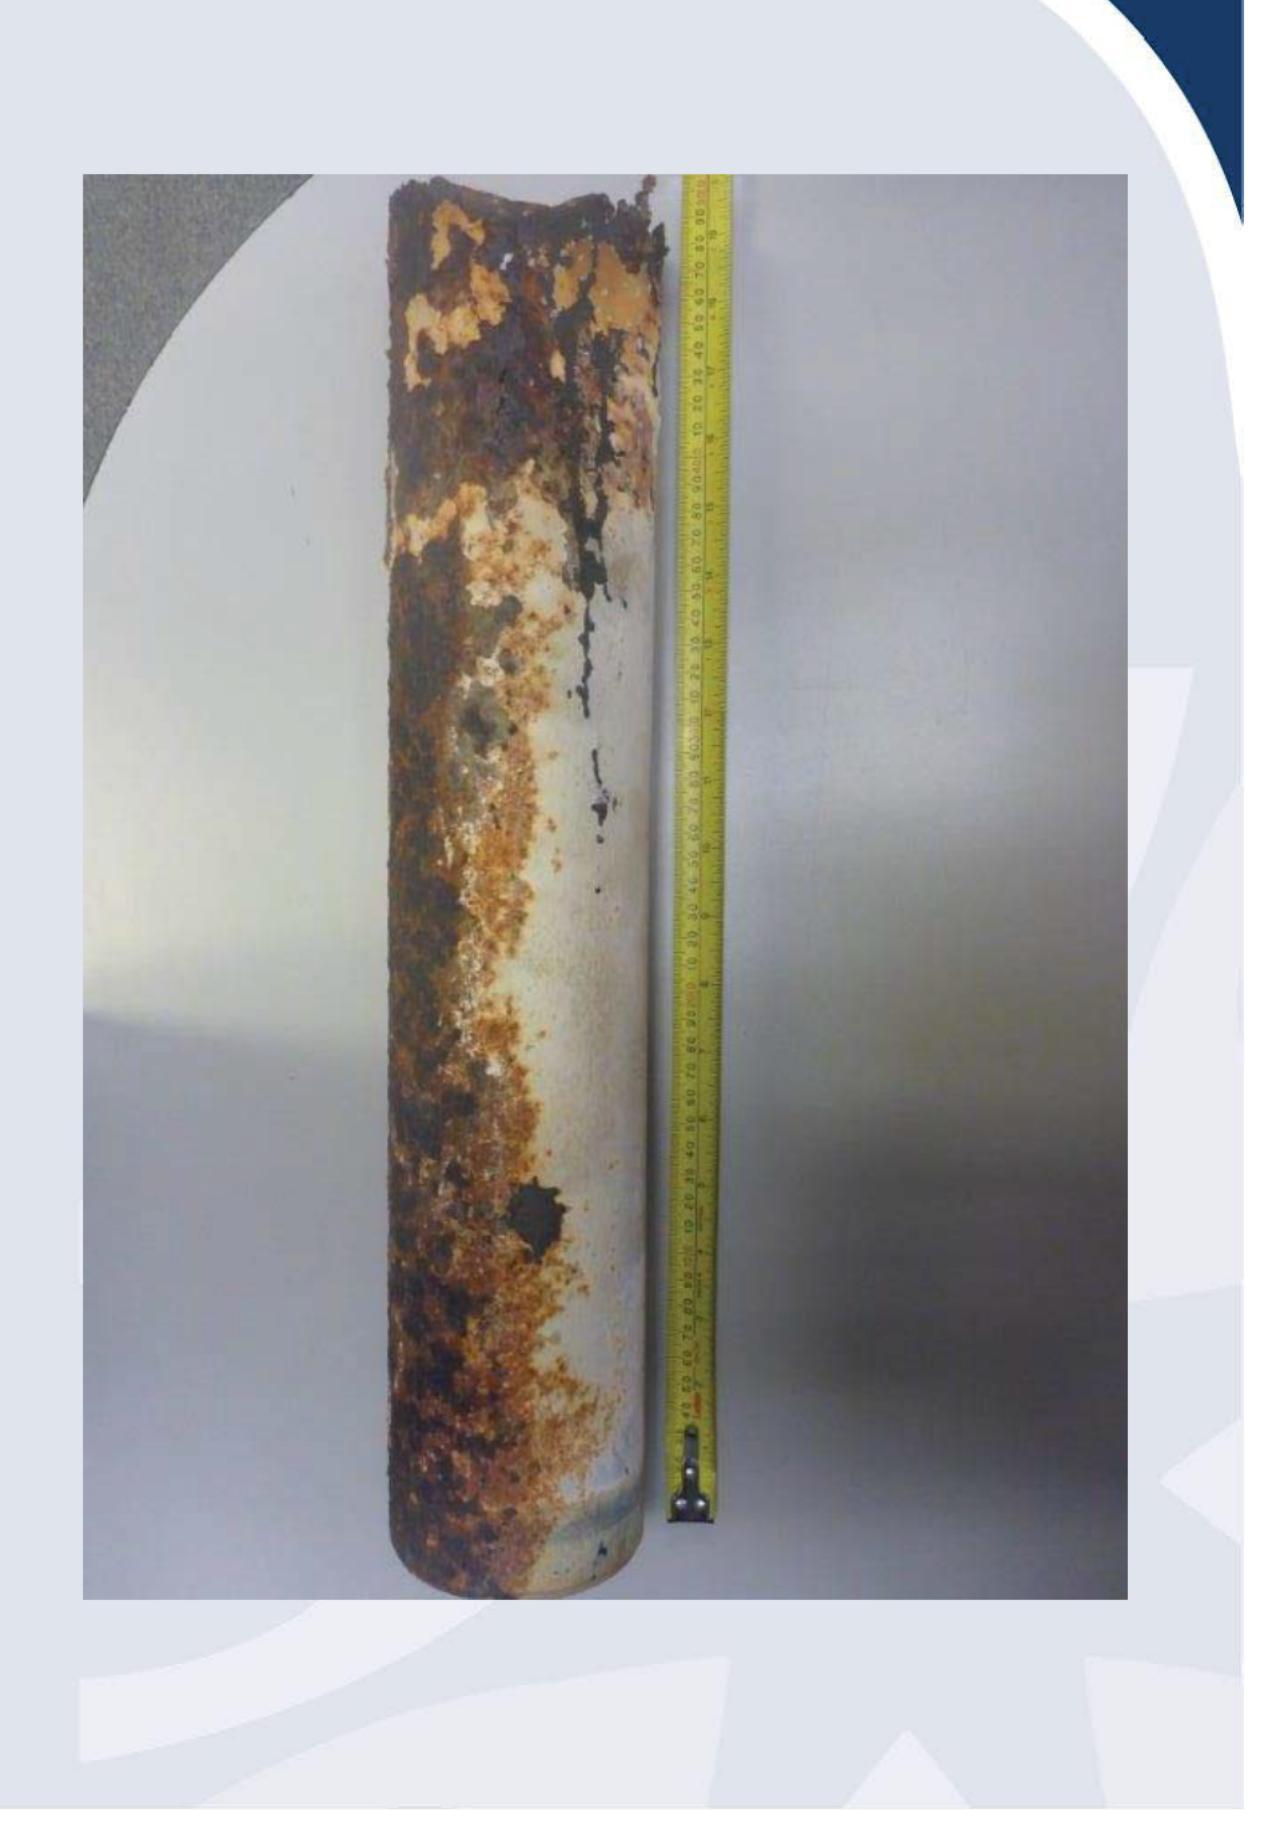
Three of the four valve shrouds and the associated valve indicators experienced severe unmonitored corrosion to an extent that they were all in a state of failure and given time or an initiating event, could have fallen to the process deck below.

Valve Shroud – Corrosion

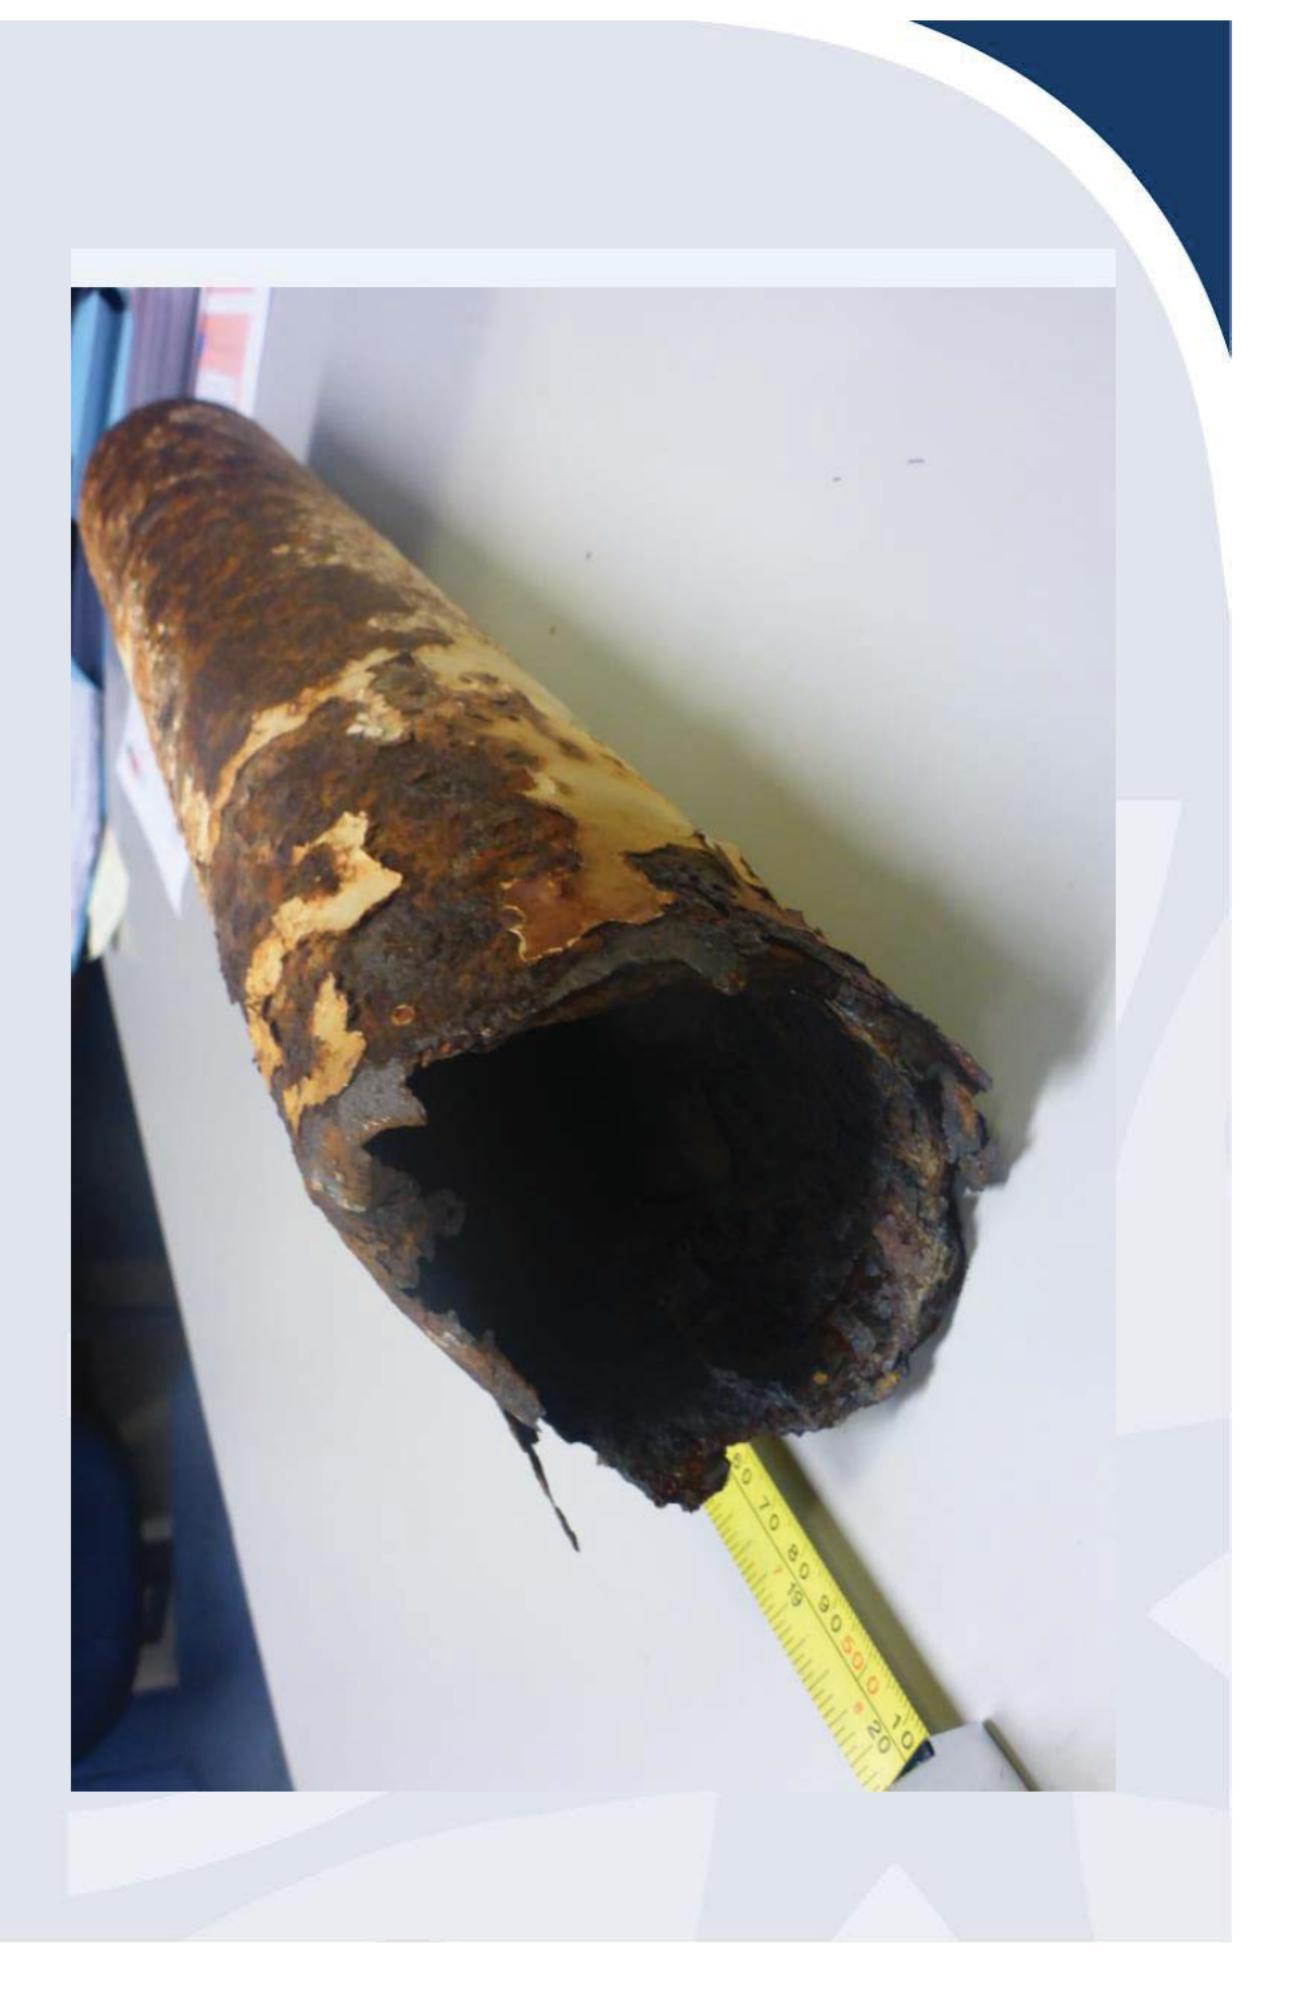
Valve shroud - Corrosion

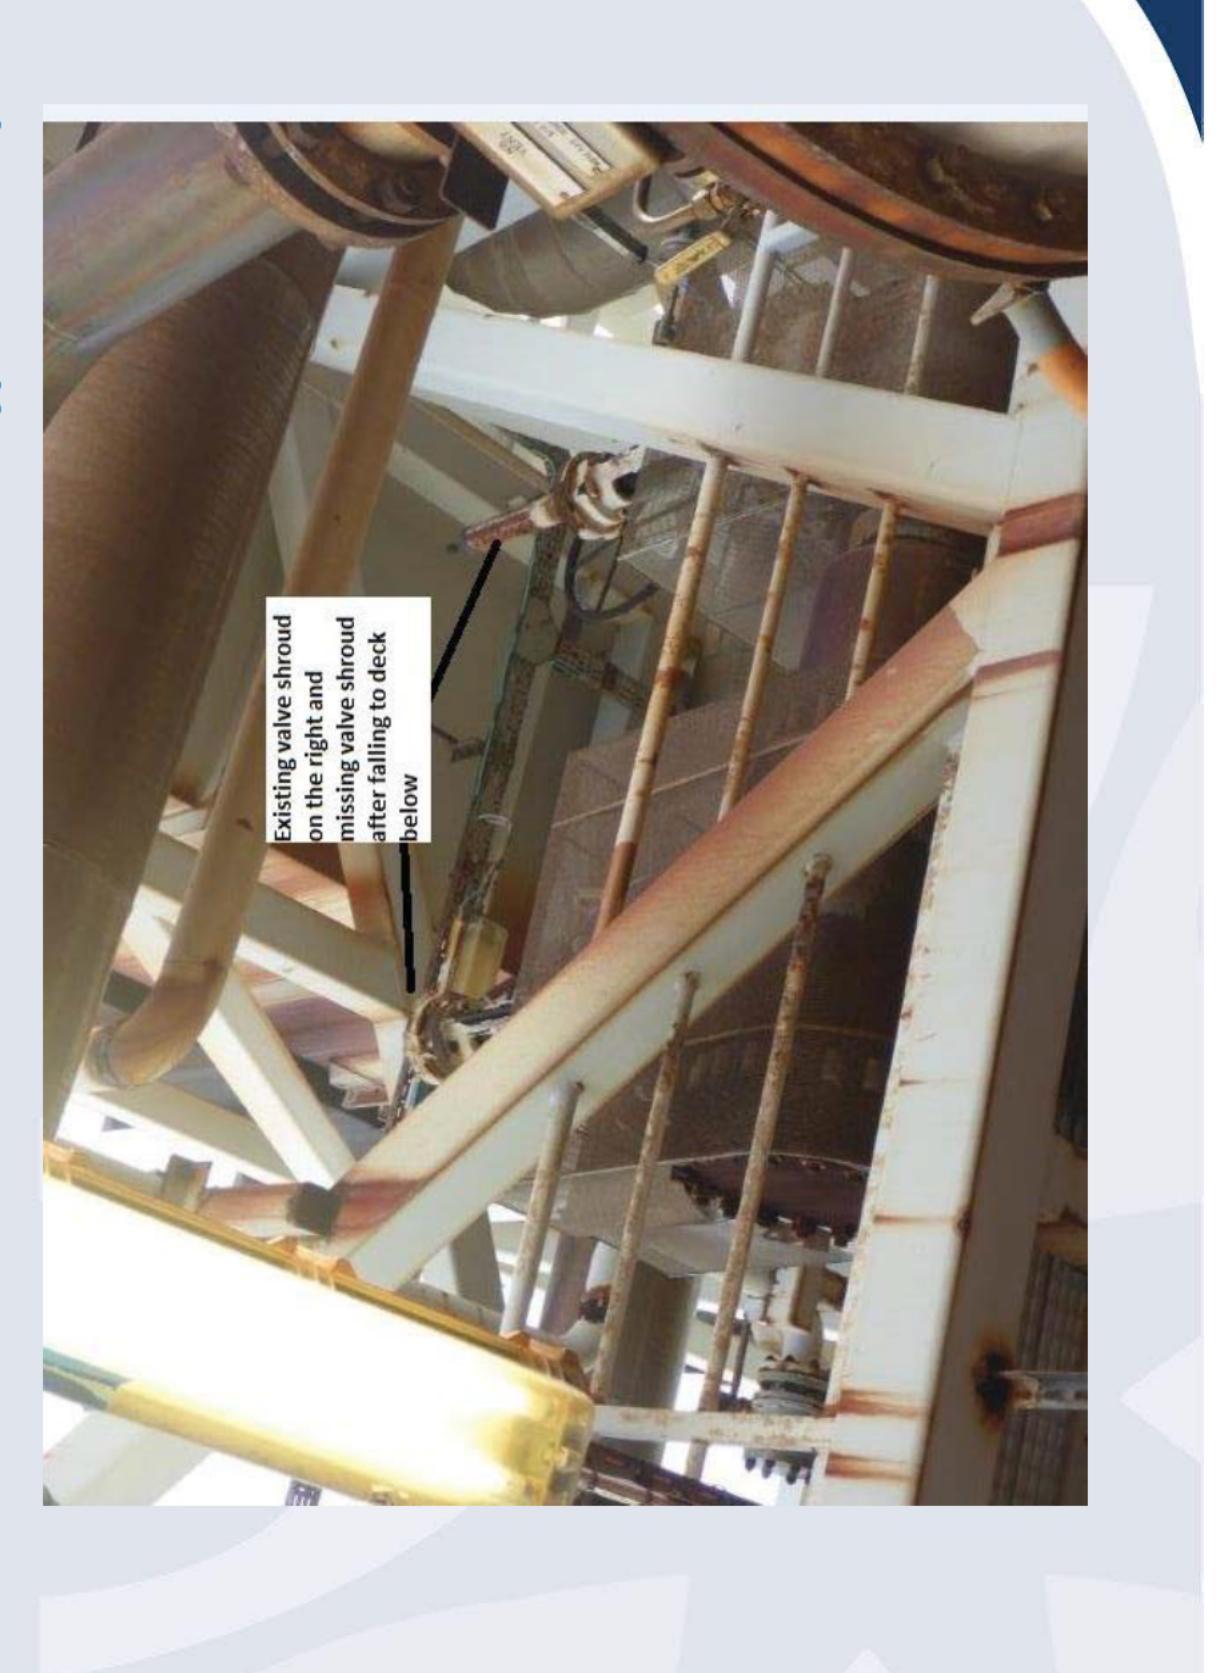
The heating medium bypass valves fell into the criteria of redundant pipework located at an elevated location.

Mezzanine deck - Redundant HM bypass valve postion

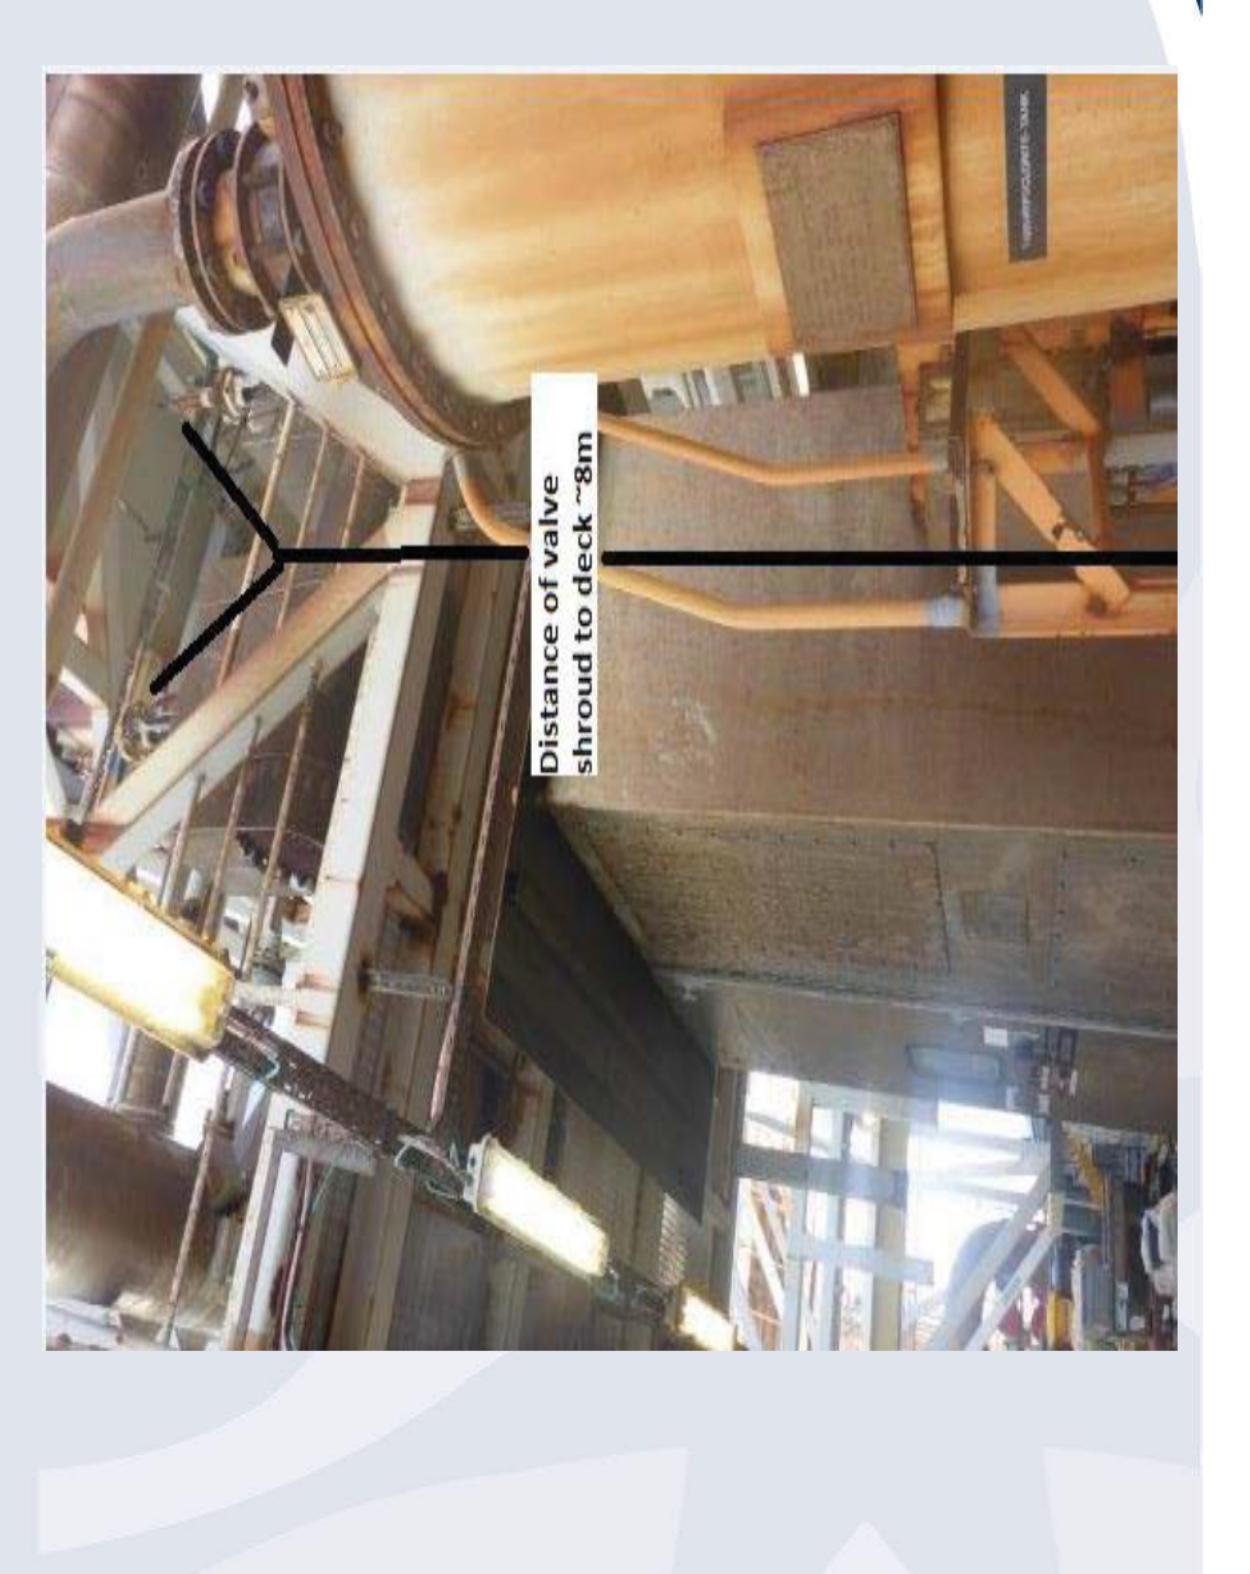
Distance of fall of the Valve Shroud = 8m

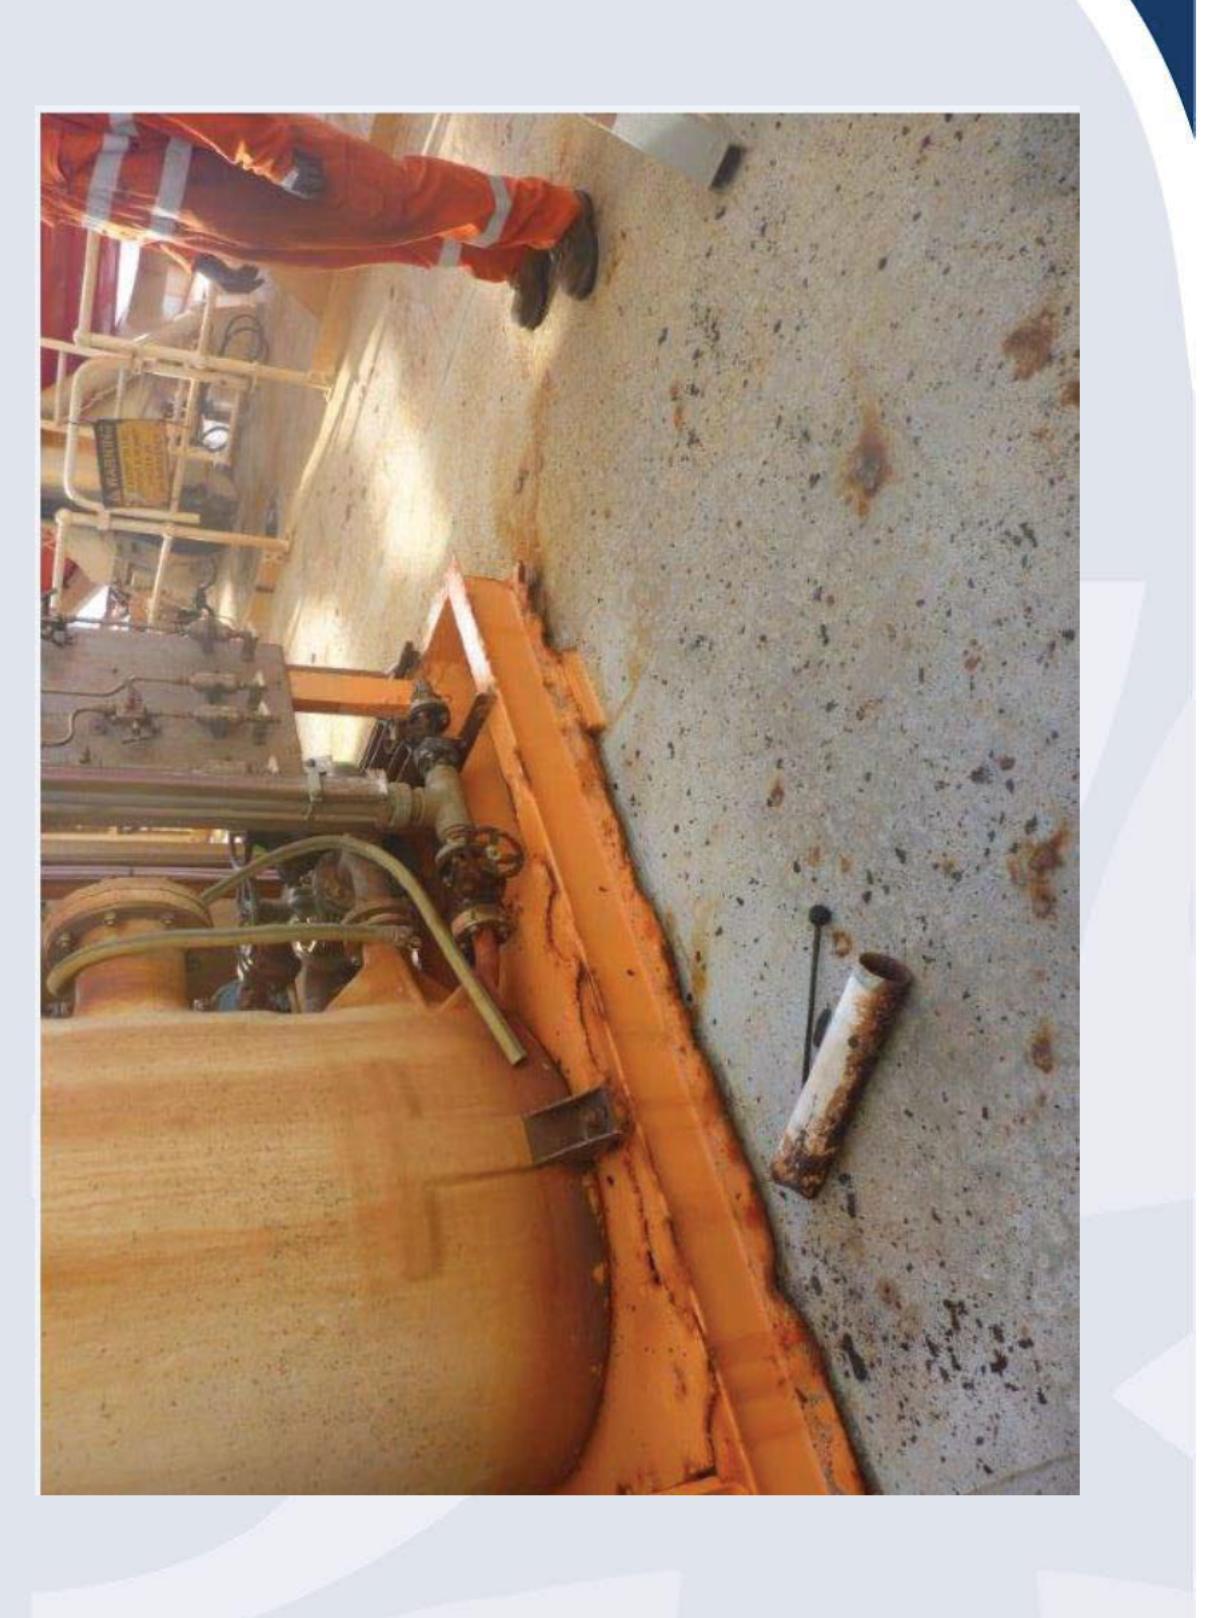
Position of Personnel in relation to the landing of Valve Shroud

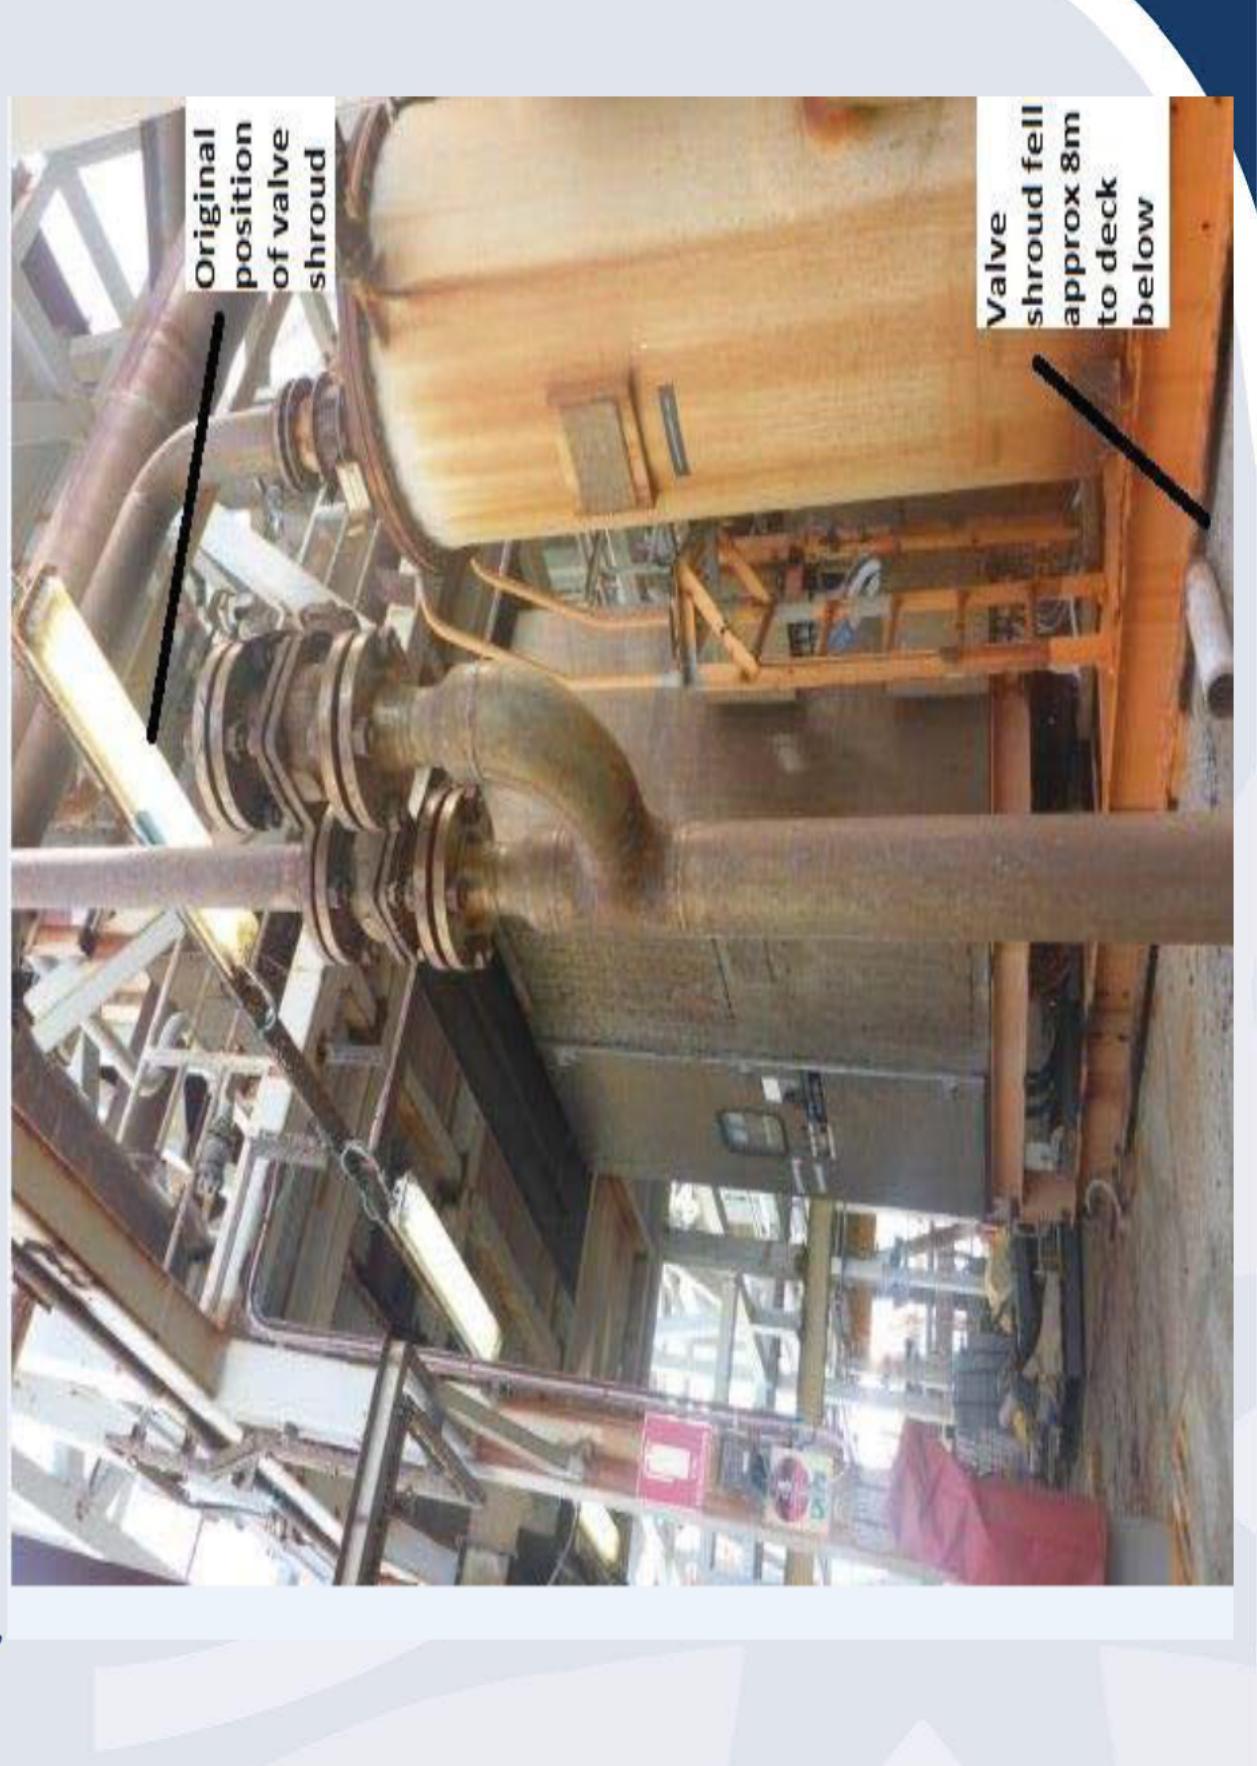
Path of fall of the Valve Shroud

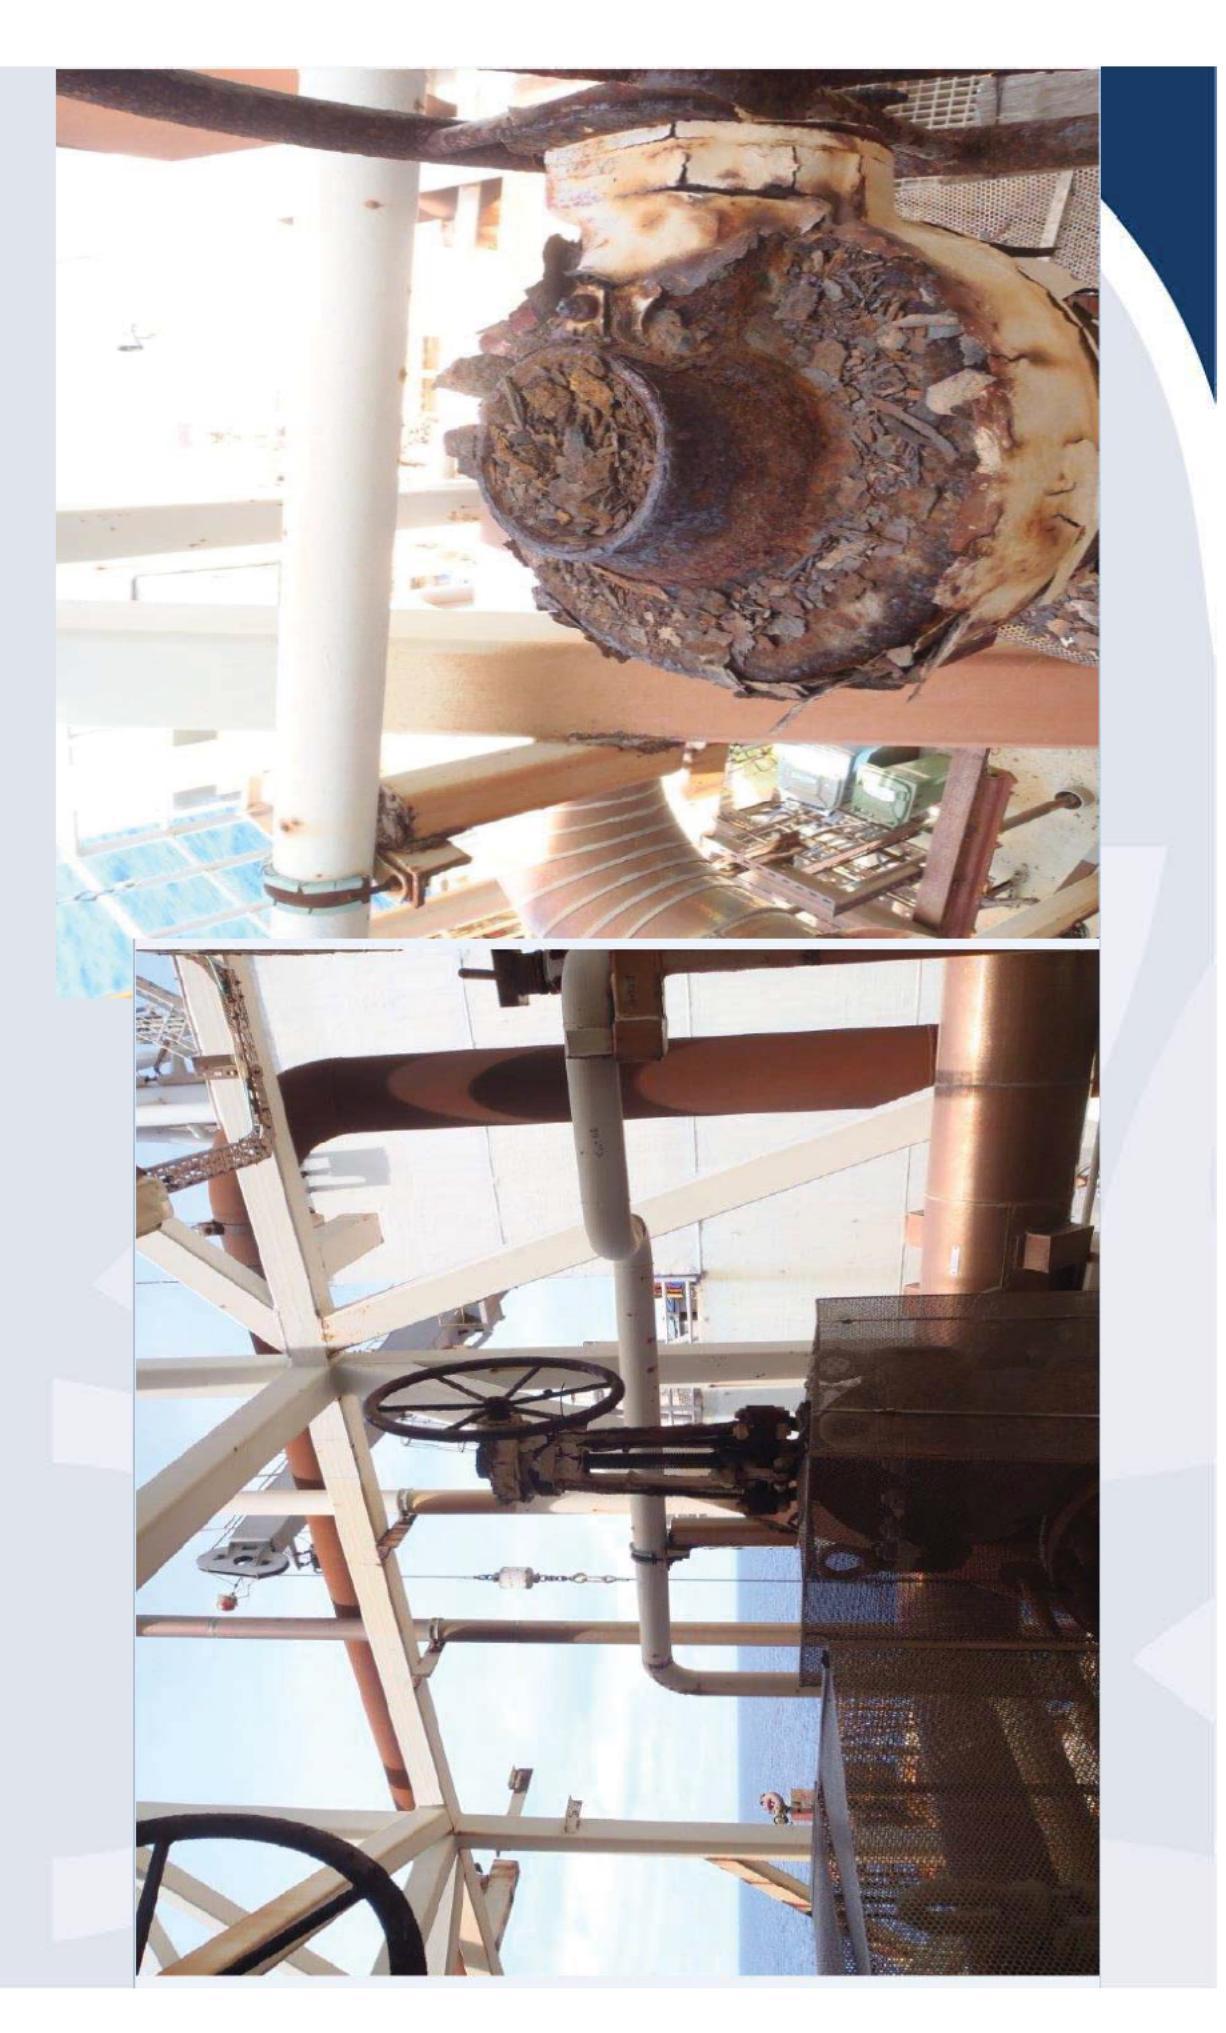
Base of Valve shroud – Severe Corrosion

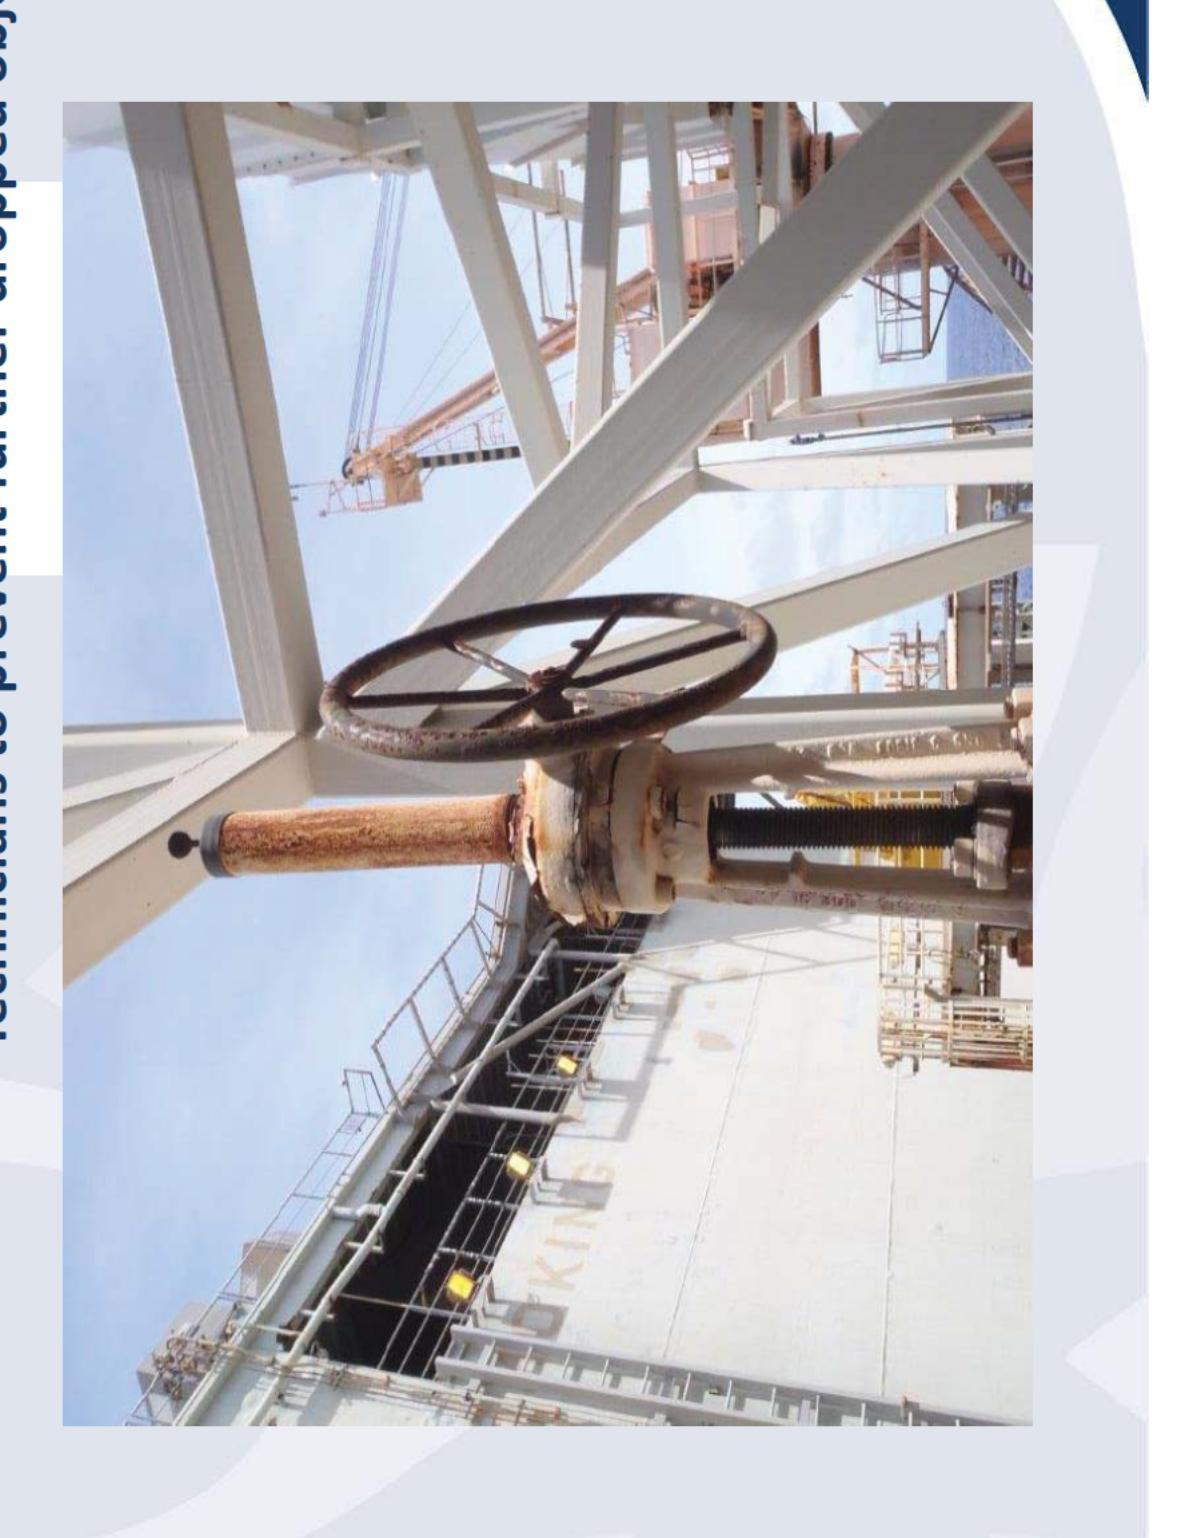
Upstream Monte Shrouds on same deck – Removed by Rope Access Technicians to prevent further dropped objects

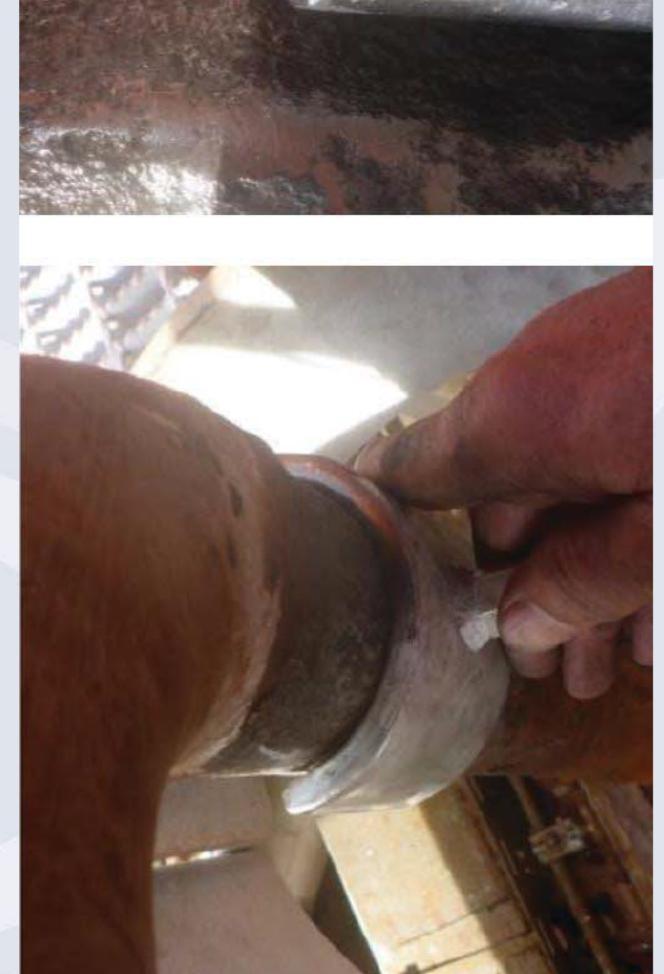
Solutions under insulation
