Facility:Northern EndeavourOperator:Woodside Energy LtdOffshore Inspection Dates:16/09/2015 – 18/09/2015

Report Number

1175

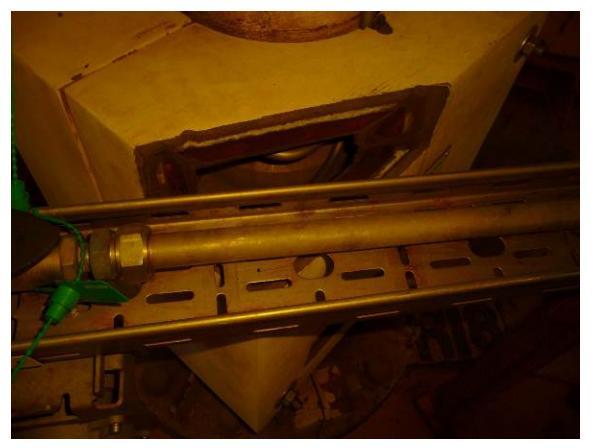
The inspectors observed that Passive Fire Protection (PFP) has been implemented to protect RESDVs and sampled BDVs as per performance standards F05 and F09. However, it was noted that the PFP at the Laminaria Production / Test RESDV and the Laminaria Production RESDV appears to have been modified at some point in the facility's history, exposing elements within, albeit not the valves or actuators directly (see photo). Facility crew were not able to provide any explanation for these apparent modifications. The inspectors consider that an assessment of this situation is necessary to ensure that the original design intent, with respect to fire protection of these RESDVs, has not been compromised.

Photo 1: PFP at Laminaria Production RESDV

Recommendation 1175-2

Review the Passive Fire Protection implemented for all RESDVs and associated fittings to ensure that that original design intent has not been compromised.

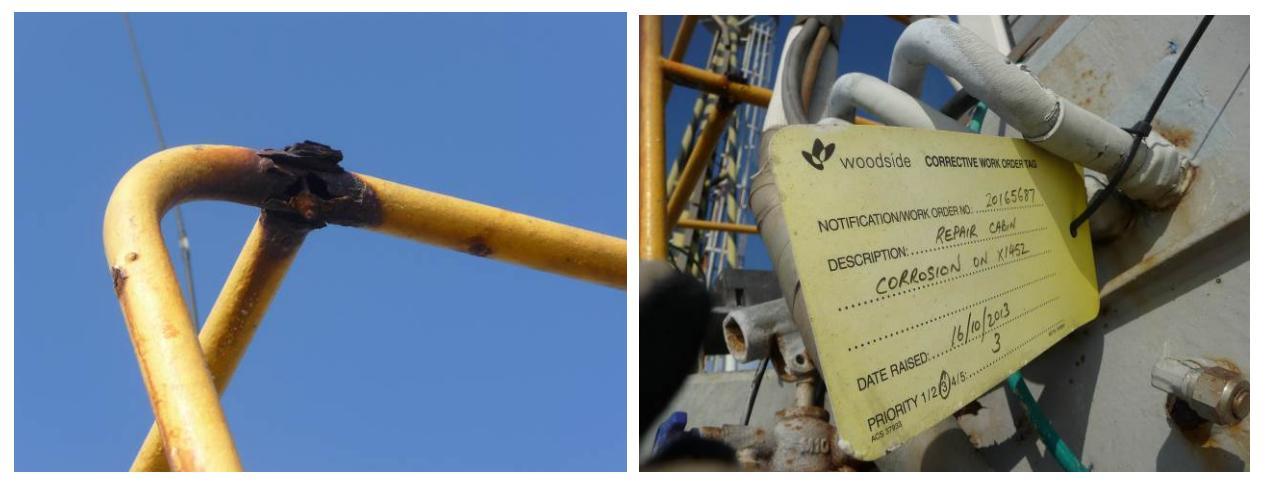
The provisions crane jib handrail crossbars, handrail connections to jib, cab window frame and cab roof were noted to be extensively corroded and the crane right hand side window glass is missing and blanked with masking tape. This would impair the vision of the crane operator during crane operations.

Photo 2: Provisions crane hand rail

Photo 3: Corrosion tags for provisions crane cab

Recommendation 1175-12

Ensure that:

- a. corrosion on the provisions crane jib handrail crossbars, handrail connections to jib, cab window frame and cab roof is permanently repaired
- b. the provisions crane right hand side window glass is replaced/permanently repaired.

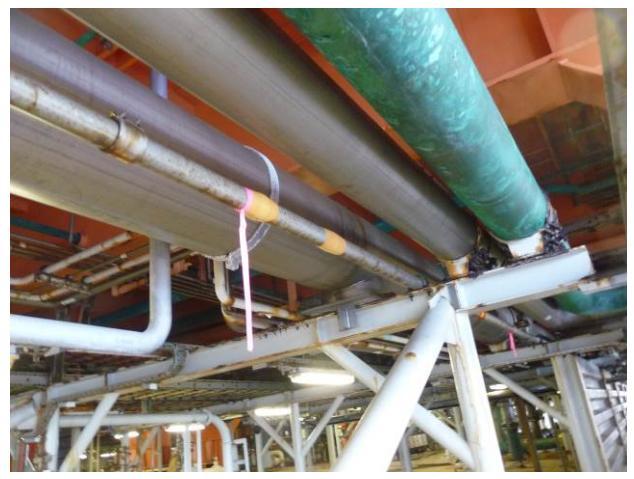
Several temporary wrap repairs were observed on the main deck aqueous film forming foam (AFFF) piping.

Photo 4: Wraps on AFFF piping

Recommendation 1175-17

Ensure that all sections of damaged main deck aqueous film forming foam piping are permanently repaired and fit for purpose.

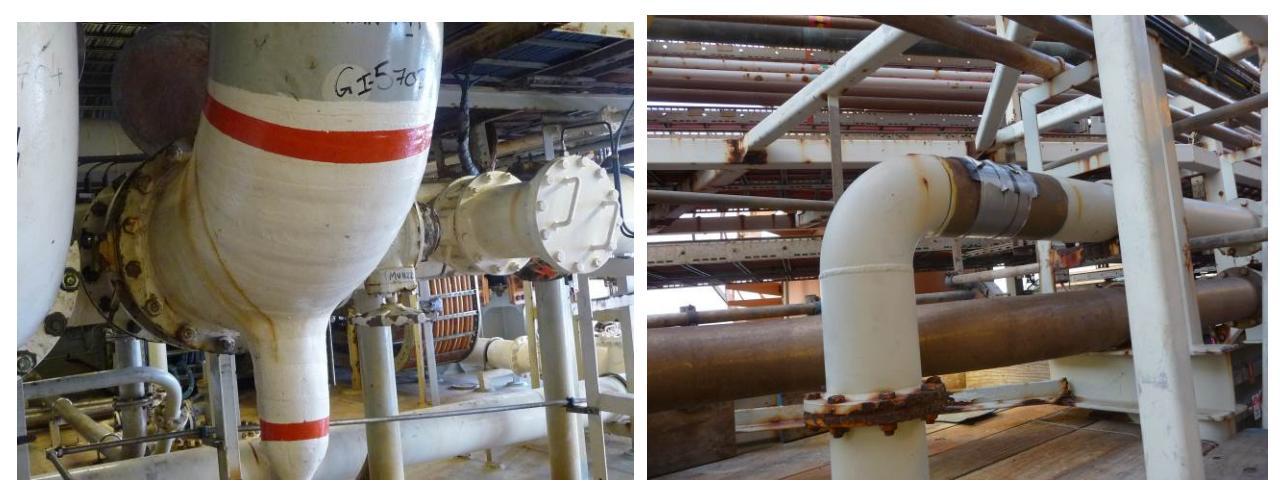
Temporary repairs were noted on the inert gas (IG) main pipe forward of deck seal and on the IG purge line at 1S cargo tank.

Photos 5 & 6: Temporary repairs on IG piping

Recommendation 1175-18

Ensure that the sections of damaged main deck IG piping are permanently repaired and fit for purpose.

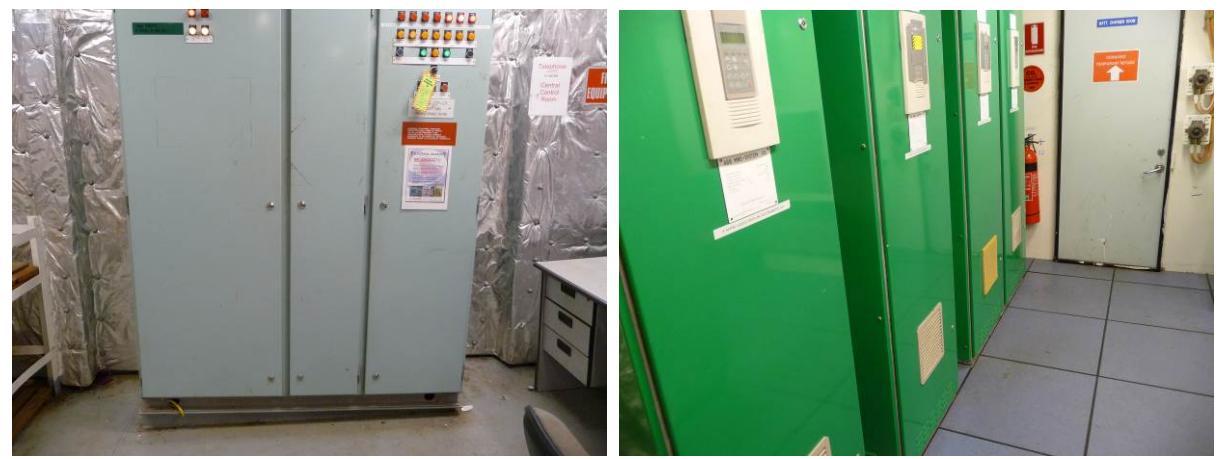
It was noted that there was inadequate coverage of rubber matting in the switch-rooms on the facility. The NOPSEMA inspectors concluded that during an emergency situation in a switch-room the risks of electric shock to members of the workforce may not be reduced to a level that is as low as reasonably practicable (ALARP).

Photos 7 & 8: No insulation mats in forward switch-rooms

Recommendation 1175-19

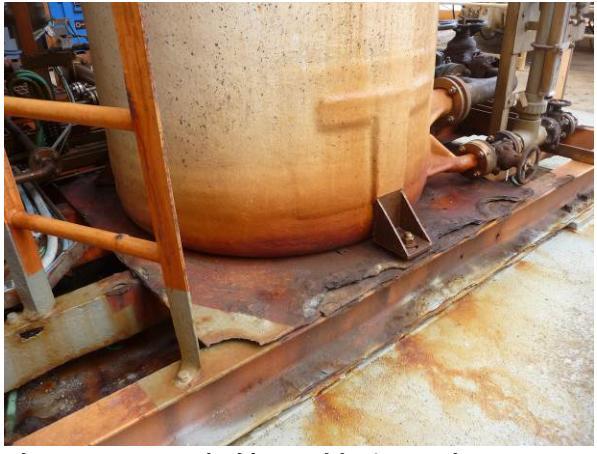
It was noted that the hypochlorite tank support base was corroded and deformed.

Photo 10: Corroded hypochlorite tank support

Recommendation 1175-21

Ensure that the hypochlorite tank support base is permanently repaired to adequately support the weight of the tank and associated accessories.

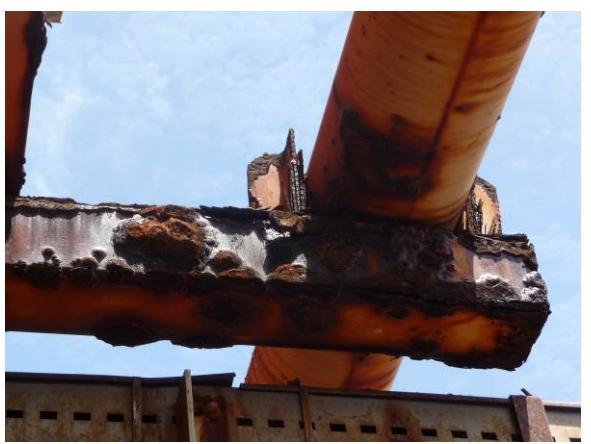
The open drain line support bracket on the port side (aft of the re-compressor skid) was noted to be substantially corroded and has the potential to become a large dropped object.

Photo 12: Corroded open drain line support bracket

Recommendation 1175-22

Ensure that corrosion on the open drain line support bracket on the port side (aft of the re-compressor skid) is addressed in a timely manner.

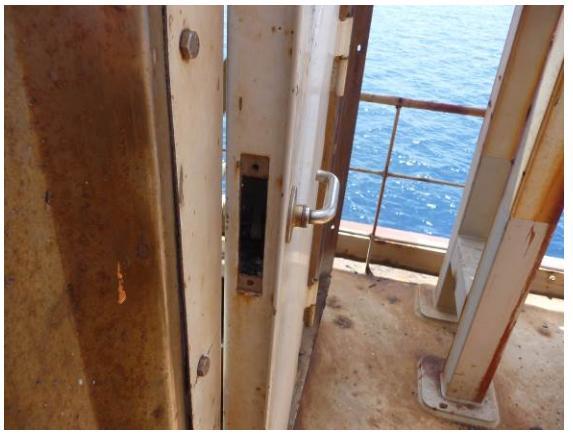
It was observed that the blast protection door protecting the aft fire pumps was damaged and not closable. The closing mechanism was broken.

Photo 13: Damaged blast protection door

Recommendation 1175-23

Ensure that blast the protection door protecting the aft fire pumps and its closing mechanism are repaired in a timely manner.

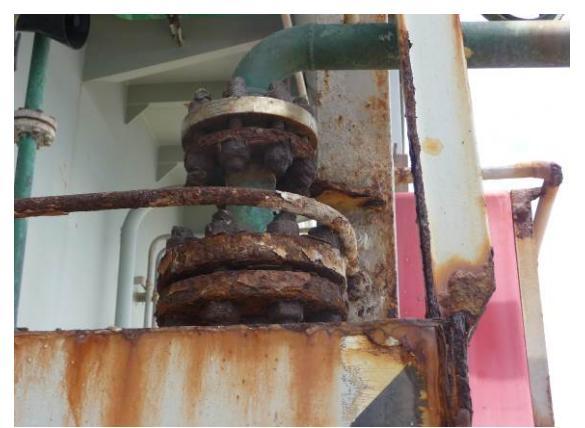
The inspectors noted that the starboard aft poop deck fire hydrant flanges were corroded.

Photo 14: Corroded fire hydrant flanges

Recommendation 1175-24

Ensure that corrosion on the starboard aft poop deck fire hydrant flanges is addressed in a timely manner.
