Safety Alert 14

Fast Rescue Craft Safety

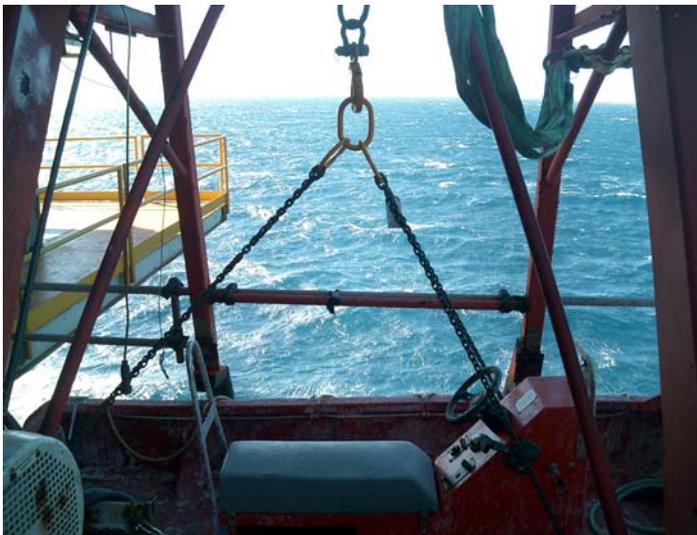
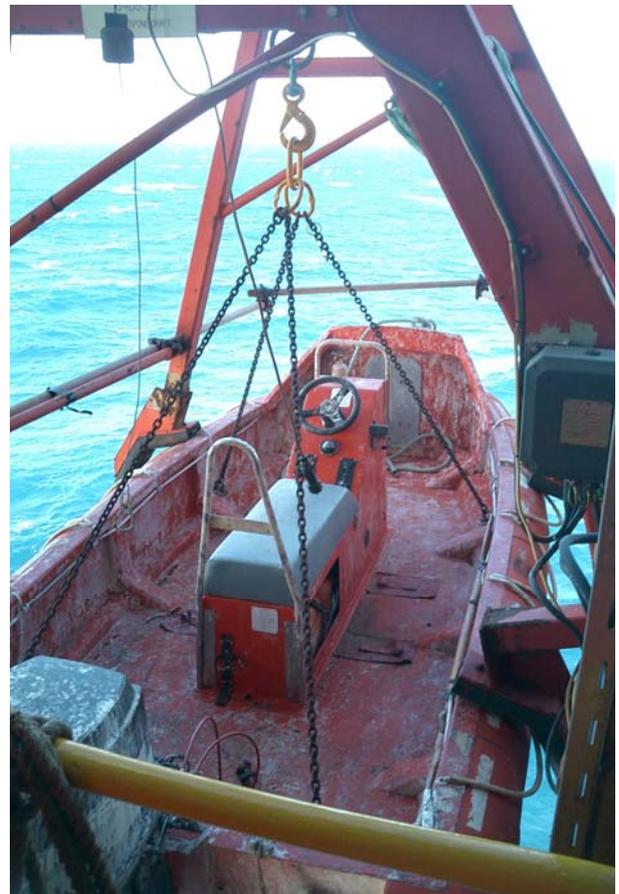
Following the failure of the platform's original FRC, a replacement FRC was brought in from a nearby facility as a temporary measure. A Job Safety Analysis (JSA) was performed by the platform workforce on the use of the replacement FRC and a number of hazards were identified, including:

- The location of the lifting point directly above the Coxswain's head without the provision of any over-head protection;
- The potential for snatching of the chains once at sea level (in rough seas); and
- No quick-release hook – potential for hand/finger injuries whilst attempting to connect to, or disconnect from, the hook.

The risk control measures identified during the JSA to address the identified hazards were limited to procedural controls and awareness of the hazards. As a result, the work party had safety concerns with the temporary arrangements and it was decided that the FRC was not safe to launch. Given that the FRC had not been taken out of service at the time of the inspection, and based on the JSA's reliance on procedural controls and hazard awareness, it was considered that the use of the FRC would present an imminent threat to safety.

Consequently, a Prohibition Notice was issued to prevent use of the FRC in its current configuration. Work restrictions were also introduced by the operator to minimise the man overboard risk.

- The use of temporary replacements for safety-critical equipment, such as an FRC, should be thoroughly reviewed through a MoC process prior to the change being made to ensure new hazards, resulting in unacceptable risks, are not introduced.
- A single layer of risk controls is generally not sufficient to adequately address identified hazards, especially when the controls are either procedural or awareness-based in nature. Preferably, there should be several layers of risk controls in place so that if one control measure fails, there are others in place to prevent the undesired consequences being realised.
- The hierarchy of controls should be considered when making changes with controls selected from as high as possible on the following list, where practicable:
 - ⇒ Eliminate
 - ⇒ Substitute
 - ⇒ Engineering Controls
 - ⇒ Administrative Controls
 - ⇒ Personal Protective Equipment
