What happened?

An engine room fire onboard a MODU recently caused significant damage. The fire took one hour to bring under control, and a further 3 hours for boundary cooling etc. There were no injuries.

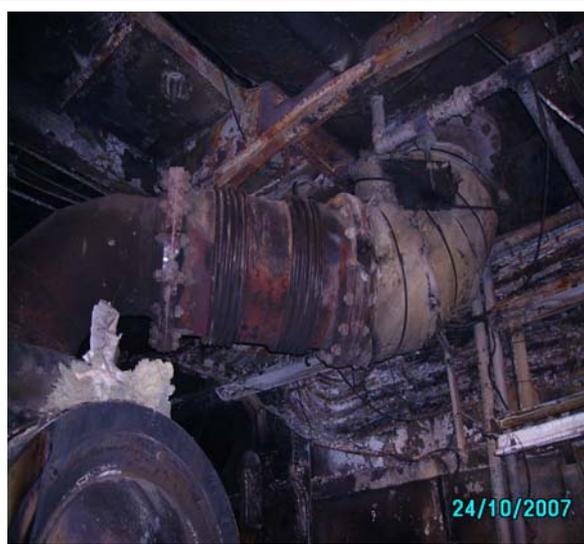
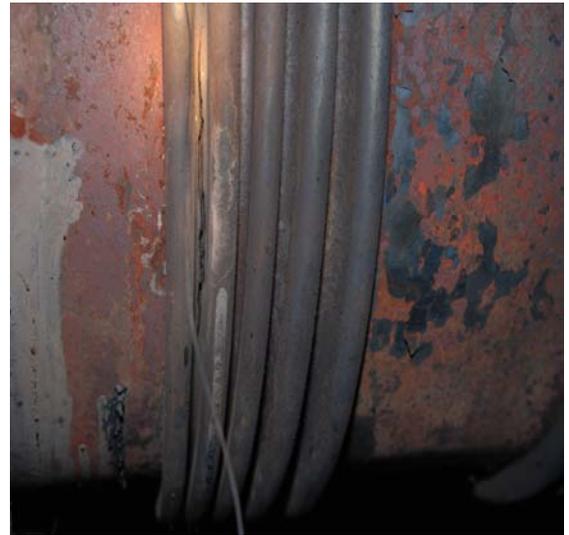
The cause of the fire is believed to be radiant heat from an uninsulated and cracked exhaust bellows igniting the insulation in the deck head. The insulation was later found to be soiled (loaded with soot and hydrocarbons). The fire spread through the engine room and briefly flashed over to the engine room roof.

- Above Pictures - Uninsulated and cracked engine exhaust bellow where fire was thought to initiate.
- Picture to right - Hydrocarbon contaminated insulation on an adjacent engine exhaust bellow. A hole in the pipe was found when the insulation was removed for inspection.

- Engine room fires are a very serious risk. Inspection and maintenance of exhausts, fuel lines, turbochargers & superchargers are critical, including the inspection and replacement of contaminated/damaged insulation. Housekeeping and cleanliness make a difference in reducing risk and damage.
- Provision and testing of emergency equipment is critical (in this case some CO₂ cylinders did not activate when required and some portable fire extinguishers did not function). Redundancy in emergency systems can save lives.
- Consideration for facility specific common mode failures and escalation factors (in this case the rig air system).
