## Scaffolding Safety

### What Happened?

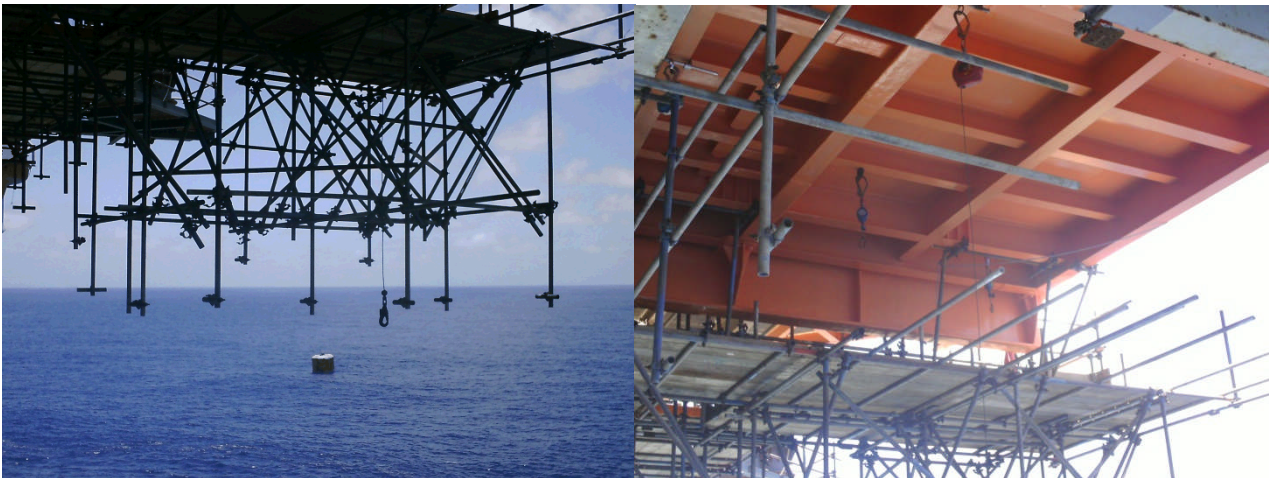
A scaffolder was dismantling a scaffold structure outboard of an offshore platform at a height of approximately 15 metres above the sea when a vertical scaffolding tube (a 'dropper') that was supporting him began to slowly slip. The tube was fixed in place with standard scaffold couplers and the tube was being pulled through these under the weight of the scaffolder.

The investigation found that the scaffolding coupler holding the dropper in place was loose and that there was no check coupler fitted above the dropper tube. It was also found that the rescue equipment used was not suitably rated for the weight of the scaffolder and the associated scaffolding. In addition, some of the certification for the equipment being used during the rescue activities was found to be out of date.

- It is considered good practice to install check couplers above the suspension scaffolding coupler as described in AS/NZS 4576 *Guidelines for scaffolding*.
- The scaffold should be visually inspected by the work party prior to using the scaffold.
- Scaffolds should be inspected regularly by a competent person.
- Only equipment within its certification period should be used.
- Safety equipment should be suitably rated for the personnel using it.
- Fall arrest equipment should be anchored at a suitably rated anchor point.
- The rescue plan should reflect the hazards the job presents rather than using a generic rescue plan for all scaffold jobs.
