**Subject:** RE: Investigation - IVT14016 - Woodside Energy (Victoria) Pty Ltd - Minerva Decommissioning and Field Management  
**Attachments:** Notifiable Incident Form NFI-00003791 (Signed).pdf, DEECA Minerva Monthly Recordable 16 April-2 May submitted 9 May.pdf, Lost Saddle Register WC 9 May 2025.xlsx, field trial saddle retention nets.JPG  
**Importance:** High

**Figure 1: Minerva Pipeline Decommissioning Operational Area**

## Notifiable incident form

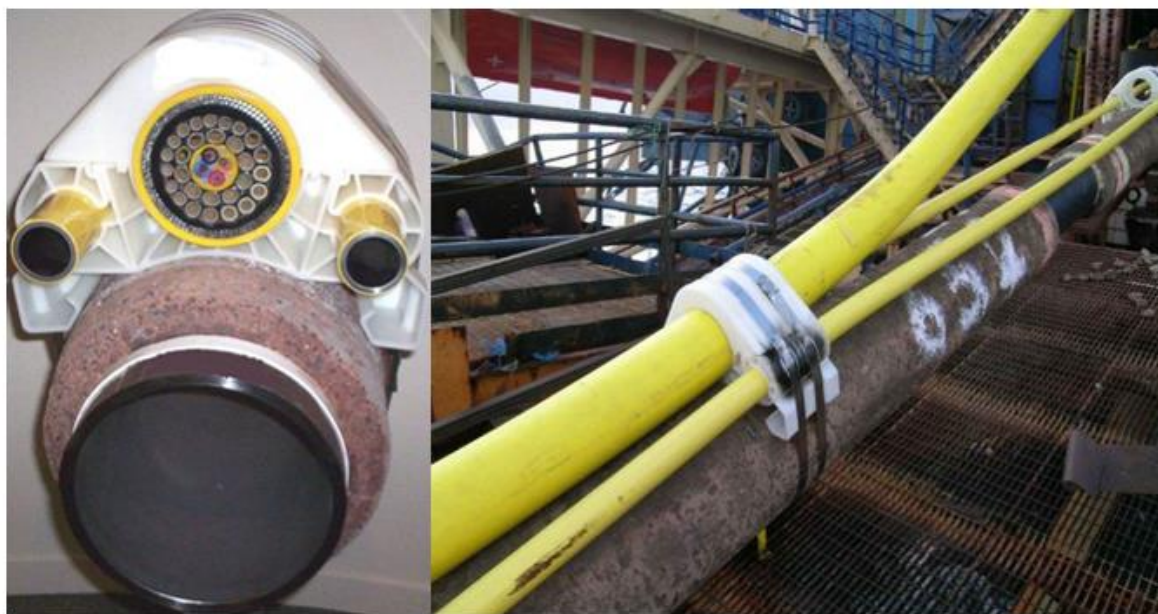
**Figure 2: Photos of piggyback clamps during the installation process**

The pipeline comprises of a 10-inch concrete coated rigid-steel flowline, bundled with an electrohydraulic umbilical and two 2-inch steel chemical injection lines and stabilisation materials (Figure 2). The Minerva pipeline bundle is secured together with polypropylene piggyback clamps spaced 6m apart. The Minerva pipeline has approximately 1600 clamps and each clamp is approximately 400 x 400mm in size. The piggyback clamps consist of 7 separate components that are held together with two stainless steel straps (Figure 3). The Minerva pipeline was laid in 2003, and the clamps have now reached the end of their 20-year design life.

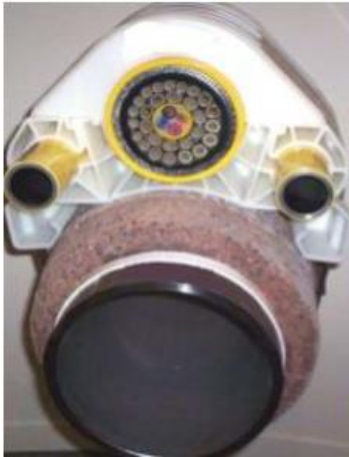
Figure 1: Piggyback clamp

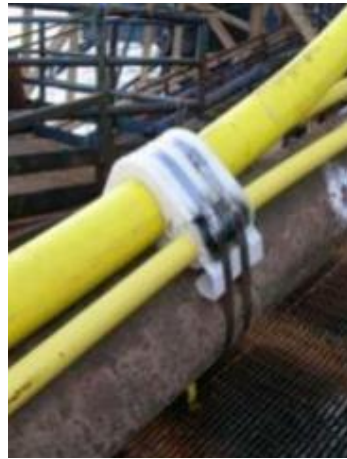
Figure 2: Piggyback clamp during construction/installation

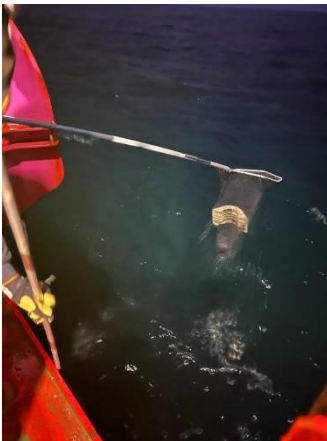
Figure 4: Piggyback clamp being recovered to deck using pool scoop.

A detailed tracking process for piggyback clamp condition was implemented, with assessments conducted on each pipe and clamp as they were recovered onto the vessel deck. This allows for evaluation of clamp integrity and identification of lost or damaged components.
