**From:** [REDACTED]  
**Sent:** Tue, 3 Jun 2025 10:56:03 +0000  
**To:** [REDACTED]  
**Subject:** RE: Report - DRAFT - Investigation IVT14016 - Minerva Decommissioning Plastic Saddles Lost to the Marine Environment (A1209024) [SEC=OFFICIAL]  
**Attachments:** NOPSEMA Engagement on Minerva Activities in Commonwealth Waters April 2025.pdf, 28 February saddle loss communications.pdf, 4 March First saddle loss during cutting.pdf

# MINERVA DECOMMISSIONING

Engagement with NOPSEMA

10 April 2025

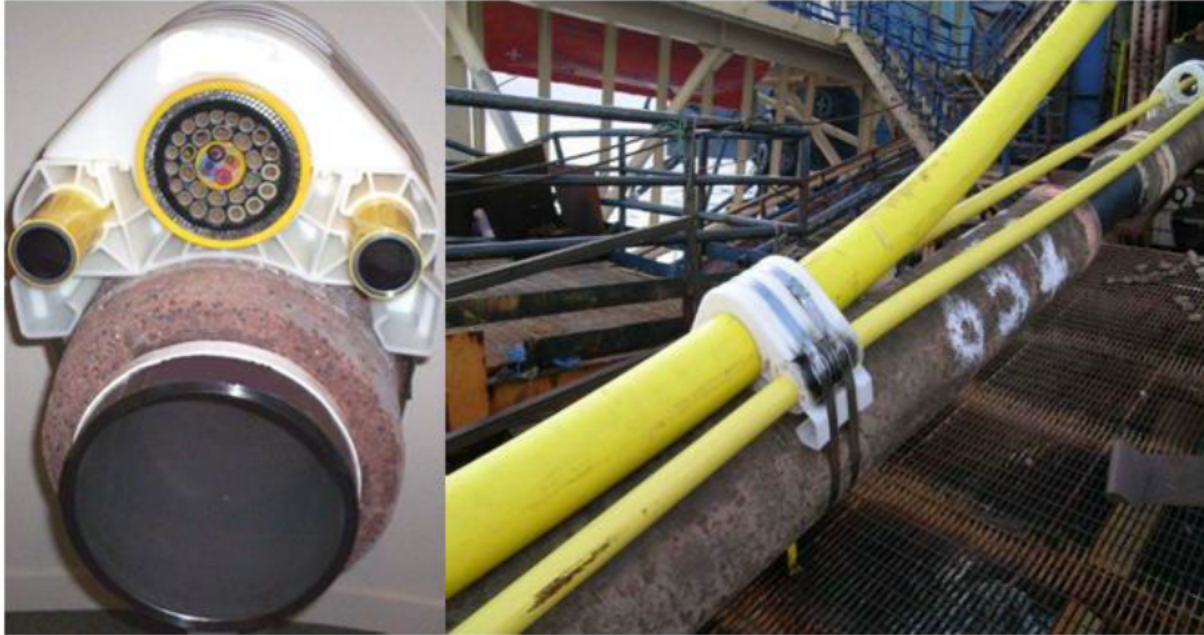
# Piggyback clamps

| Infrastructure | Quantity | Approximate Dimensions | Weight | Primary Materials | Current Status and Condition <sup>1</sup> | Removal under this EP? |
|---|---|---|---|---|---|---|
| Piggyback Clamps | 821 | 360 x 446 x 400 mm | ~ 3.1 Te | Polypropylene<br>Nickel-based alloy | Current Status: Design life of 20 years.<br>Clamps still holding piggybacked lines onto the pipeline.<br>Burial: Predominately buried.<br>Condition: Good condition. | Yes<br>Commonwealth waters component only. |

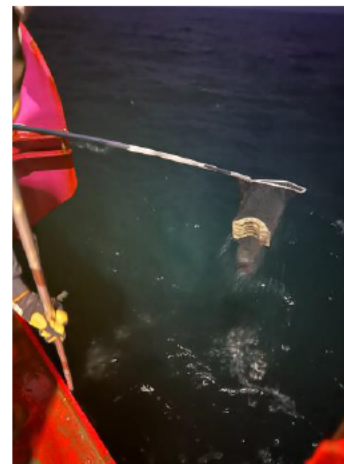
Pool scoop saddle retrieval 2/4/25

- Cut on Field Joints (easier to identify, better separation from clamps, cleaner cut)
- Pool scoops on board to retrieve saddles if safe (sea state) – successful recovery already performed
- Continue close monitoring and log of losses as pipe is landed on deck
- Procedure to cut at least 500mm from saddle
- SS7 to report loss in daily HSE report
- Recovering negatively buoyant saddle segments with ROV

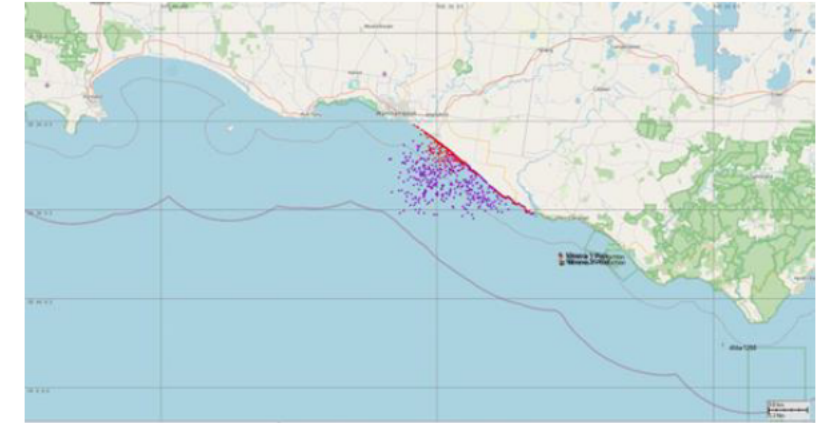
Example of Drift Modelling performed for Saddle Clamps – 10,000 items

- Hydrodynamic Modelling to estimate saddle resting location has been conducted - analysis in progress
- Drone surveys of beaches (AMOSOC) to identify washed up saddles and attempt recovery
- Beach walks to recover plastic – dependent on coastline (cliffs etc)
- Drone survey from vessel when cutting to search for saddles floating to surface – limited by sea state and recovery capabilities
- FRC spotting and recovering plastic – ALARP concerns due to exposure of human life
- Risk Assessment for unplanned discharge of plastic to the environment

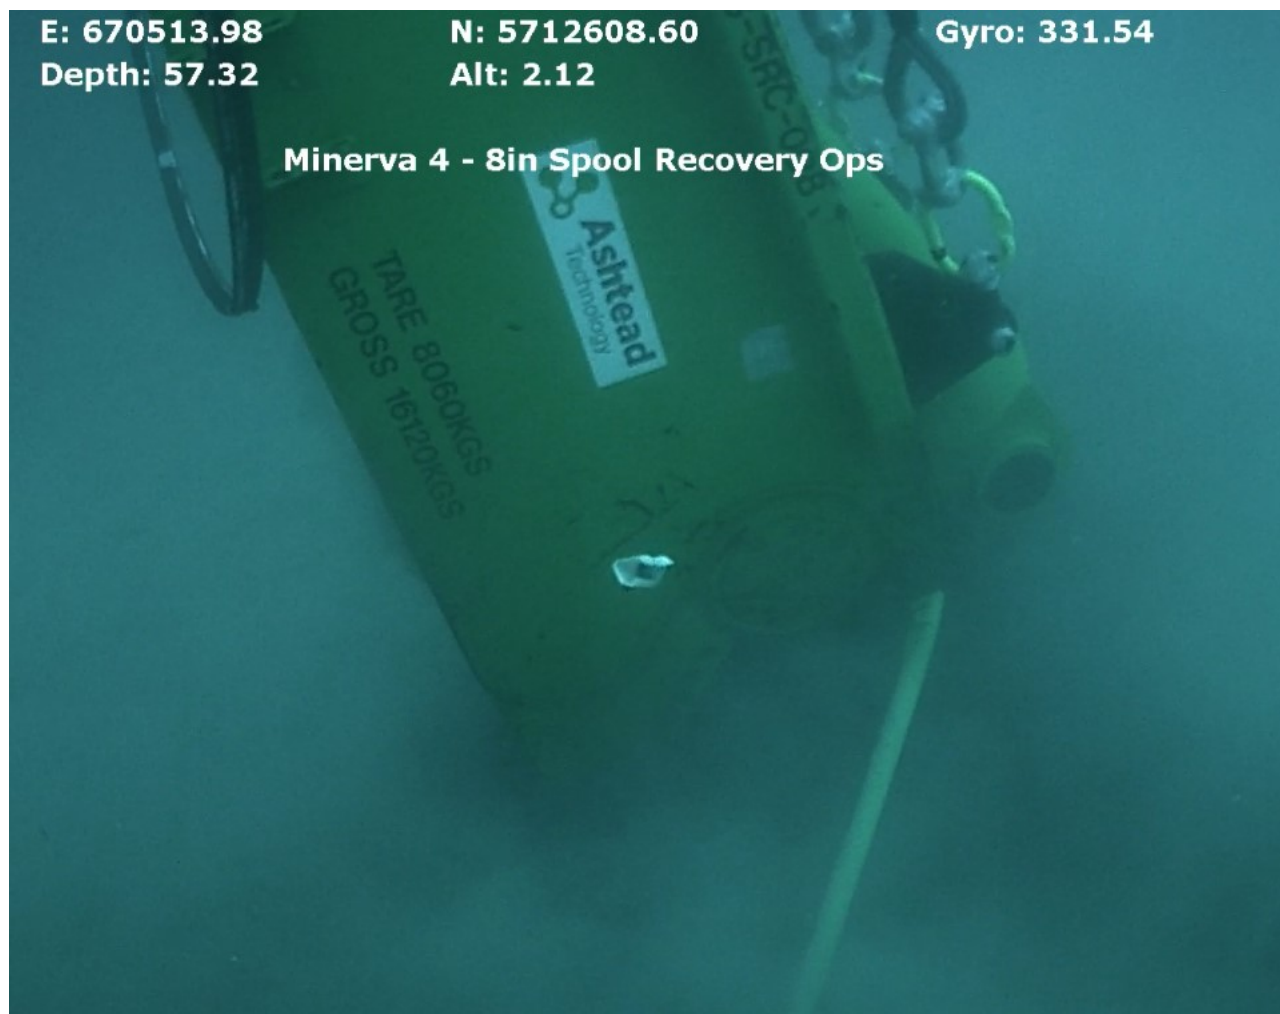
As discussed with [REDACTED] this afternoon, we observed a plastic saddle wing float up when undertaking shear cutting subsea. We were not able to find it on the surface. Here is an attached photo for context.

From our discussions onshore between [REDACTED] and myself a few weeks ago, we agreed we would advise if this occurs again and we would re-assess reporting requirements and mitigation actions based on frequency. i.e. 2 or 3 saddles per 24 hour period.
