Near Miss: Incorrect Use of Combination Spreader/Lifting Bar

No. 4900-HS-H0105

On Saturday 29 May 2017, a 9-tonne alternator was delivered to the Northern Endeavour (NE) facility along with a combination spreader/lifting bar. Used as a lifting bar the tool has a Safe Working Load (SWL) Limit of 4.05 tonnes, whereas when used as a spreader bar it has a SWL of 15 tonne. Subsequently, on 10 June 2017, the alternator was lifted using a rigging configuration where the combination spreader/lifting bar was used as a lifting bar, resulting in the bar being overloaded. When the situation was discovered the spreader/lifting bar was taken out of service and an investigation was commenced.

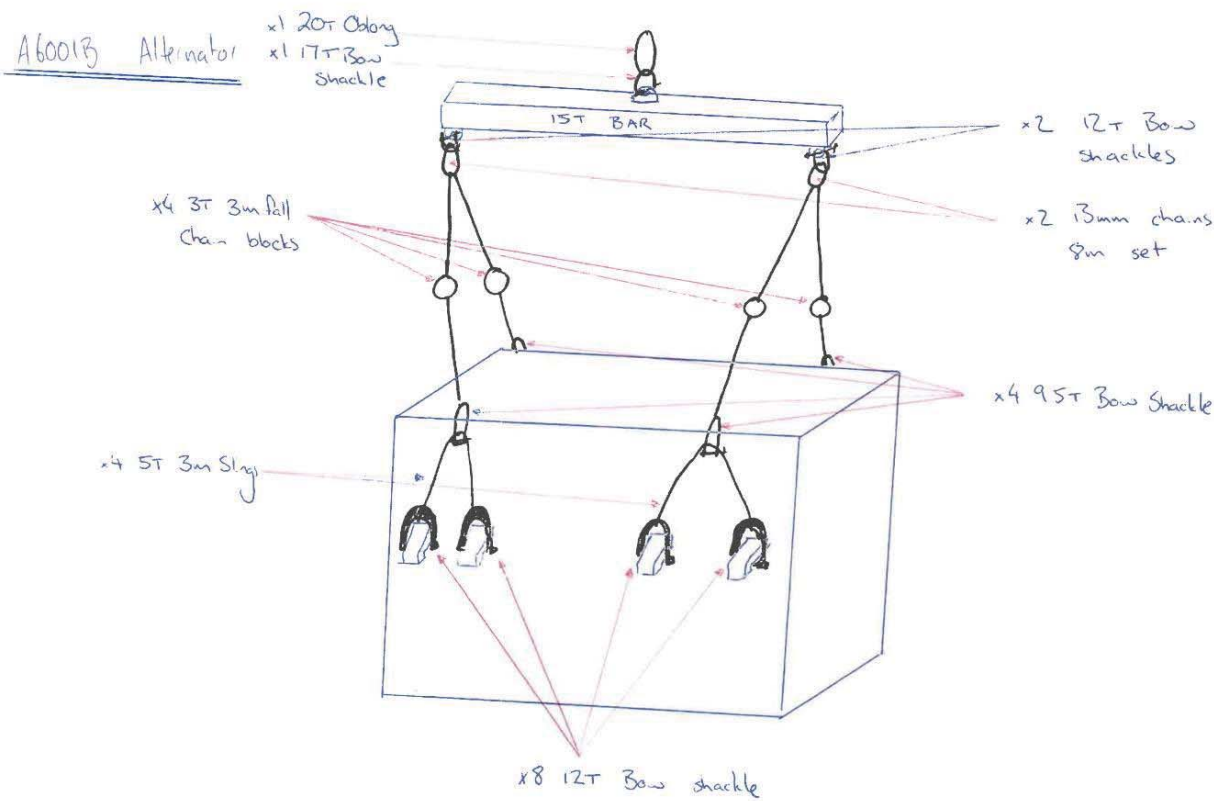
Appendix H Lifting Equipment Configuration

The rigging configuration employed the "lift bar" arrangement and not the spreader bar arrangement. The lift bar arrangement had a SWL of 4.05 tonne. On completion of constructing the rigging configuration, the rigging team reviewed and amended the PTW.
