# Dropped A-frame-mounted crane boom protection bumper

9 October 2026

NOPSEMA is alerting facility operators to a high-potential dropped-object incident involving a crane boom protection bumper mounted on the A-frame of an offshore pedestal crane.

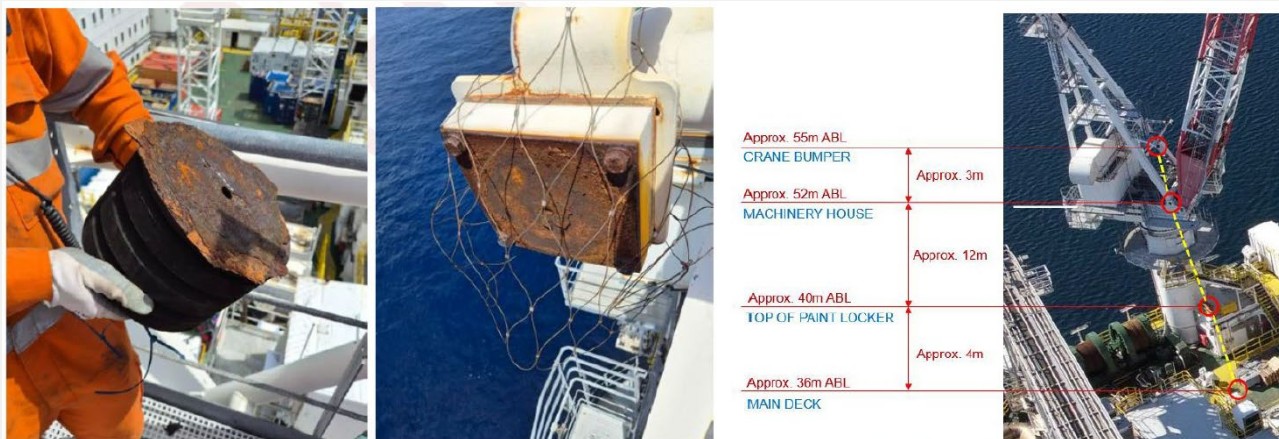
- deterioration and corrosion within the bumper attachment arrangement;
- apparent use of adhesive between the bumper and its securing plate; and
- a secondary retention arrangement that did not arrest the bumper after it detached.

The incident demonstrates that the presence of a bumper or secondary retention does not, by itself, confirm that the complete attachment arrangement is secure and fit for service.

- **Identify comparable equipment** and inspect crane boom protection bumpers with the same or similar design and attachment arrangements.
- **Inspect the complete assembly**, including the bumper, securing plate, bonding surfaces, fasteners and secondary retention. Inspection methods should be capable of identifying concealed corrosion or deterioration.
- **Verify the design and installation** against the original equipment manufacturer's specifications, including the suitability of any adhesive and secondary retention.
- **Manage the risk until integrity is confirmed**, including restricting crane operation and personnel access to potential drop zones where necessary.
- **Review maintenance and dropped-object controls** to ensure these components are included, with appropriate inspection access, frequencies, acceptance criteria and corrective actions.
