Near Miss: Dropped Object -Valve Shroud from Heat Medium Bypass

No. 4900-HS-H0077-03

This Near Miss: Dropped Object - Valve Shroud from Heat Medium Bypass has been reviewed by Upstream Production Solutions Pty Ltd and Northern Oil & Gas Australia Pty Ltd and is approved for the Northern Endeavour Project.

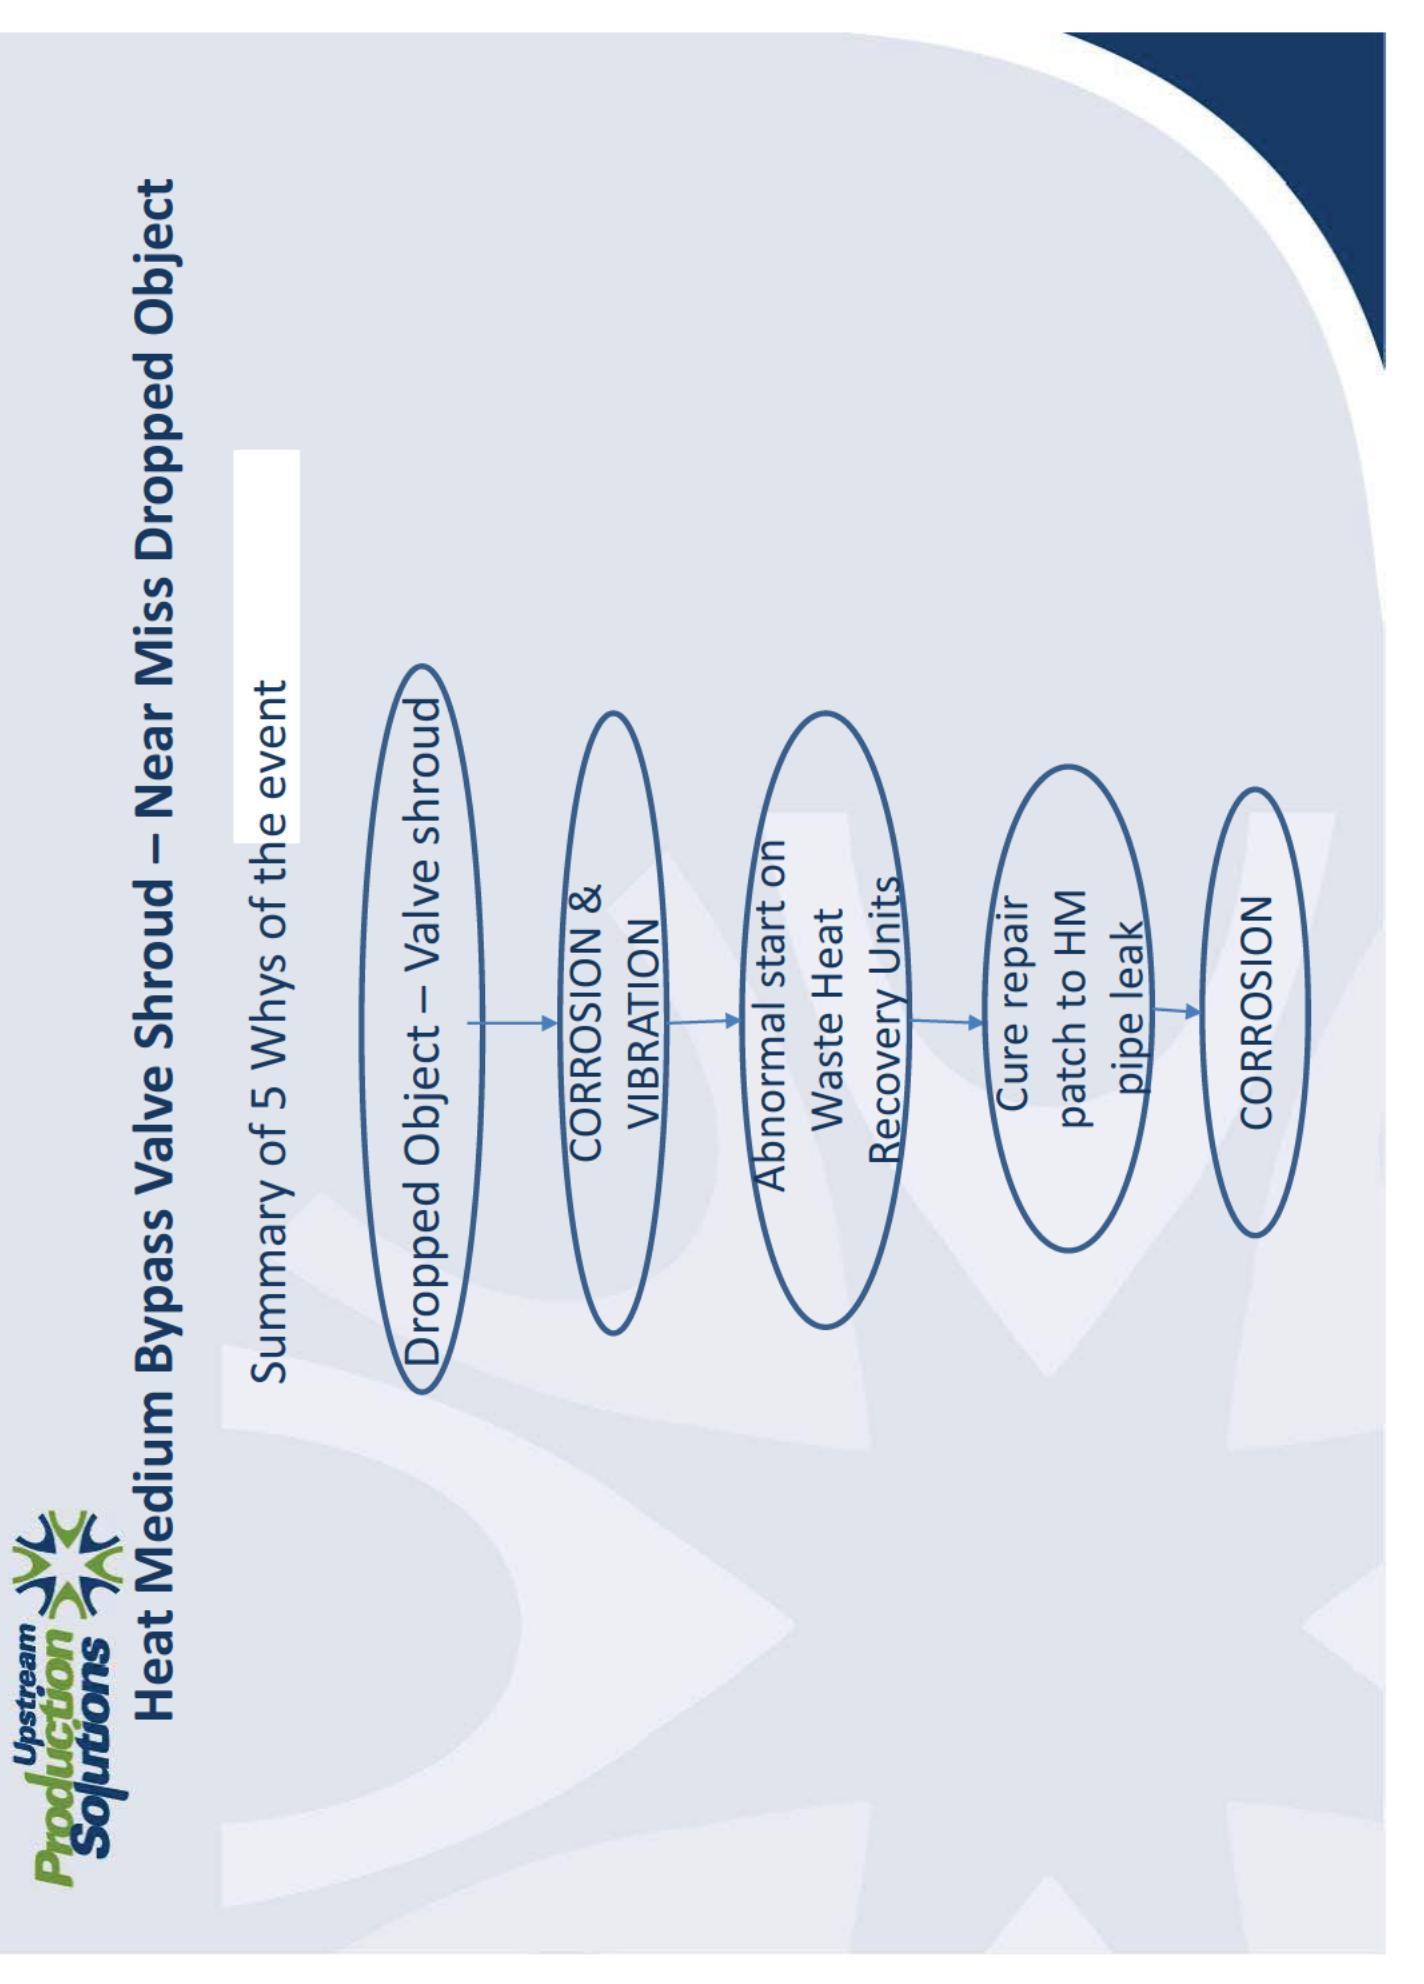
The sequence of events as per the investigation.

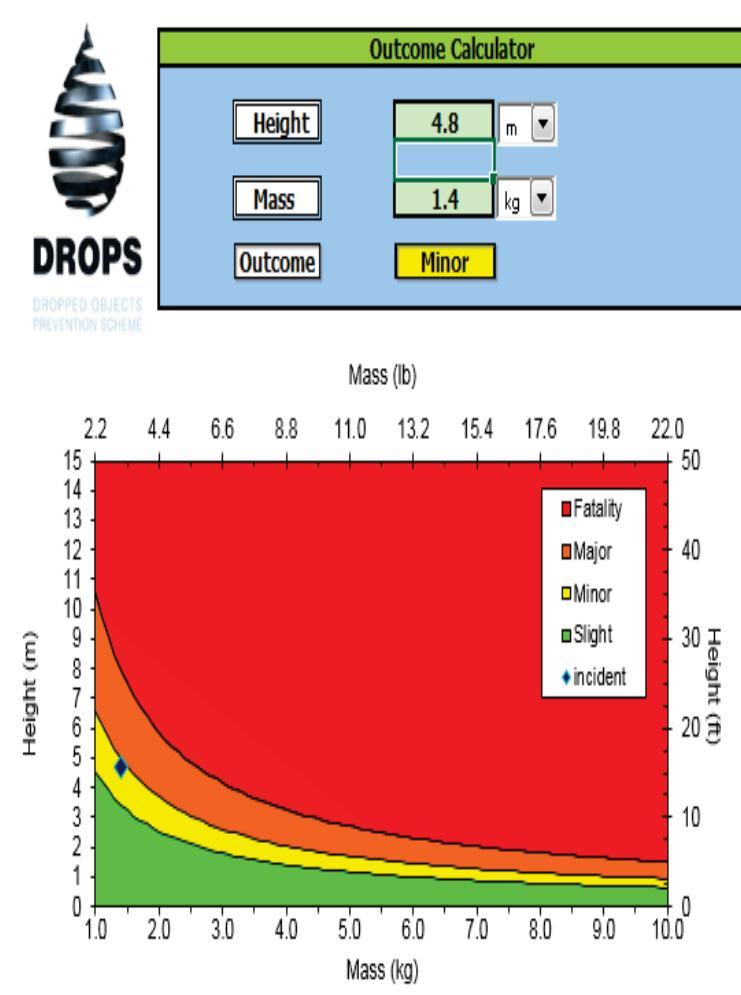
Appendix B.1 Incident 002648

- (1) Corroded valve handle dropped object from mezzanine to process deck 07 October 2016.
- (2) This was categorised as a "minor" incident as the dropped height/weight calculated was rated as minor. An action arising from this incident review (identify other potential dropped objects in the area) was closed on 14 February 2017.

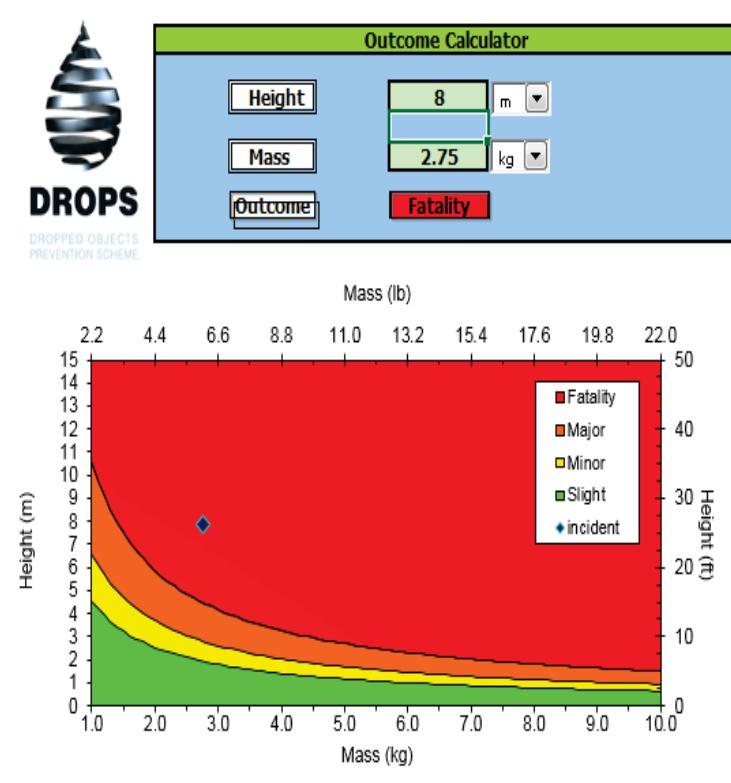
Appendix B.2 Incident 002761

At 1616 hours on Monday 12 February 2017, a 3.75 kilogram section of corroded pipe and a steel rod fell 8 meters, missing an operator by 1.5 meters. Analysis indicates that if the objects had struck the operator this would most likely have caused a fatality.
