Title:Major Investigation Report Angel Loss Of Containment Piping Failure On Coalescer B Vent Line Welev13060135

**Major Investigation Report: Angel Loss of Containment :
Piping Failure on Coalescer B Vent Line -
WELEV13060135
Asset/Site: Angel Facility
Date of Occurrence : 20th June 2013**

Incident Reference: WELEV13060135

Location, Date and Time: Angel Facility, 20th June 2013, 01.12 hrs

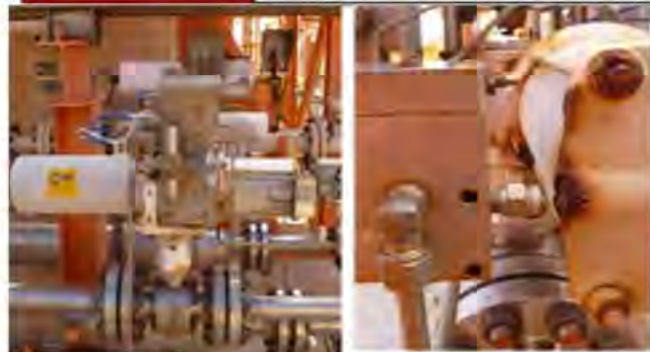
Event #	WELEV13060135	Brief Description	At approximately 0220hrs on the 20th June 2013, during restart of the Angel platform from a planned shutdown, a gas release was observed by the Area Authority on shift. The platform was immediately shut down and de-pressured.
Date	Thursday, 20 June 2013	Outcome	No personnel were injured during this event. This event resulted in the Angel platform being shutdown for an additional 42hrs while an investigation was held and controls were put in place. The approximate loss of containment value is calculated at 62kg.
Event Type	Loss of Containment - Hydrocarbon	Root Causes	<ol style="list-style-type: none"> 1. On/Off Valve exhaust flow regulator fails catastrophically allowing valve to close rapidly resulting in pressure spike lifting PSV. 2. PSV fails to reseal with blowdown (reseal pressure) lower than operating pressure. 3. Extended duration PSV chatter attributable from 2 phase flow, led to eventual failure of system weak point (pipes support) and loss of containment. <p>ROOT CAUSE – Problem Not Anticipated</p>

Risk Rating	Potential B (H&S)	Actions	<p>IMMEDIATE MITIGATION: V11316, 11320 and 11420 are isolated on the panel only under the red tag requirement under a long term permit and opened only when facility is manned and operator in attendance.</p> <ol style="list-style-type: none"> 1. Provide adequate support to heavy Exhaust Flow Regulator. 2. Review selection of PSV type considering event scenario. <p>(Refer to Major Investigation Report for additional observations)</p>
GSR Involved	N/A	Lessons Points	Correct approach by outside operations to allow safety systems to manage event rather than try to intervene and isolate.
