Error tolerance in dynamic positioning systems

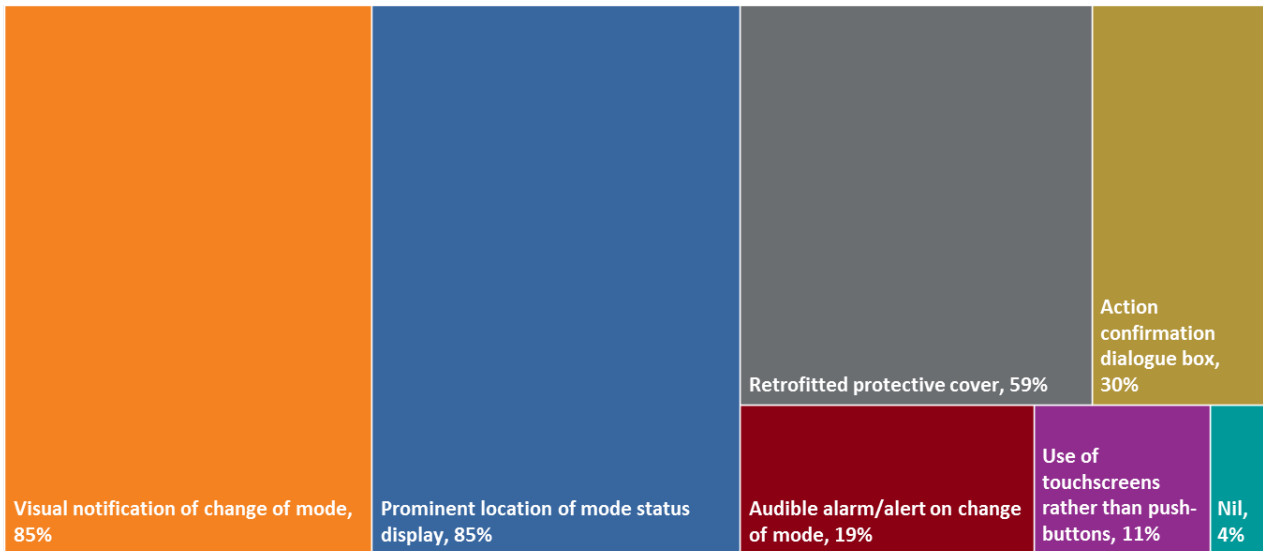
Figure 1 - Means of protecting against unintentional deactivation of three-axis control

Information received from 28 DP facilities¹ indicates that 96% rely on double-press functionality as a means of protecting against unintentional deactivation of three-axis control. The majority of facilities had taken additional steps to protect against unintentional deactivation. These are summarised in Figure 1.

- DP officers chair fitted with a table to avoid objects being placed on DP console.
- Altered keyboard layout has positioned the control-axis buttons in a location that reduces opportunities for inadvertent deactivation.
- Use of trace lines during DP operations to identify inadvertent vessel drift.
- Incorporation of alerts into training and drills.
- Clean desk policies.
- Procedural controls including standing orders and case study discussions.
