Fibre Reinforced Plastic (FRP) deck gratings

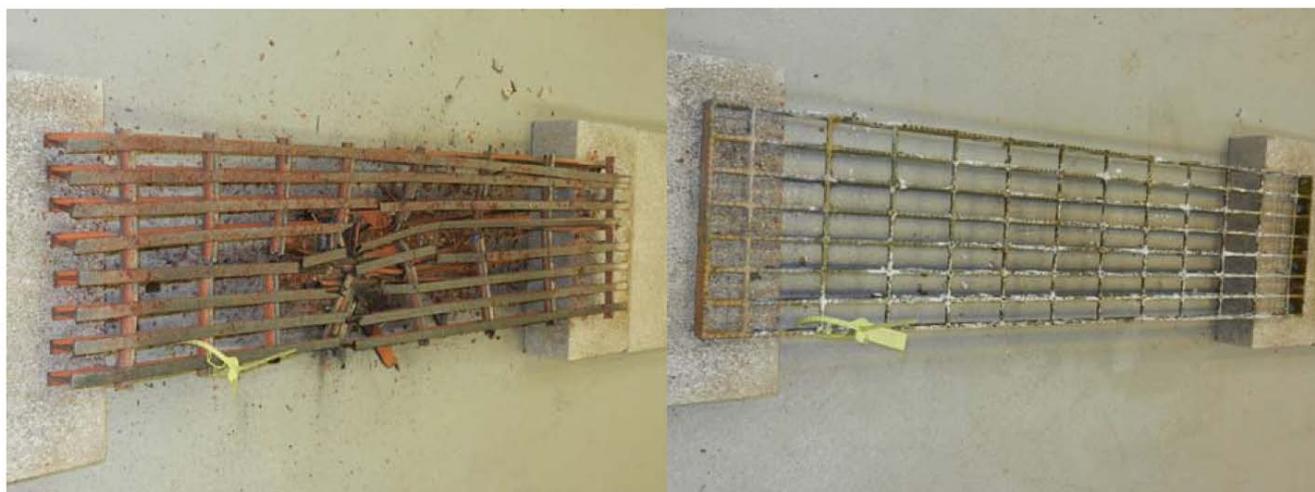
FRP deck gratings have the potential to appear undamaged after being exposed to hydrocarbon fires and can catastrophically fail while under the load of an individual. For example, a worker who runs over the grating has the potential to fall and encounter serious injury.

Figure 1 FRP (left) and steel (right) gratings post dynamic testing.

- Operators should ensure that when proposing to make a change they take all reasonably practicable steps to source available safety information related to the change, and act on it where appropriate.
- FRP grating has been shown to be vulnerable to hydrocarbon fires and its use on an offshore facility needs to be assessed to ensure that risks associated with its use are ALARP.
- If facility operators use FRP grating they need to clearly define the performance required of the grating. For example the temperature and duration of fire that the FRP should resist and still subsequently support a minimum weight under dynamic conditions.
- The performance required of the FRP grating should then be compared against the performance described by suppliers to ensure that the FRP grating can meet its required performance.
