## Vessel loss of position while diving in close proximity to a hydrocarbon facility

For further information email [alerts@nopsema.gov.au](mailto:alerts@nopsema.gov.au) and quote: **Safety Alert 62**.

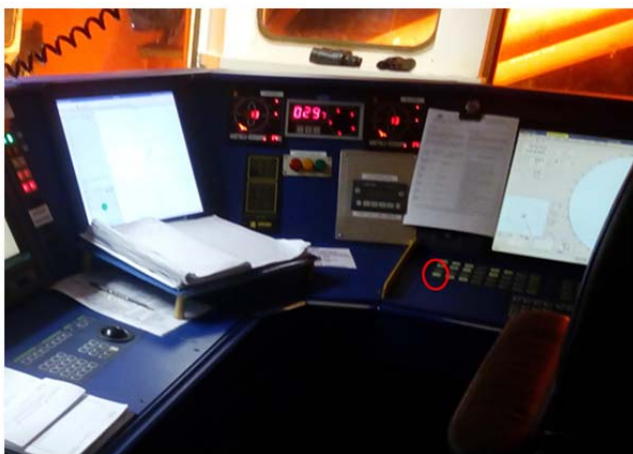
Recently a vessel facility undertaking construction activities had an unplanned movement while diving activities were being conducted approximately 130 metres from a hydrocarbon facility. The loss of position was caused by a deactivation of the forward/aft automatic positioning function by unintentionally deselecting the 'surge' button on the DP (Dynamic Position) console located on the bridge (Image 1 & 2) which then deactivated the 'Auto Position' mode. The deselection was thought to have occurred by the placement of a notepad on the side of the console. The vessel drifted off location by over 40 metres and this drift was initially noticed by a diver when his umbilical started to become taut.

Once the DPO (Dynamic Position Operator) became aware of the excursion, the 'Auto Position' mode was reactivated causing the vessel to stop moving and remain in position. During this time, the diver had followed his umbilical, moved clear of any obstacles, and walked with the vessel.

Image 1 – DPO workstation

If either of the controls identified above were in place, it is unlikely the incident would have escalated to a loss of position event. In order to rectify the issue the operator, with assistance from the manufacturer, are currently upgrading the control systems software to provide a separate dialogue box confirmation requirement when deactivating the 'Auto Position' mode.

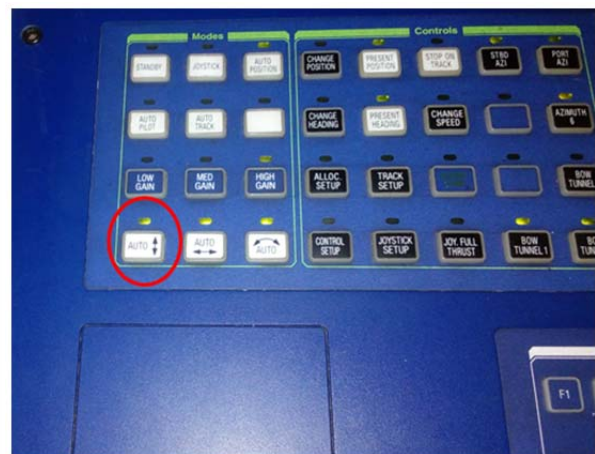
Image 2 – Inset of DP console ('Surge' button circled)

Due to the potential severity of the consequences of this incident NOPSEMA directed its inspectors to investigate the incident by conducting an OHS inspection on board the facility (independent of the facility operator's own investigation). NOPSEMA's investigation identified that the auto DP mode buttons (Surge, Sway and Yaw) were located in the left hand corner of the console next to desk space commonly used for completing DP related checklists and logs. Consequently, these buttons were susceptible to accidental activation by personnel.

The inspectors found that although the incident arose by an accidental and unknowing double press of a button by the DPO, the design of the DP system allowed a human error to escalate this act into a dangerous

occurrence by neither requiring any positive confirmation of deactivation of 'Auto Position' mode nor providing any alarm that required acknowledgment that 'Auto Position' mode had been de-activated. The situation was exacerbated and recovery impeded as deselecting the 'surge' button automatically deactivates the excursion alarms in that axis and the DP display was no longer providing useful feedback in terms of the loss of position event as the excursion rings started to track with the vessels movement.
