Tube Compression Fitting Failure

For further information email alerts@nopsa.gov.au and quote **Safety Alert 48**.

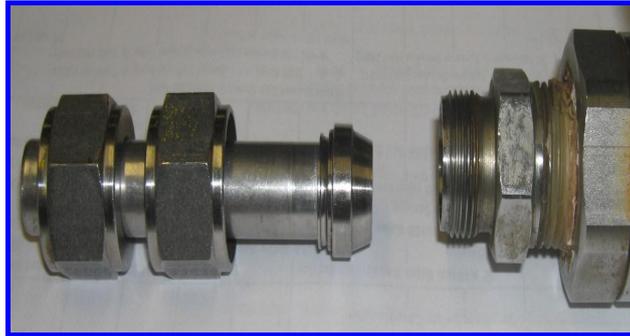
A recent near miss incident has identified that compression fittings associated with high pressure tubing lines have the potential to fail by working loose under certain conditions.

- incorrect insertion depth with ferrules set at the end of the tube (see above photograph); or
- ferrules had worked loose over a period of time because of improper fitting assembly at installation followed by exposure to vibration or pressure pulsations.

Materials such as MP35N alloy, used for ferrules for some compression fittings, are of a very high yield and tensile strength. This quality however, can prevent the ferrule from "biting" into the parent tube material if insufficient pressure and torque is applied when assembling the fitting.

Operators should carry out an audit of compression tube fittings and ensure that these fittings have been installed in accordance with the manufacturer's recommendations and that the ferrules remain in the correct location.

Operators are to ensure installation and inspection competency in personnel including contractors and third parties undertaking the fitting and maintenance of compression fittings. This may include the implementation of a maintenance audit regime that routinely inspects compression fittings subjected to vibration and pressure pulsations, with comprehensive and complementary training and procedures.
